I N D E X

Sea Bee Service News
Republic Aviation Corporation

Service News No 1

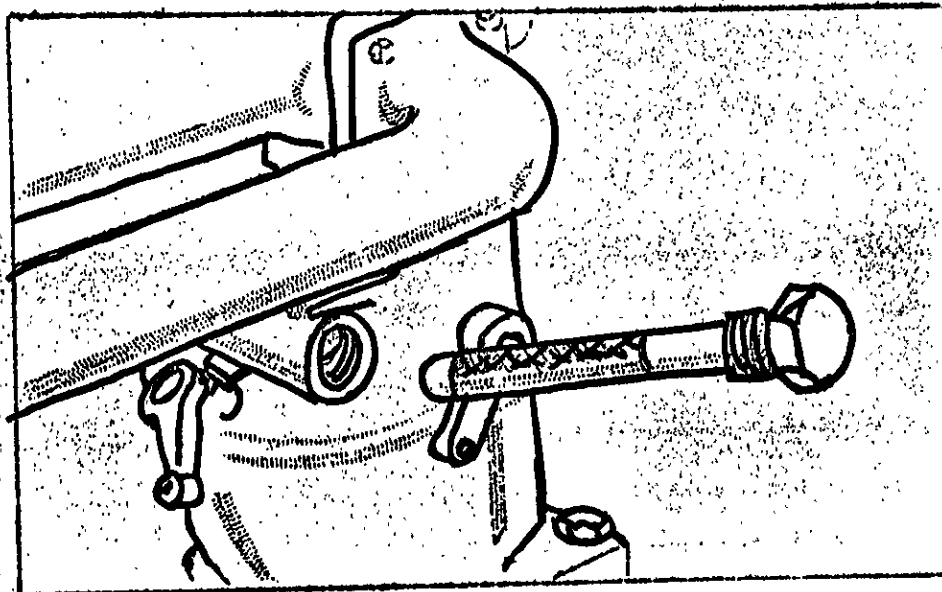
The extremely fine mesh of the carburetor finger screen is easily clogged by fine particles and fibers of foreign materials which pass through the coarser filters in the tank and fuel line. One case has been experienced wherein fine fiber, possibly decomposed paper, sufficiently blocked off the area of the finger screen to cause lean operation with resultant high head and oil temperatures. Before establishing the source of difficulty, forced landings were experienced ~~due to fuel starvation.~~

CLEAN CARBURETOR FINGER SCREEN EVERY 10 HOURS!

It is imperative that the strainer be removed and thoroughly cleaned every ten hours of operation. The main fuel strainer, being of larger size and coarser mesh, should be cleaned every 25 hours. Great care should be taken to prevent the entrance of any foreign material into the fuel system.

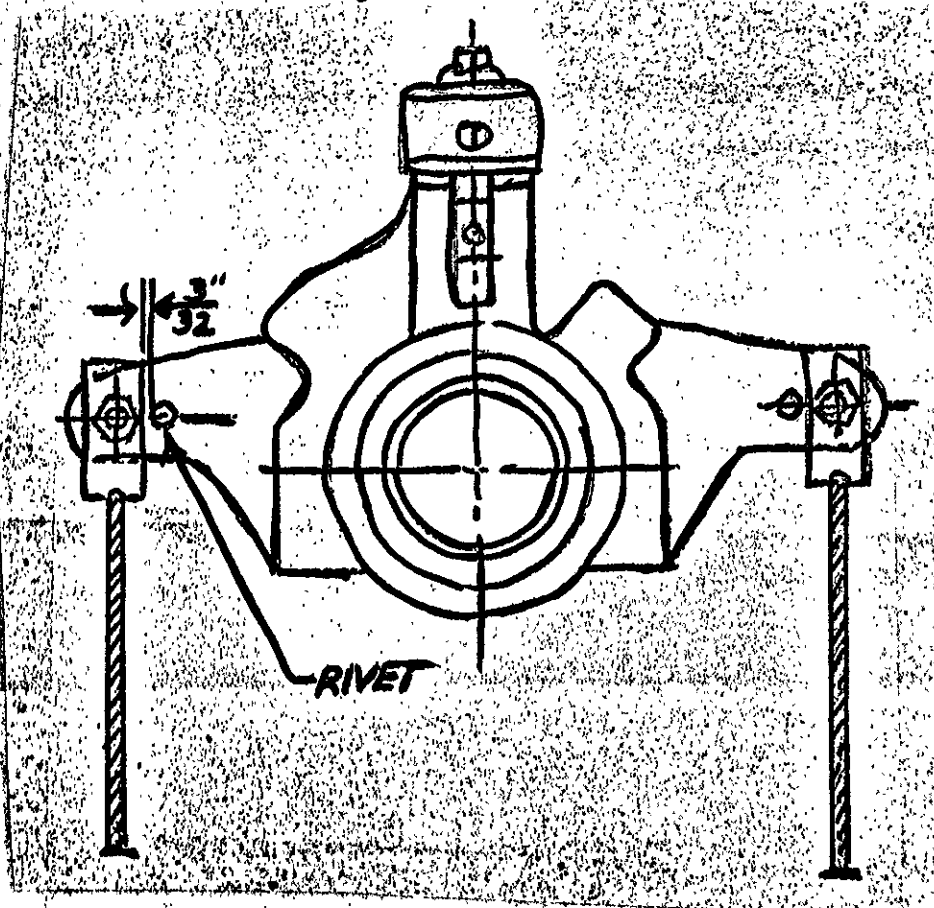
INSTALLATION STEERABLE TAIL WHEEL

To prevent steerable tail wheel control cable terminals from swivelling one hundred and eighty degrees on the quadrant when the tail wheel is retracted, rivets are placed along-side the terminals. If the cable terminals swivel there is danger of breaking the cables. Some of the early quadrants shipped in kits did not have these rivets installed. Please inspect these quadrants and if the rivets are not evident, install a rivet, screw or bolt so that there is $\frac{3}{32}$ inch clearance between the inboard edge of the terminal and the edge of the head of the rivet, screw or bolt.
