FLYING BOAT SEAMANSHIP

Former RAF flying boat ground tradesman Bill Mortimer explains some of the little-known aspects of flying boat operations

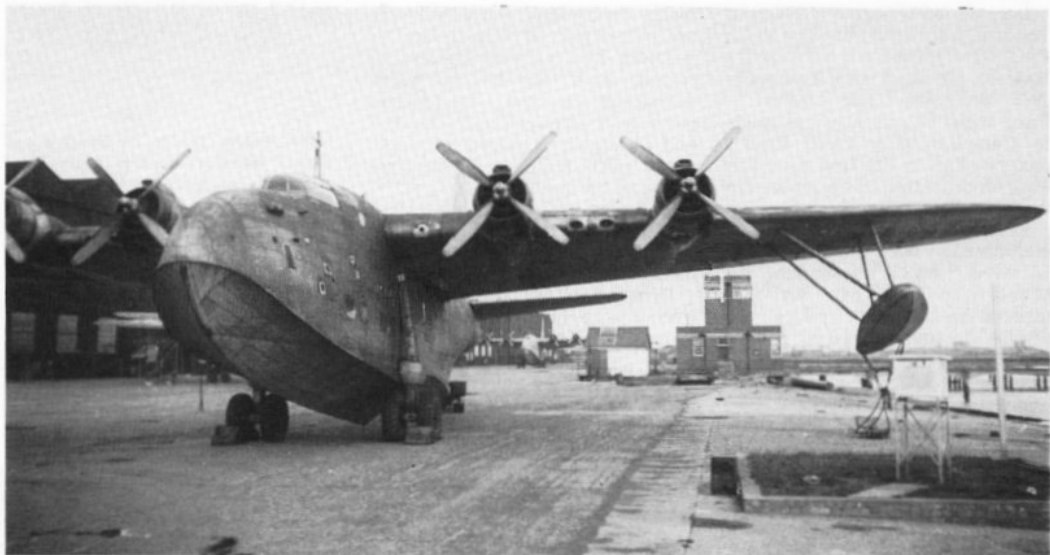
Sunderland V PP162 on a mooring at high water off Felixstowe slipway and gantries. The 50-ton Titan crane is in the background. (Bill Mortimer)

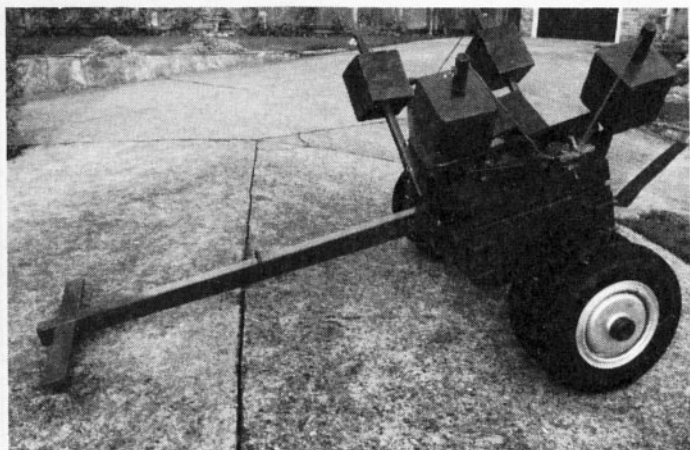
Sunderland type tail trolley. Manufactured by Captain Vic Hodgkinson for 'Beachcomber', Southampton Hall of Aviation. (Captain Vic Hodgkinson)

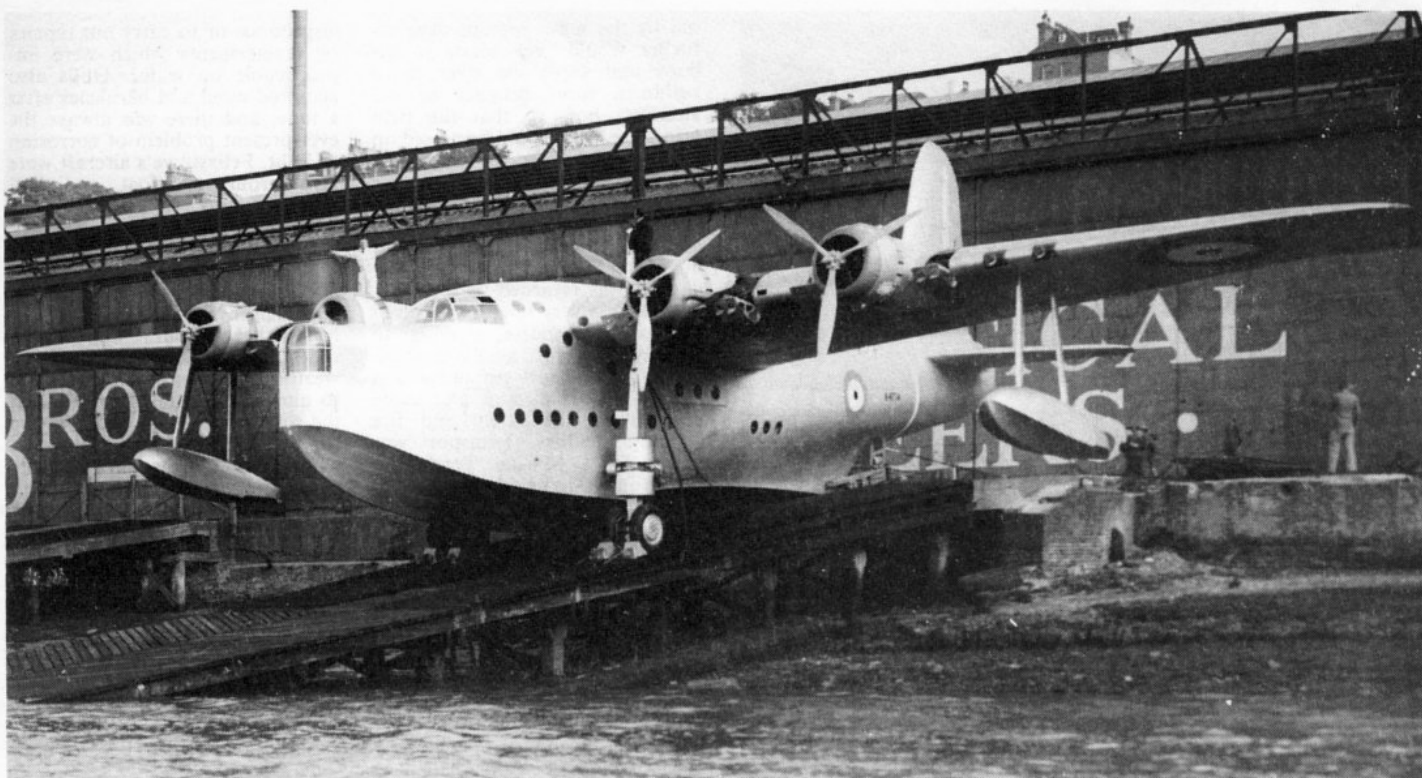
An excellent pre-war picture of the prototype Sunderland outside the Short Bros works at Rochester on its beaching trolley during preliminary engine runs. Note that there are slight differences between the main legs and those shown below.

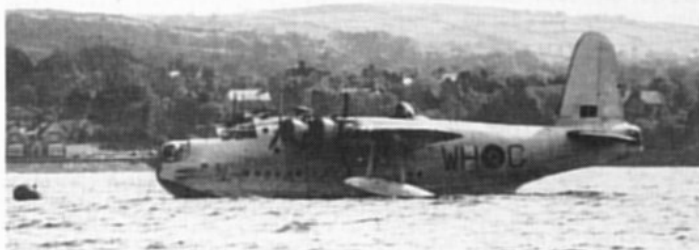
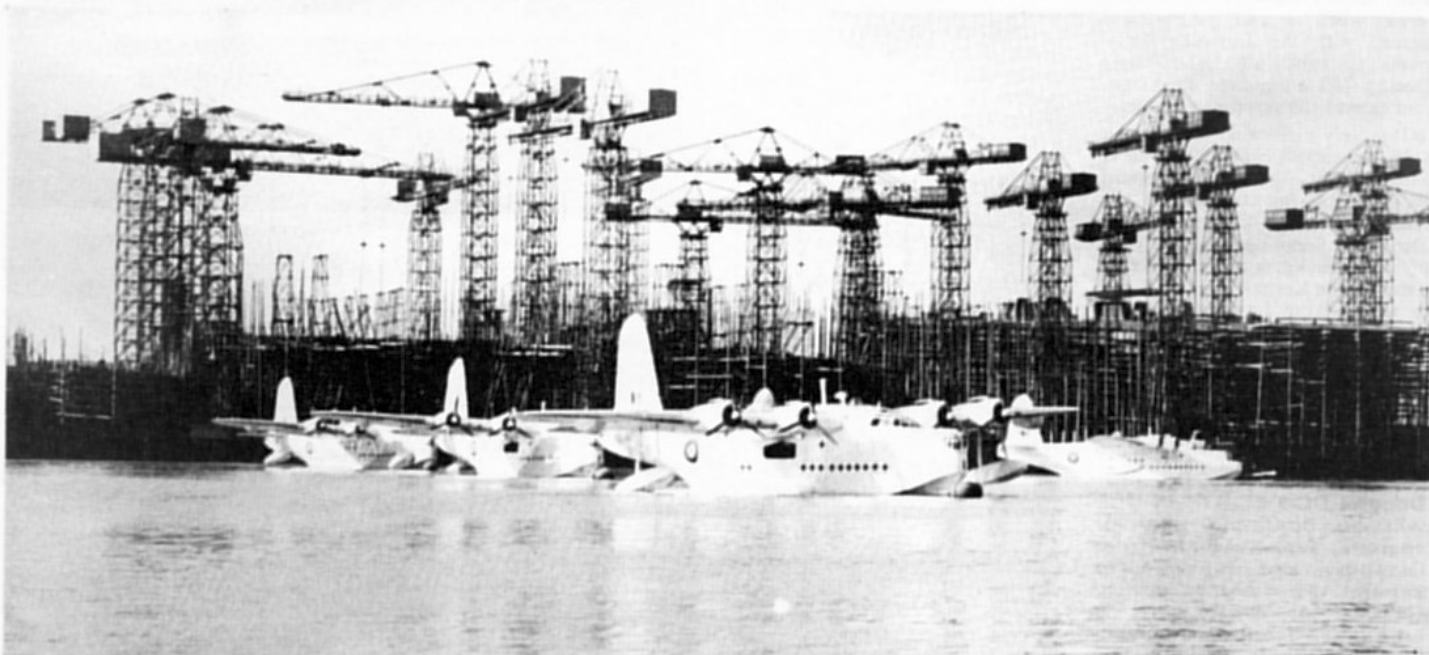
Right: Ideal conditions. A Sunderland III NJ188 of No.330 (Norwegian) Squadron at its buoy. Both wind and tide are coming from the same direction thus presenting the right sort of parameters for immediate taxi and take-off should this be needed. Below: Tail piece. These four Sunderland Vs are moored in the channel outside Short Bros Belfast factory at the end of the war.
