I N D E X

Sea Bee Service News
Republic Aviation Corporation

Service News No 1

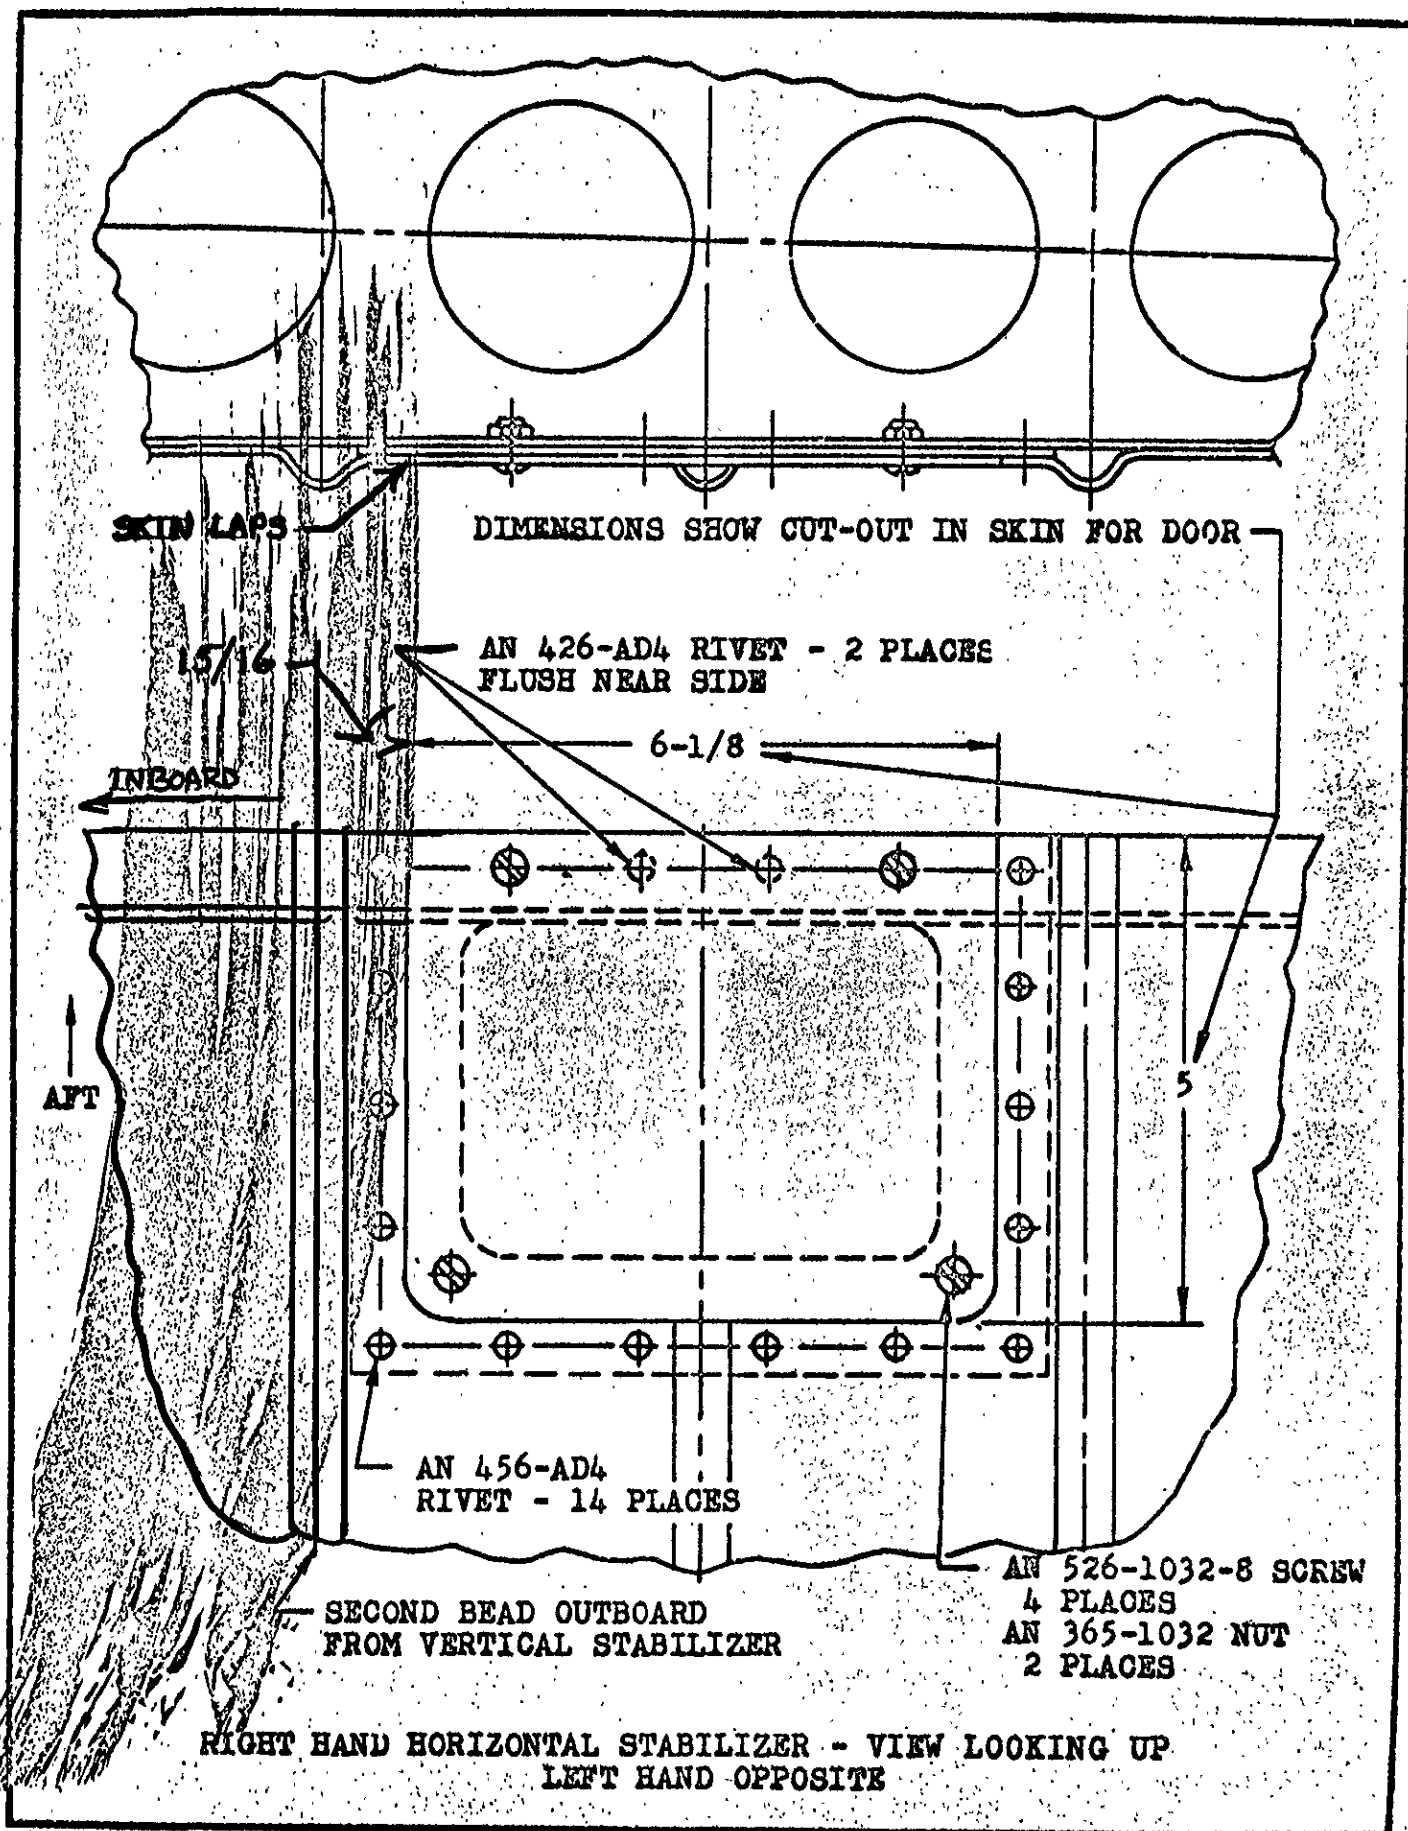
FIG. 2

The large handholes require a door and frame for each stabilizer. These may be made in accordance with instructions on Figure 1 and installation of the frame and door may be accomplished as shown on figure 2.

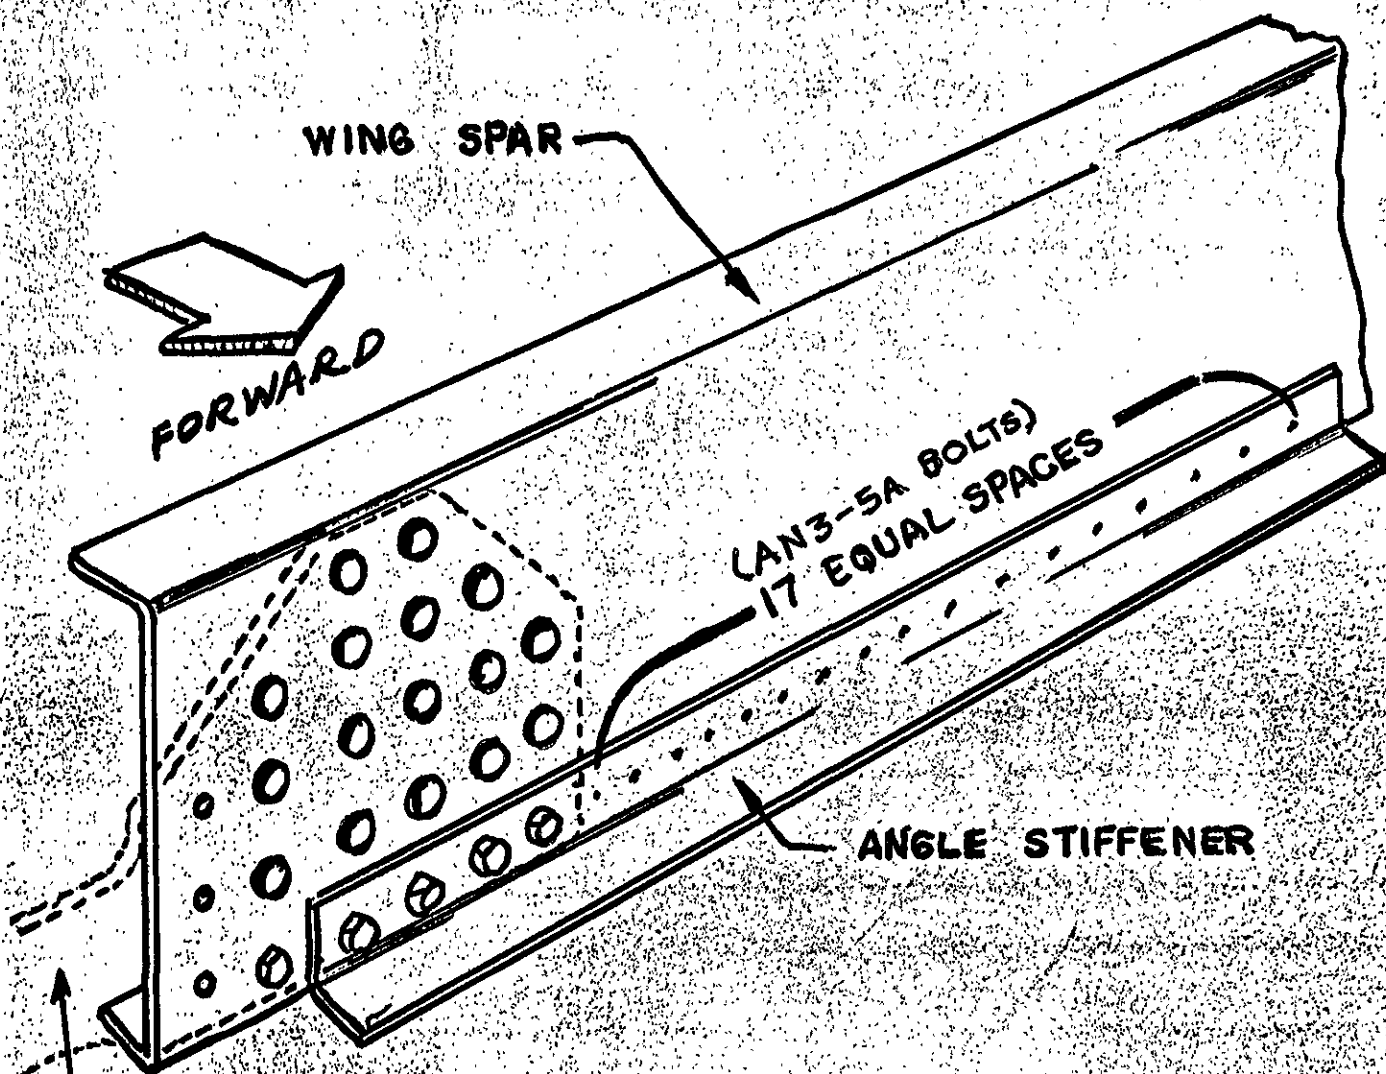
Reason for Change: The design of the wing float strut is adequate for normal usage. However, a brace has been developed which will double the ability of the strut to take side loads such as are imposed during drift or rough water landings. This brace, which attaches to the wing lift strut fitting and the bottom of the float strut, is designed so that two rivets will shear before a heavy side load could damage the lift strut fitting. As this brace also increases the strength of the float strut in a fore-aft direction, it is necessary to add a reinforcing angle to the rear spar at the inboard end so that an adequate margin of safety is provided between the ultimate strength of the float strut and the point at which the rear spar may crimp.

1. Place flaps in partially down position.
2. Remove four outboard bolts from fitting on inboard end of rear spar, leaving inboard end bolts as is.
3. Place 17W21028-1L angle in position shown on Figure 1. This is on the forward bottom side of the aft wing spar. Insert angle thru spar lightening hole. Install second from inboard end bolt thru existing hole in angle and clamp outer end of angle in position.
4. Mark location of seventeen holes to be drilled in spar web as shown on Figure 1 and drill thru web and angle with a #10 (.193) drill. Install AN3-5A bolts, AN365-1032 nuts and AN960-10 washers.

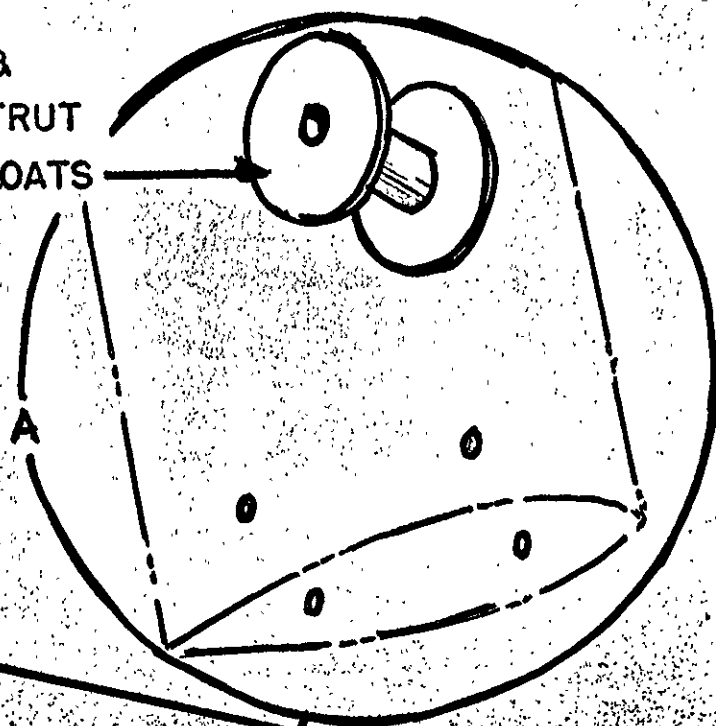
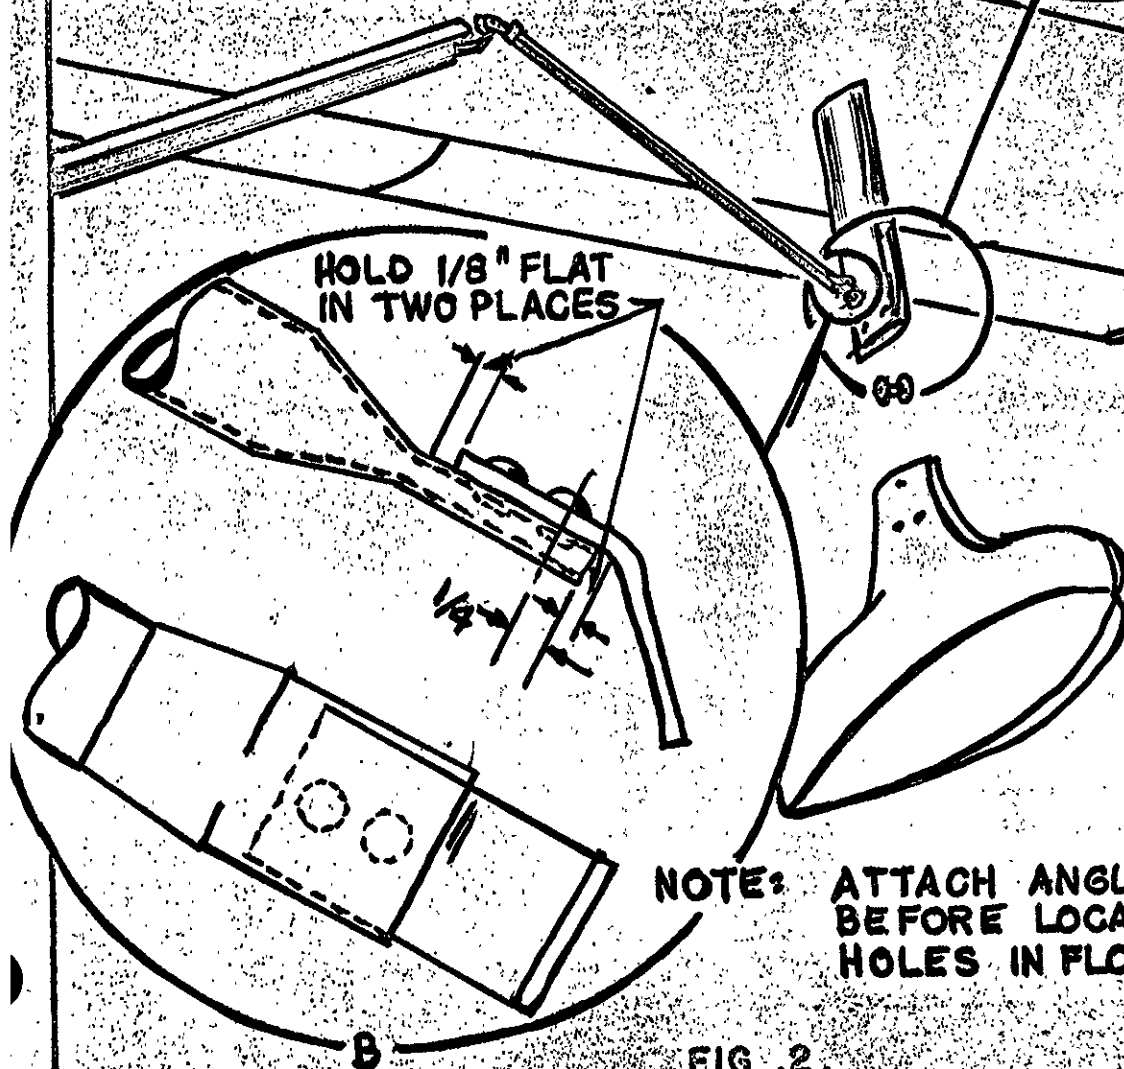
FIG .2.

NOTE: ATTACH ANGLE TO STRUT
BEFORE LOCATING RIVET
HOLES IN FLOAT BRACE

7. Install Float Strut Brace Assembly 17W22013-1L, Spacer 17W22011-1 and Lug 17W22010-1 as follows on the left wing referring to Figure 2.
 - a. Remove wing float.
 - b. Attach Strut Brace Assembly 17W22013-1L to forward side of wing lift strut fitting using same bolt which attaches lift strut to fitting.
 - c. Reinstall wing float, first placing Spacer 17W22011-1 and two Washers 17W2201L-1 over spacer in upper attaching hole in strut as shown on Figure 2 (a).
 - d. Put Lug 17W22010-1 in place as shown. Using pilot holes in lug as guides drill thru lug at end of strut with a #20 (.161) drill first being sure that there is at least 1/8 inch flat at the two locations shown on Figure 2 (b). Attach lug to strut with two AN441-5-7P rivets.
8. Repeat above installation on right side.
9. Make suitable entry in log books.
