**Handbook of  
Structural Repair  
PBY 5**

AN 01-5M-3

# Handbook of Structural Repair

• **PBY-5 • PBY-5A • PBY-6A**

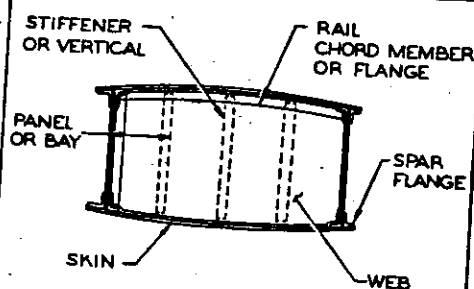
WING BULKHEAD

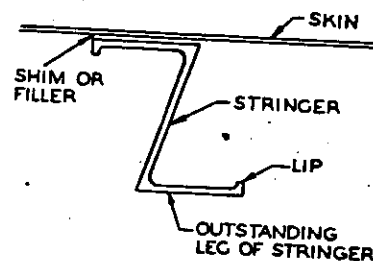
PLATE-STRINGER COMBINATION

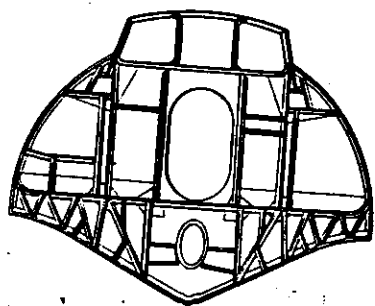
HULL BULKHEAD

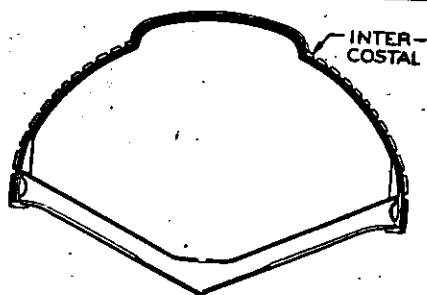
HULL BELTFRAME

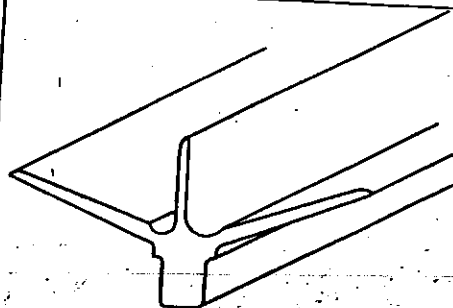
KEELSON

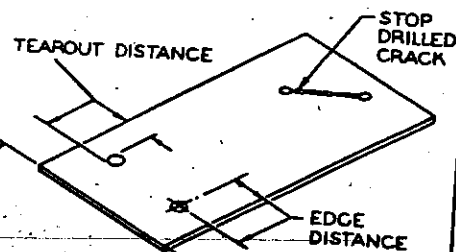
TEAROUT DISTANCE

STOP DRILLED CRACK

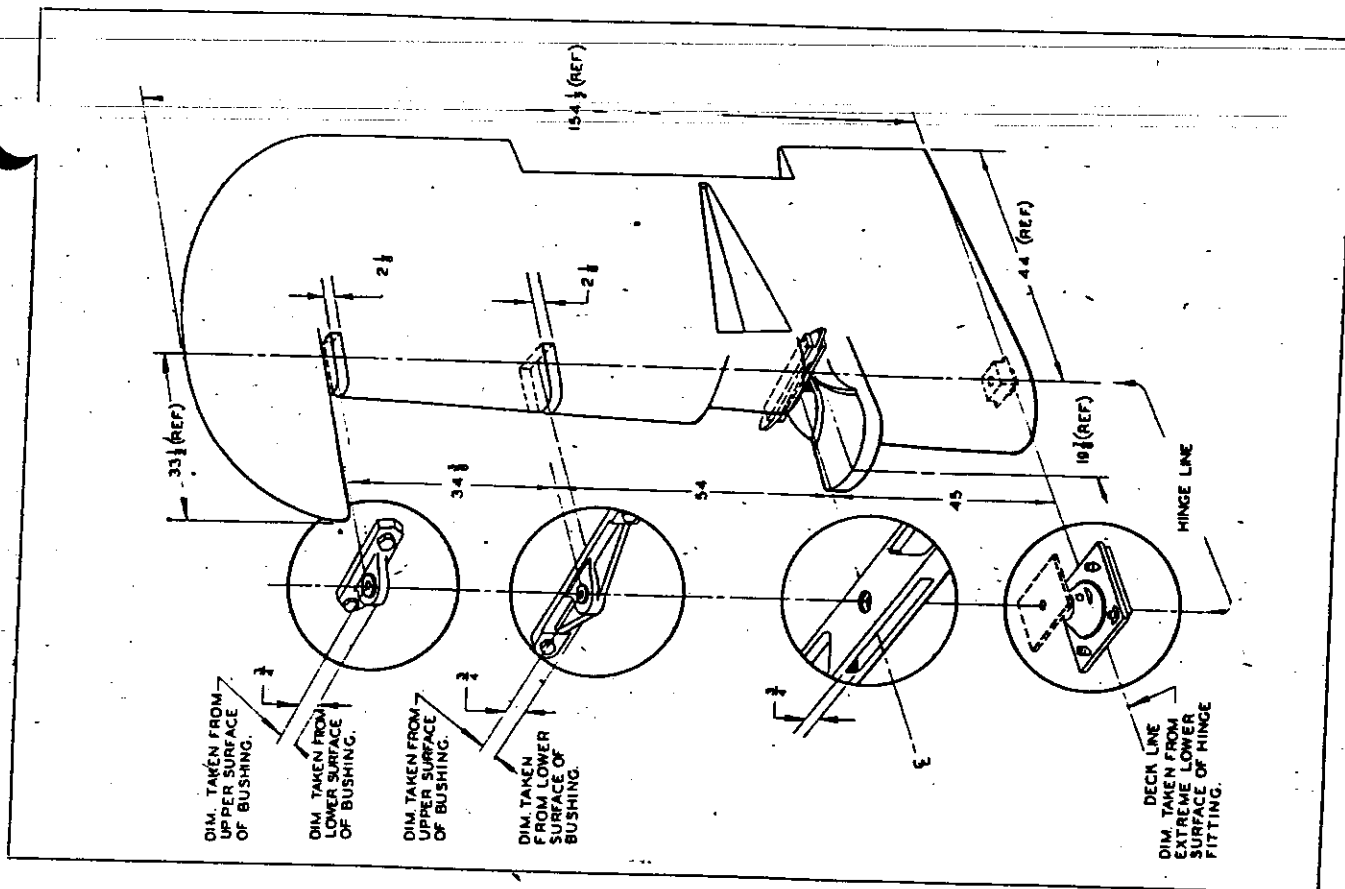
Figure 1-2—Rudder Jig Points

1-48. The control surfaces (aileron, rudder and elevator) should be supported by jigs at the hinge points and trailing edges. (See figures 1-1, 1-2, and 1-3.)

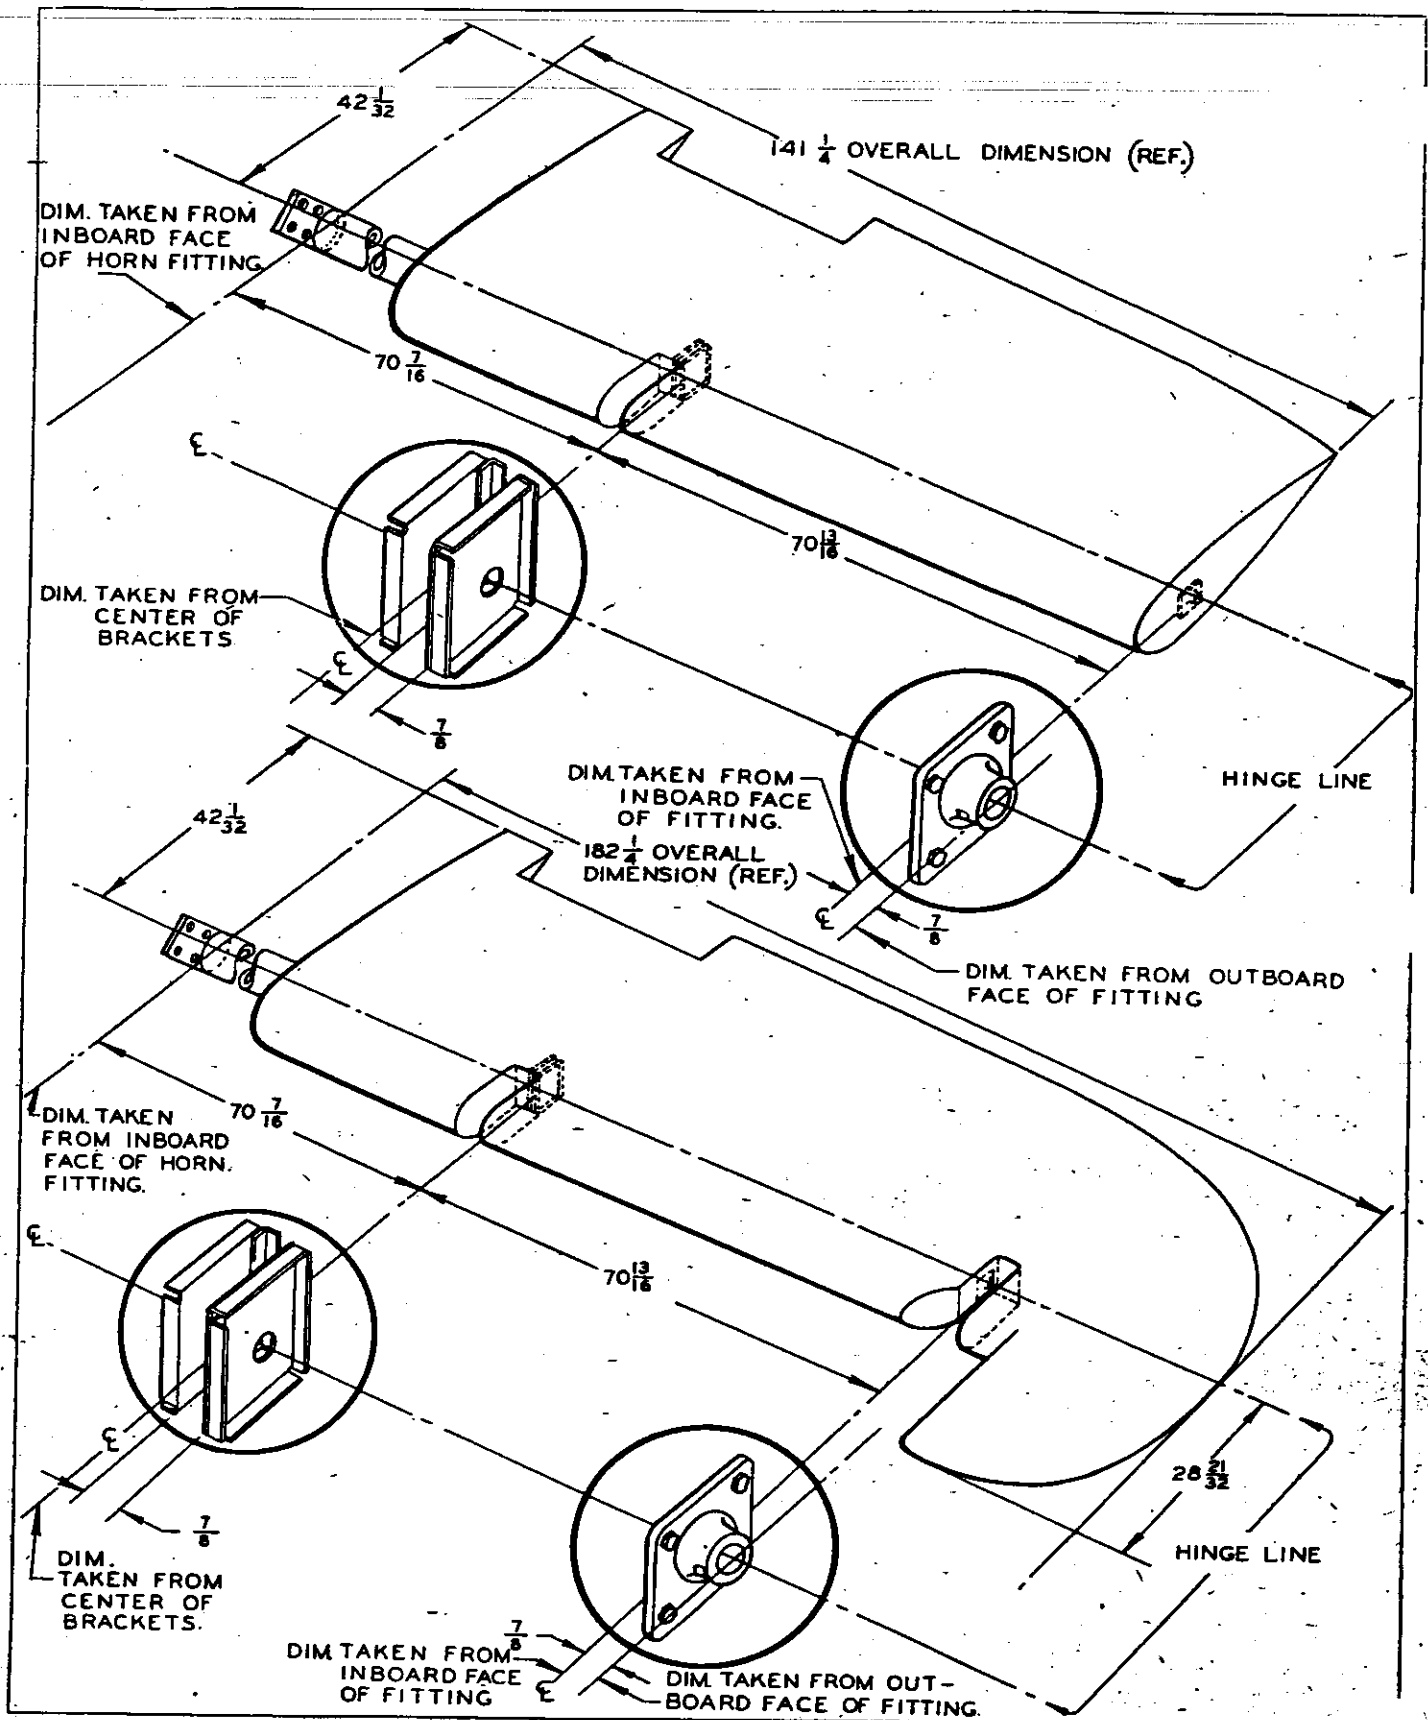
Figure 1-3—Elevator Jig Points

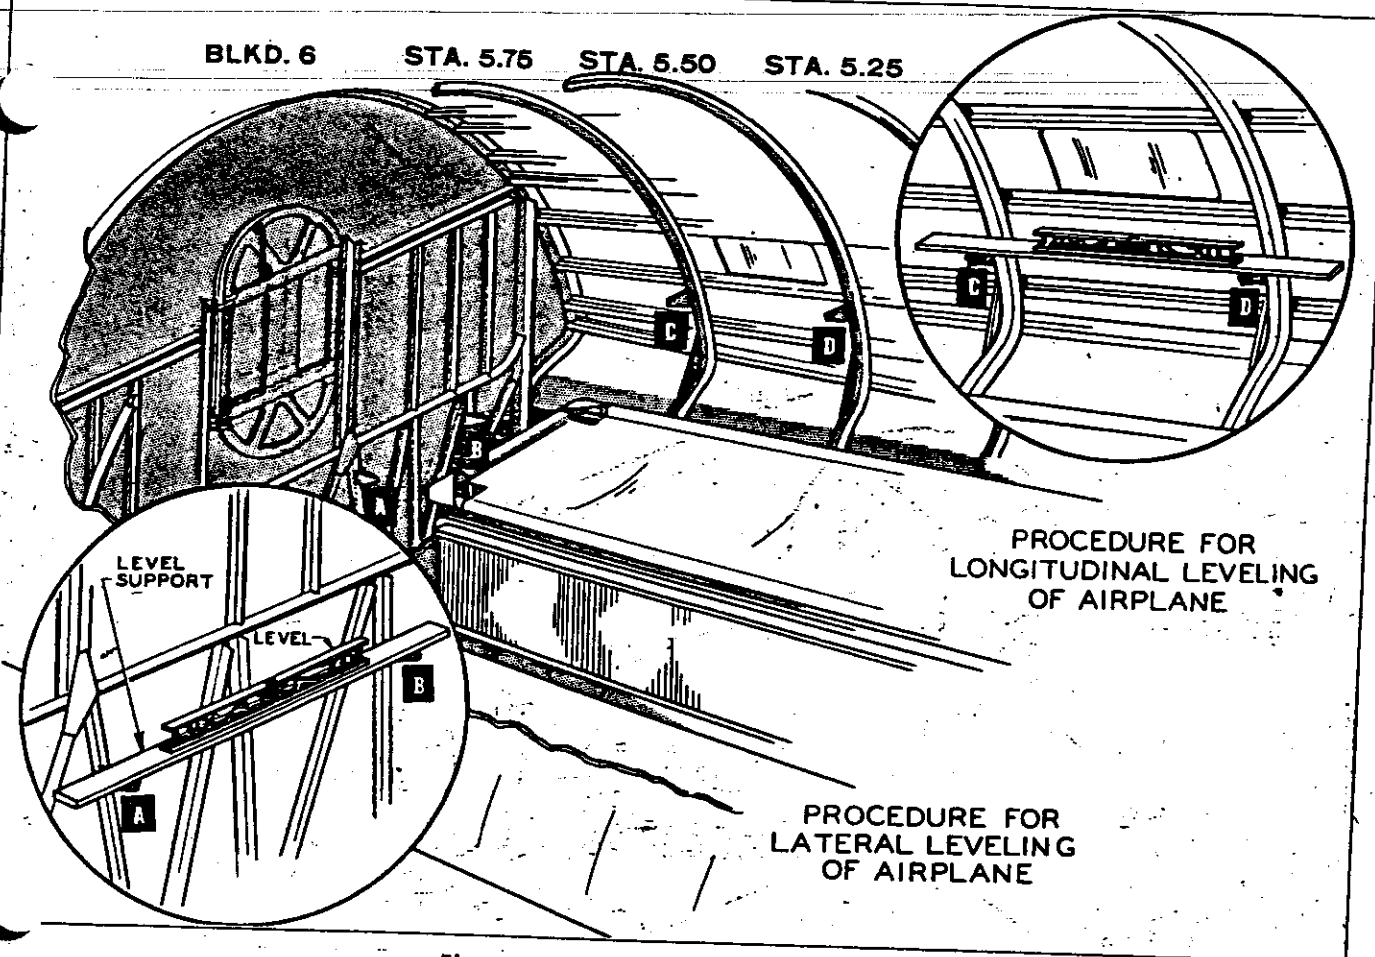
Figure 1-4—Airplane Leveling Lugs

1-50. The two leveling lugs for lateral leveling are located on the port forward face of bulkhead 6, below the level of the door. (See figure 1-4.) Lay any straight bar and a spirit level across the leveling lugs and jack up one side of the airplane a few inches off the ground. Then jack up the other side of the airplane until the spirit level indicates level position. This is done while the airplane is on either the beaching gear or landing gear.

1-51. The leveling lugs for longitudinal leveling are located on the port side of the airplane above the bulkhead and are attached to bulkframe 5.50 and 5.75, on PBV-1 airplanes and bulkframes 5.25 and 5.75 on PBV-5A. (See figure 1-4.) Lay a leveling bar and spirit level across the lugs. To level the airplane while on the

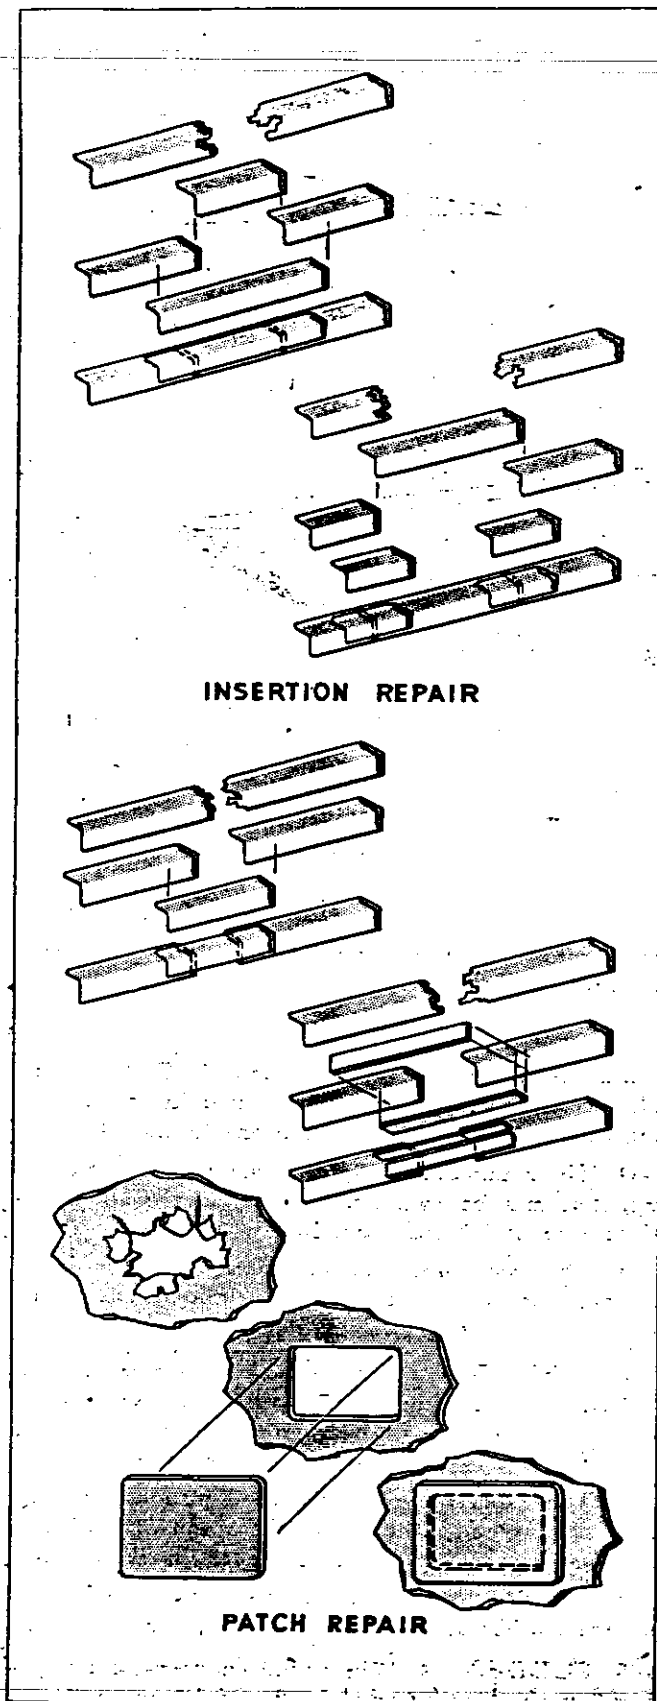
Figure 1-5—Types of Repair by  
Patching and Insertion

1-55. **DAMAGE REPAIRABLE BY PATCHING.** Patching in general refers to that type of damage which will permit the addition of a repair piece laid over the damaged area. For example a patch on the skin would consist merely of a piece of sheet cut slightly larger than the cleaned up damaged area, riveted to the undamaged skin. (See figure 1-5.) A patch on an extrusion

or other formed part would consist possibly of a reinforcing strip laid over the damaged area or another formed part nested in and riveted to the damaged part. (See figure 1-5.) Patches should be designed to utilize existing rivet patterns when possible. Repairs to watertight bulkheads, hull, and floors are made watertight by the use of zinc chromate tape, or equivalent seals inserted between the overlapping edges of the patches. Repairs in the fuel tank are made gas tight by the use of neoprene as a gasket material and by using gas tight rivet spacing.

**1-56. DAMAGE REPAIRABLE BY INSERTION.** Repair by insertion may be defined as a repair which by reason of the extent of damage does not lend itself to patching because of the excess weight which would necessarily be added. For example if a stringer were damaged over a long length the damaged portion would be removed and a new stringer length inserted. The new piece would be spliced into the untouched structure at each end. (See figure 1-5.)

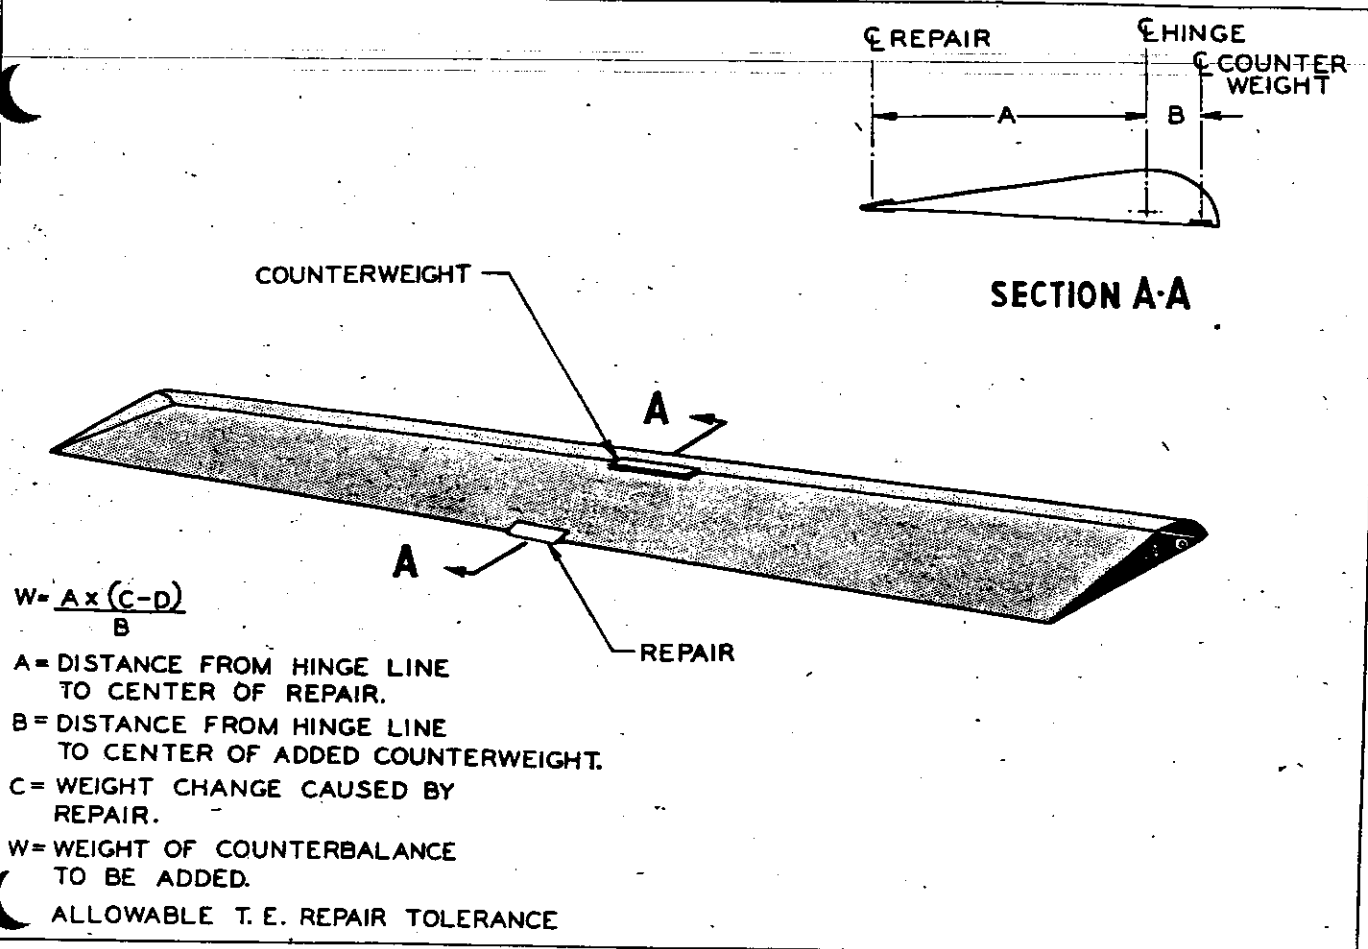
Figure 1-6—Determination of Unbalance Caused by Repair

1-72. DETERMINING AMOUNT OF UNBALANCE CAUSED BY REPAIR.  
(See figure 1-6.)

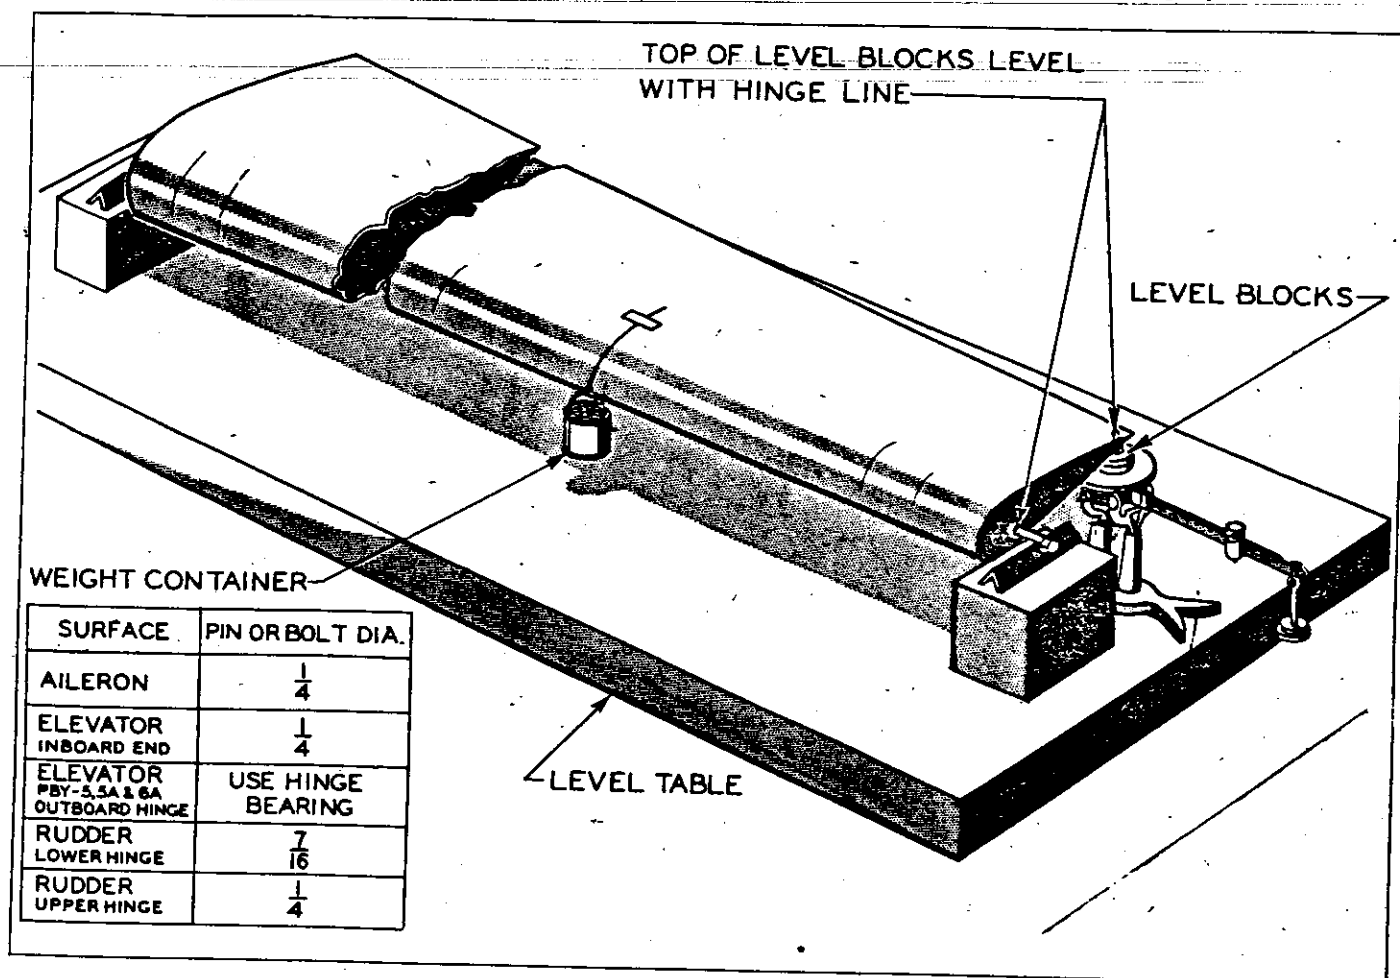
Figure 1-7—Determining Static Balance

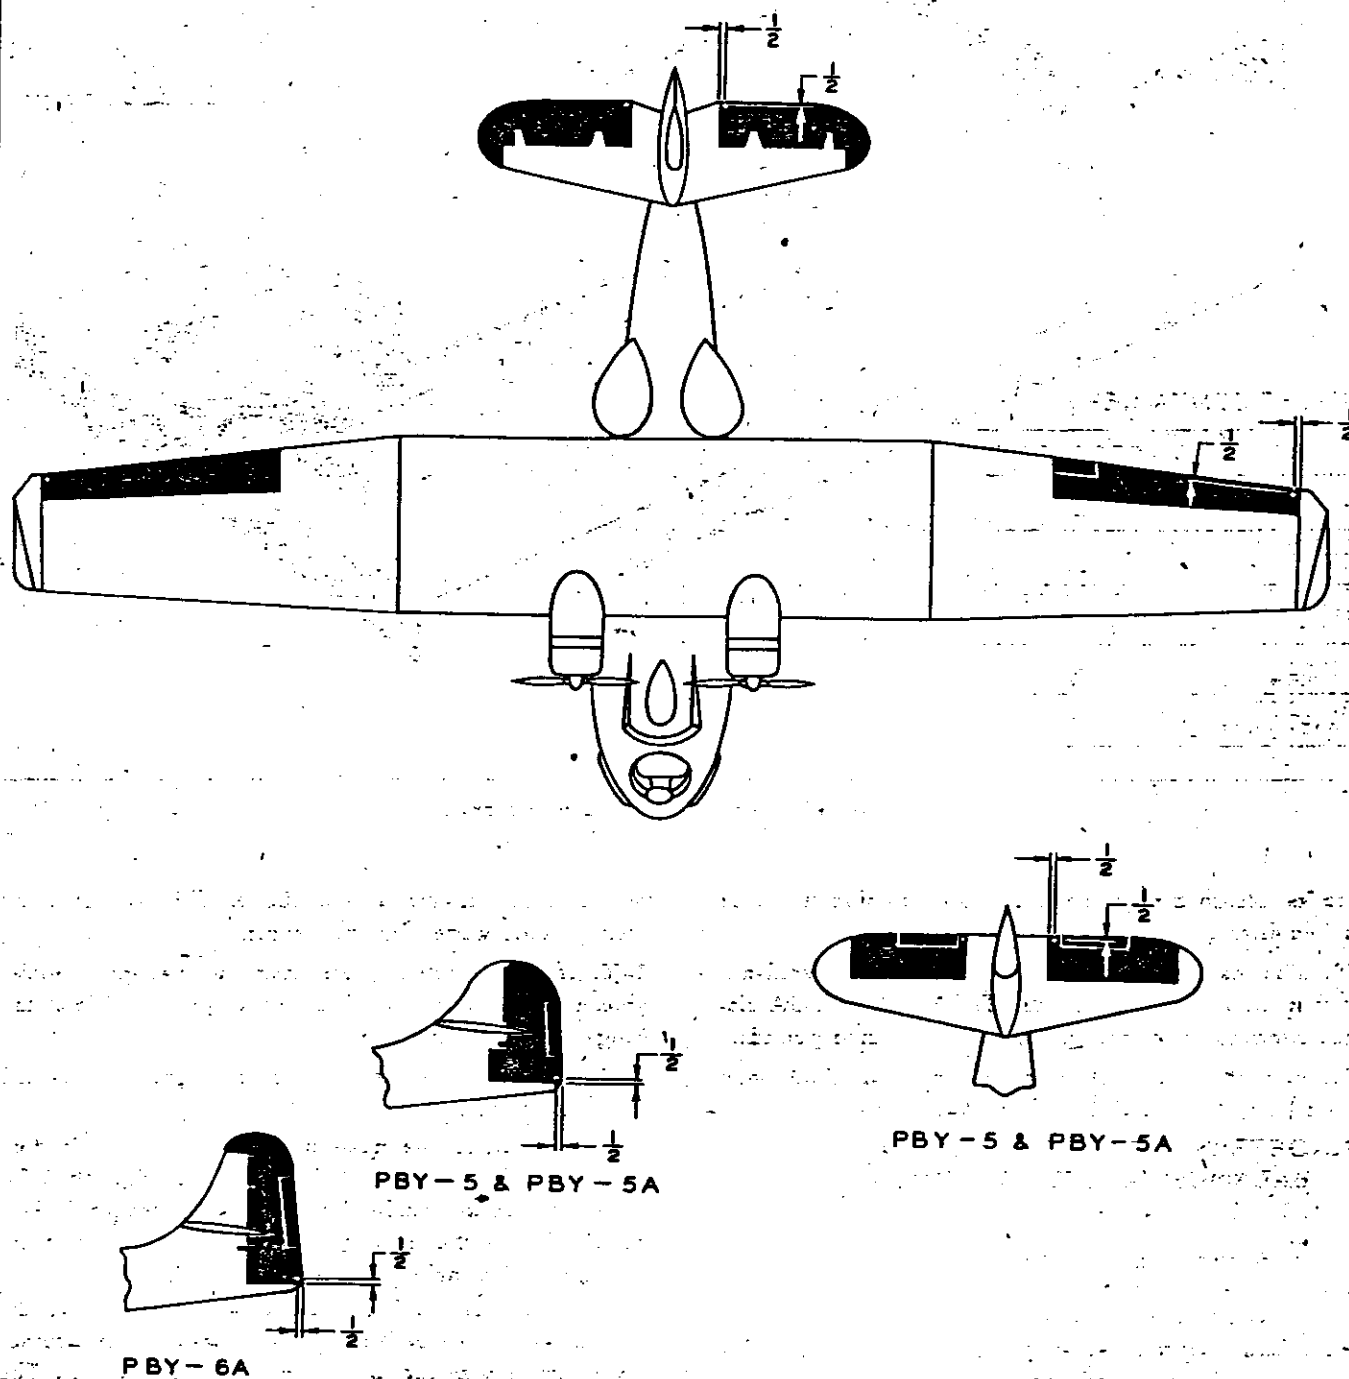
Figure 1-8—Static Balance Points

1-80. Place a balance scale under the trailing edge of  
the surface at the point indicated in figure 1-8. A spring  
scale may be used in place of the balance scale.

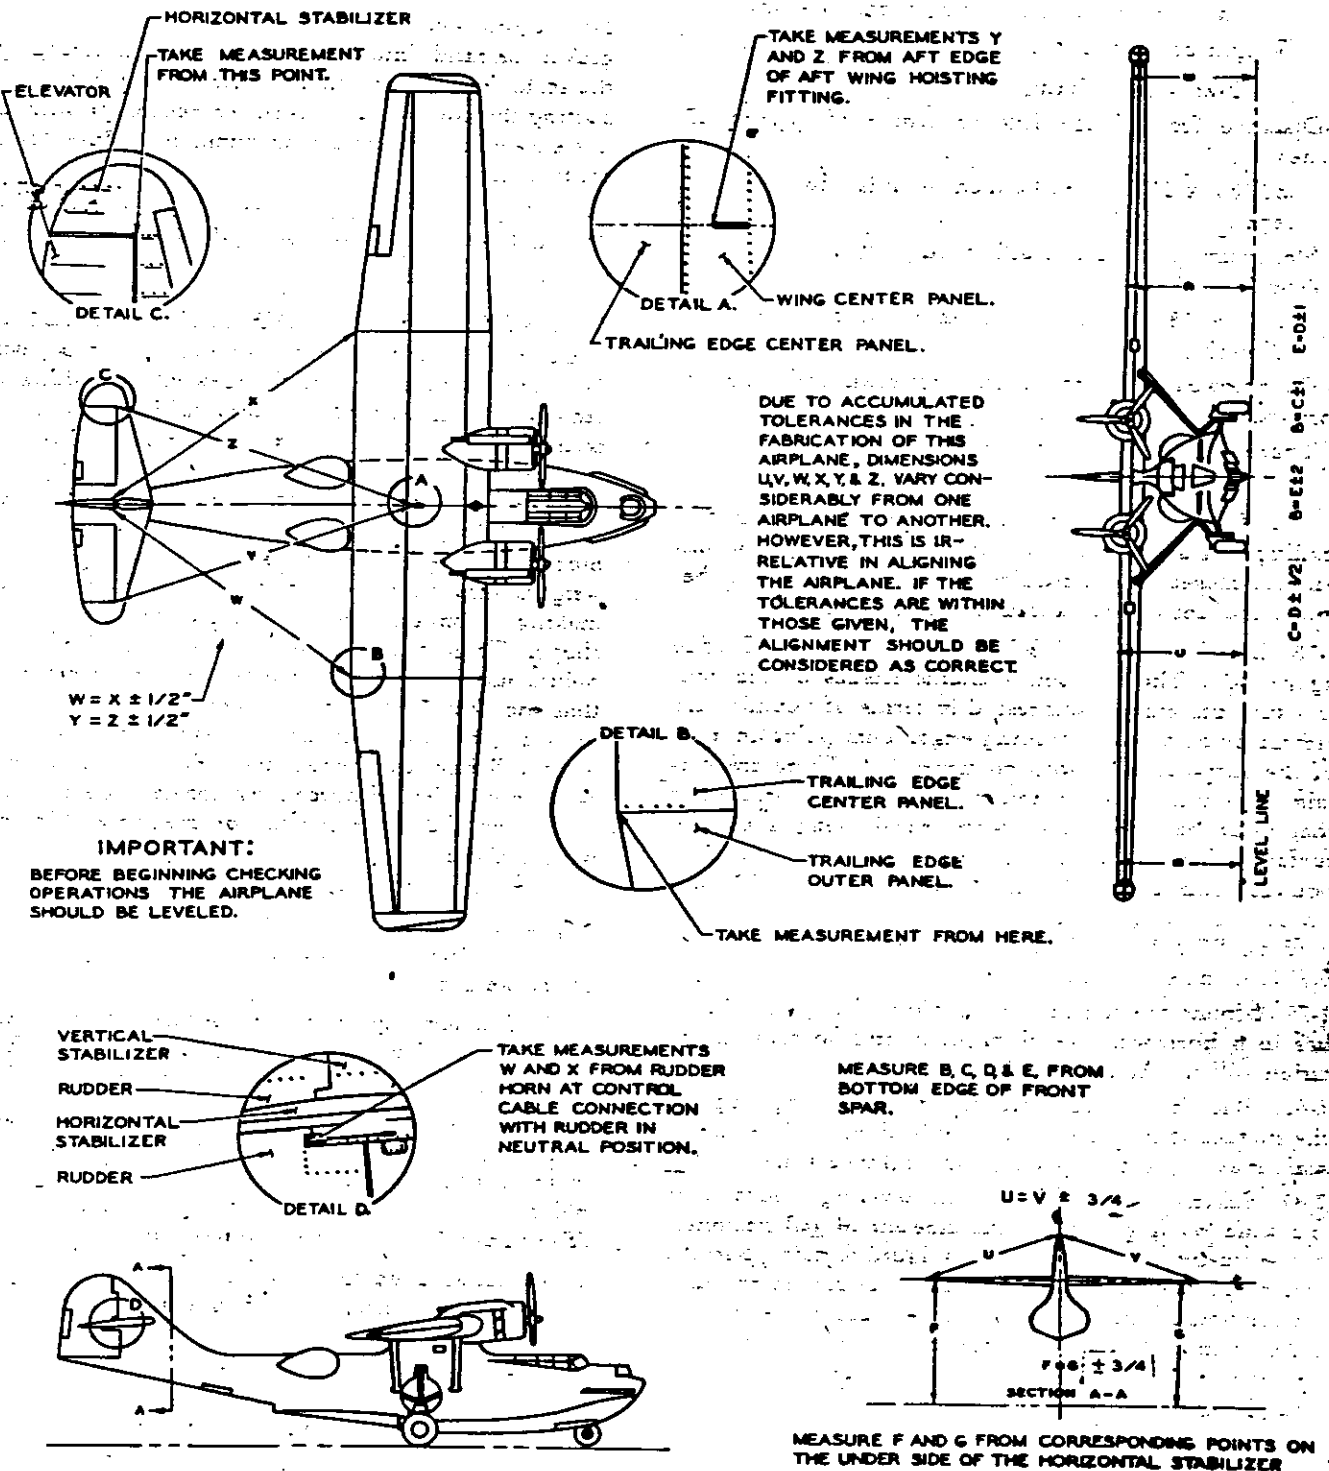
Figure 1-9—Rigging Diagram

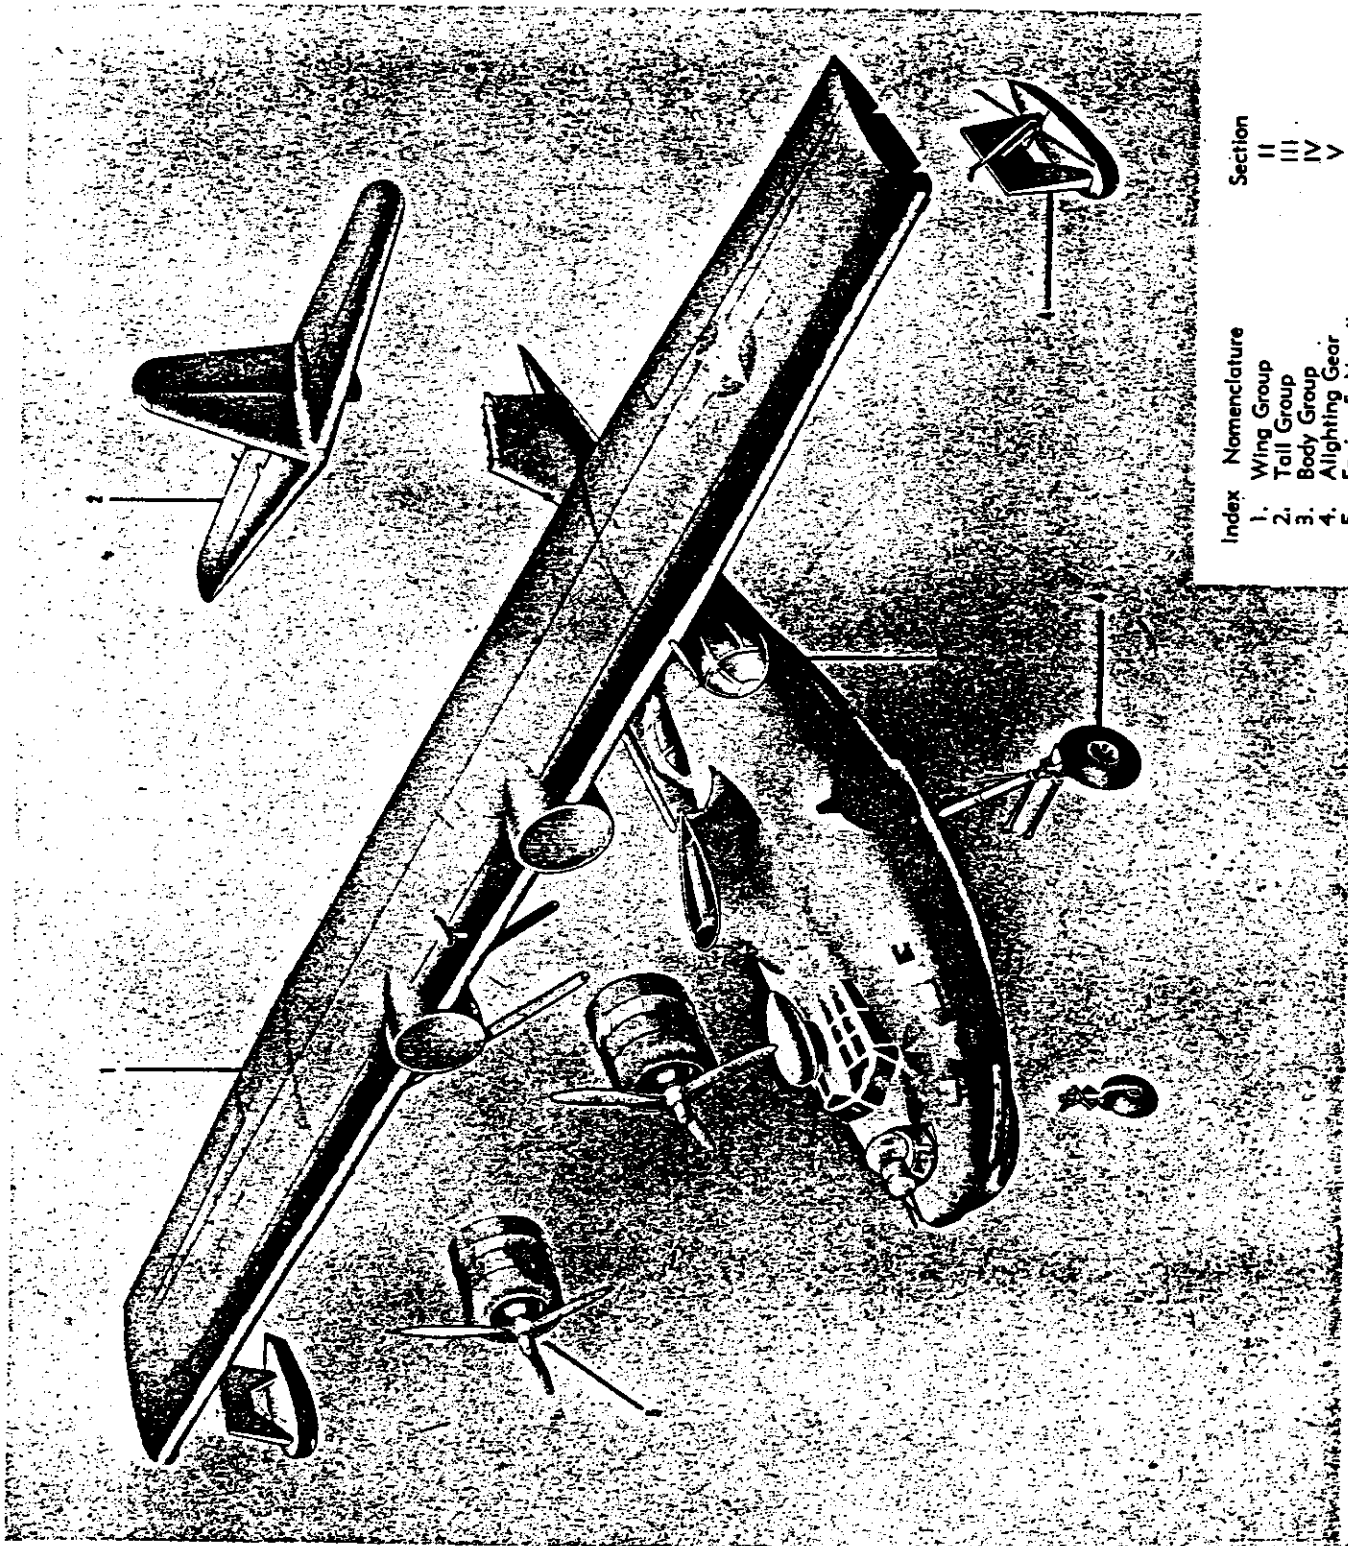
Index	Nomenclature	Section	Figure
1.	Wing Group	II	2-1
2.	Tail Group	III	3-1
3.	Body Group	IV	4-1
4.	Landing Gear	V	5-1
5.	Engine & Nacelle	VI	6-1

Figure 1-10—Main Airplane Components

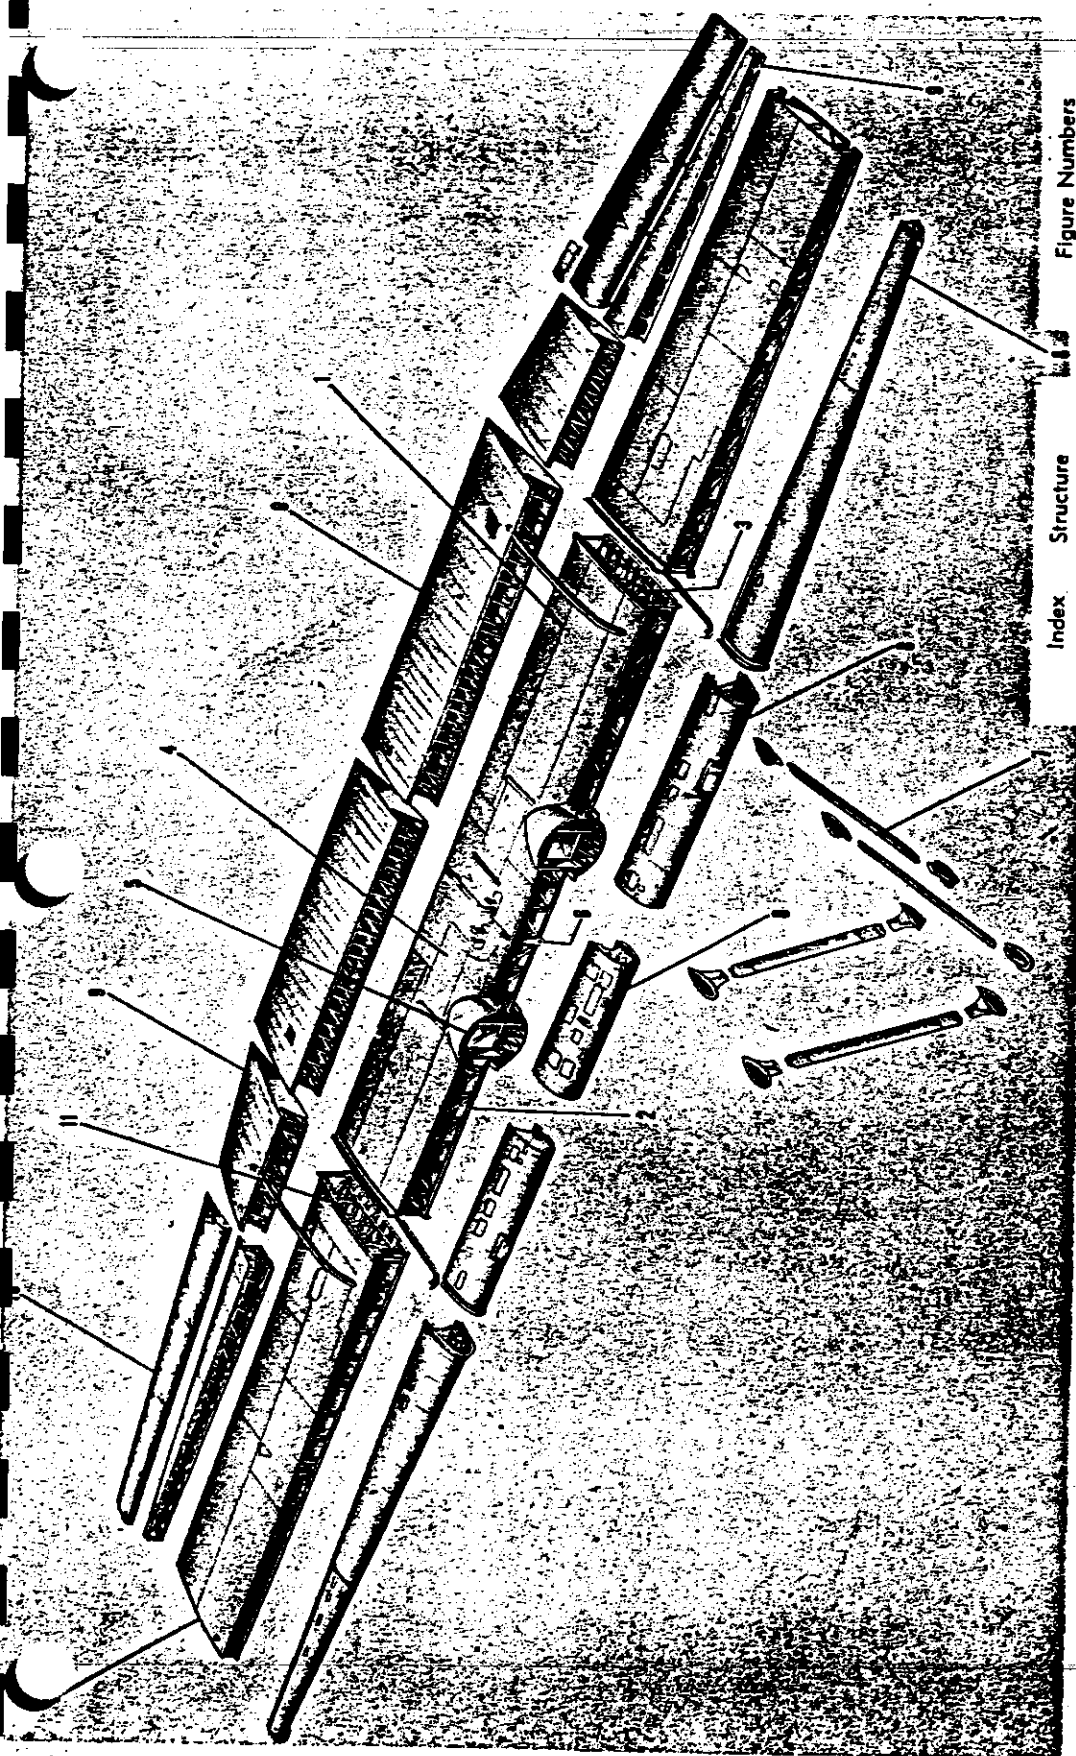
Index	Structure	Figure Numbers
1.	Plating	2- 2 to 2-10 incl. and 2-35
2.	Spars	2-11 to 2-15 incl.
3.	Bulkheads	2-16 to 2-19 incl.
4.	Integral Fuel Tank	2-13, 2-17
5.	Nacelle	2-20 to 2-22 incl.
6.	Wing-Hull Attachment	2-23, 2-24
7.	Struts & Strut Attachment	2-25, 2-26
8.	Leading Edges	2-27, 2-28
9.	Trailing Edges	2-29 to 2-32 incl.
10.	Ailerons	2-29, 2-30, 2-31, 2-33
11.	Panel Splice	2-34, 2-35

Figure 2-1—Main Wing Components

(See figure 2-1.)

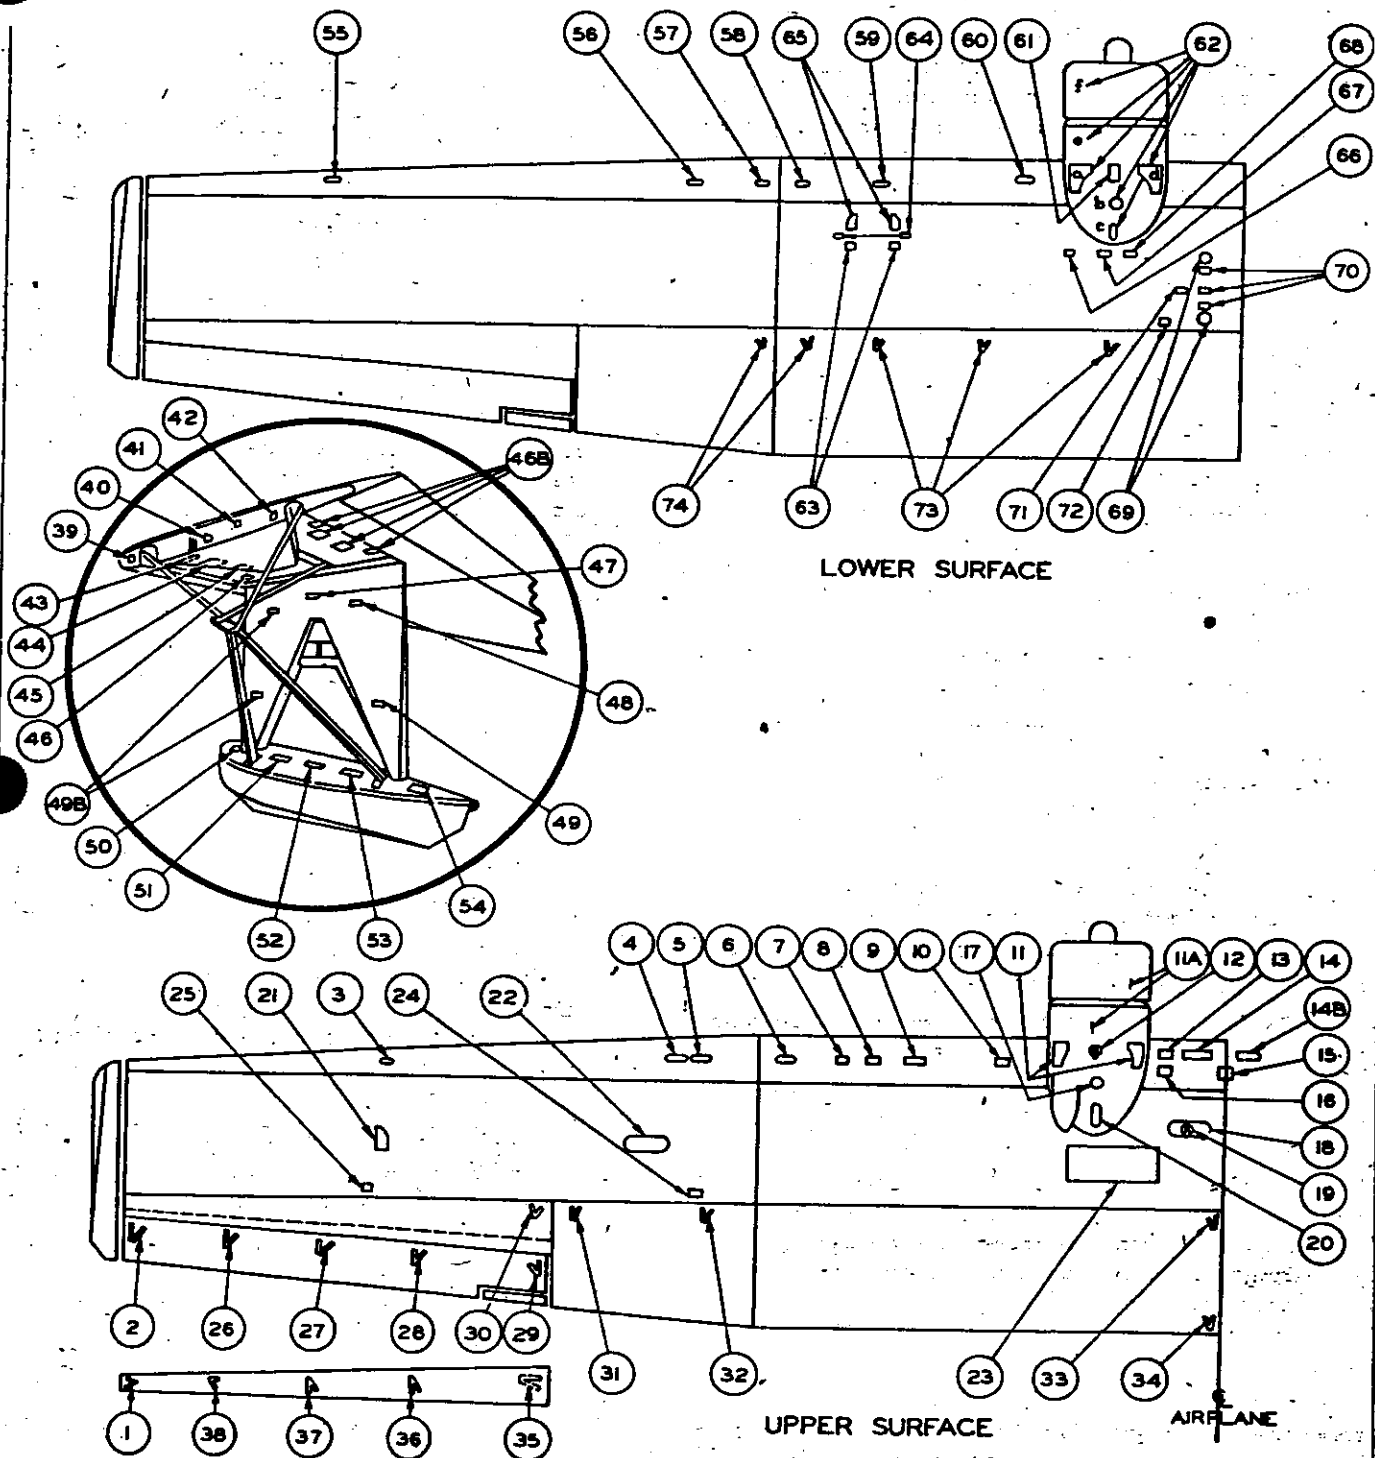
Figure 2-2 (Sheet 1 of 2 Sheets)—Wing Access Doors

1. Access to Attachments of Aileron Cut-Out.
2. Access to Aileron Hinge.
3. Access to Float Control Gear Box.
4. Access to Leading Edge.
5. Access to Leading Edge.

72. Fuel Cell Manifold Access Doors.
73. Access to Aileron Controls. (The first from left also gives access to anti-icer exhaust duct connection.)
74. Access to Wing Splice.

2-7. Location of wing access doors is shown in figure 2-2.

The fuel cell access door and the fuel cell manifold access doors on the lower surface (See figure 2-2, index Nos. 66, 67, 68, 70, 71, 72, 23.) carry load and must be repaired like any other area of plating.

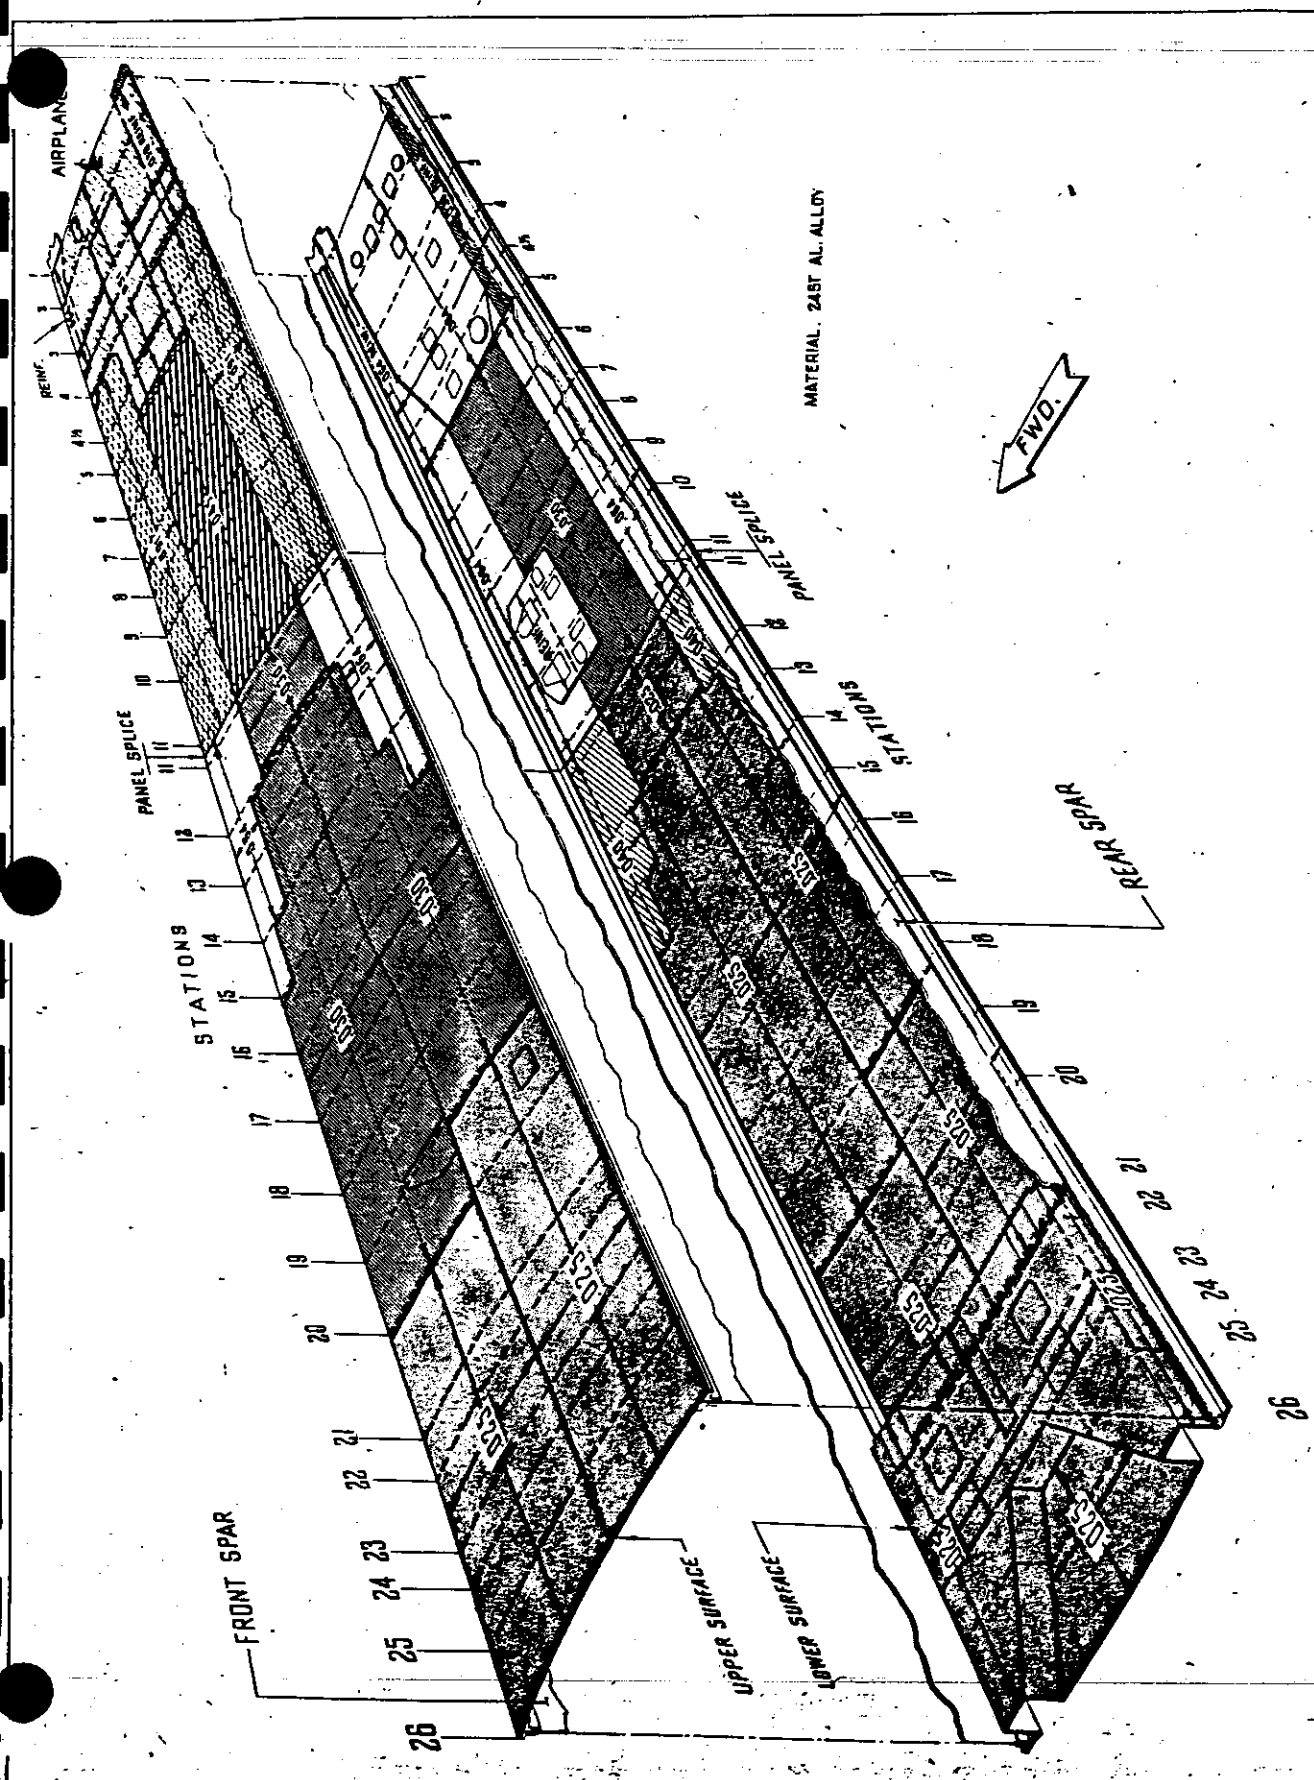
Figure 2-3—Wing Plating Diagram

(See figure 2-3.)
