**Handbook of  
Structural Repair  
PBY 5**

AN 01-5M-3

# Handbook of Structural Repair

• **PBY-5 • PBY-5A • PBY-6A**

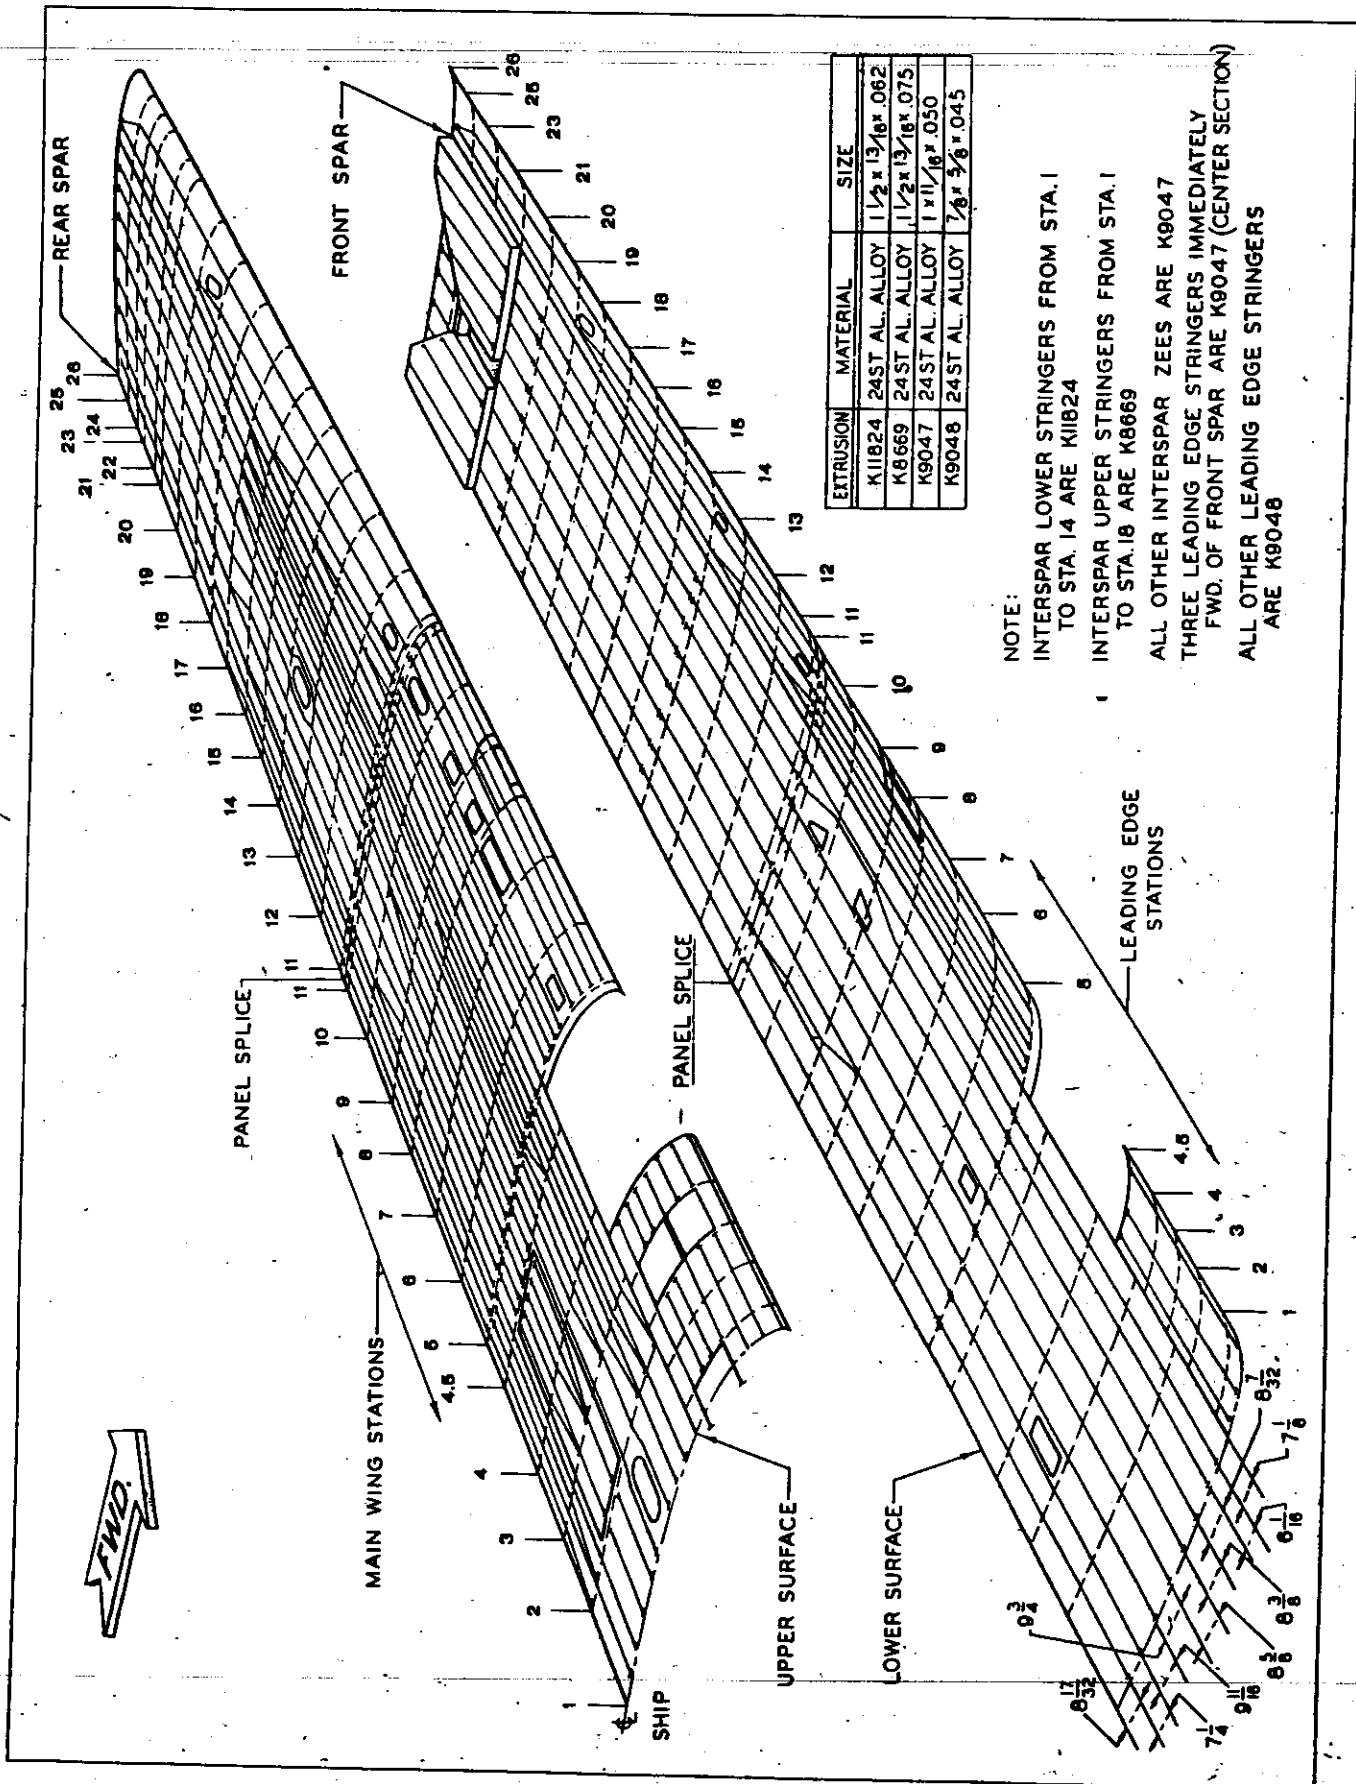
Figure 2-4—Wing Stringer Diagram

2-14. GENERAL. The wing plating consists of 24ST aluminum alloy and alclad skin mounted on 24ST extruded zee stringers. (See figure 2-4.) The upper and lower plating from the center line of the airplane to station 5 on each side form part of the integral fuel tanks. The skin in this area is 24ST Alclad. A large fuel cell access door in the upper surface plating forms an integral part of the structure.

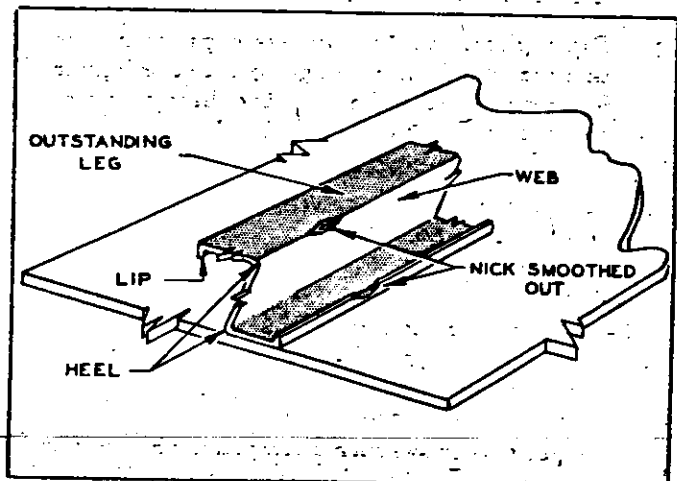
Figure 2-6—Stringer Nomenclature

e. Isolated nicks in stringers which affect less than 1/2 of the outstanding leg may be considered negligible provided they are smoothed out (See figure 2-6.)

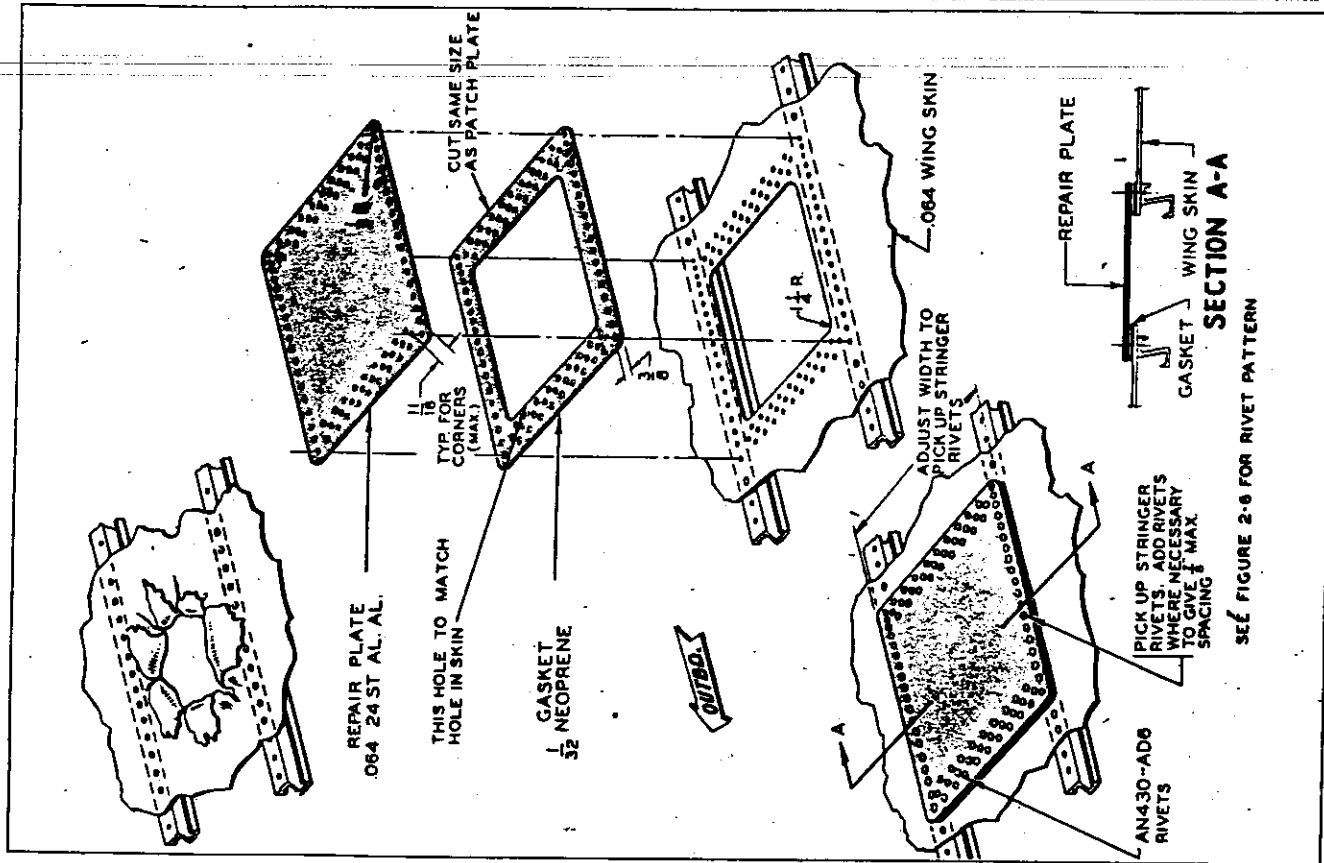
Figure 2-9—Typical Wing Skin Patch

of the template must always run in a spanwise direction i.e. parallel to the stringers. Patches in the fuel tank area should be used with a neoprene gasket to insure gas tightness. Patches outside the fuel tank area need not be used with a gasket. Typical patch repairs to the wing plating are shown in figures 2-8 and 2-9.

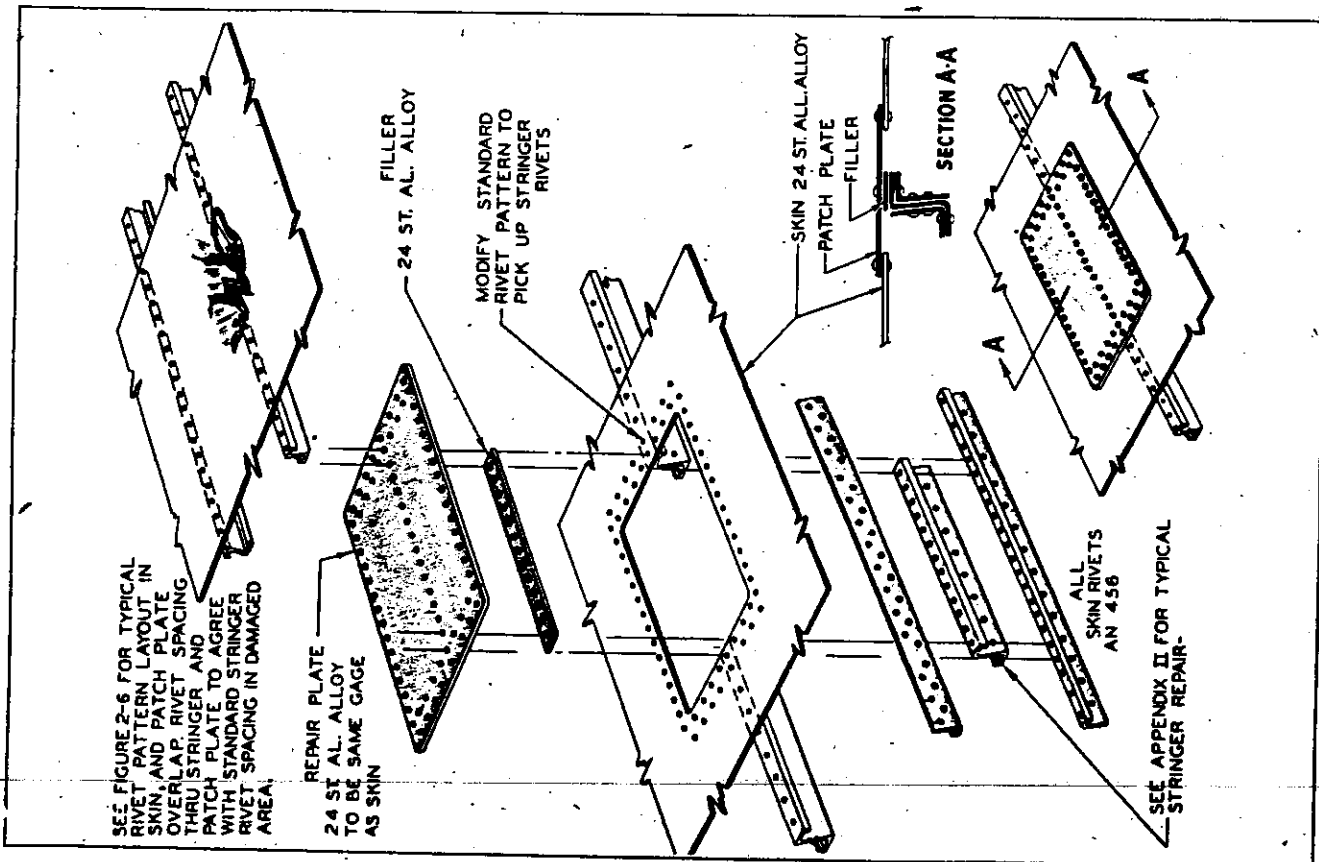
Figure 2-8—Wing Skin Patch-Stringer Damaged

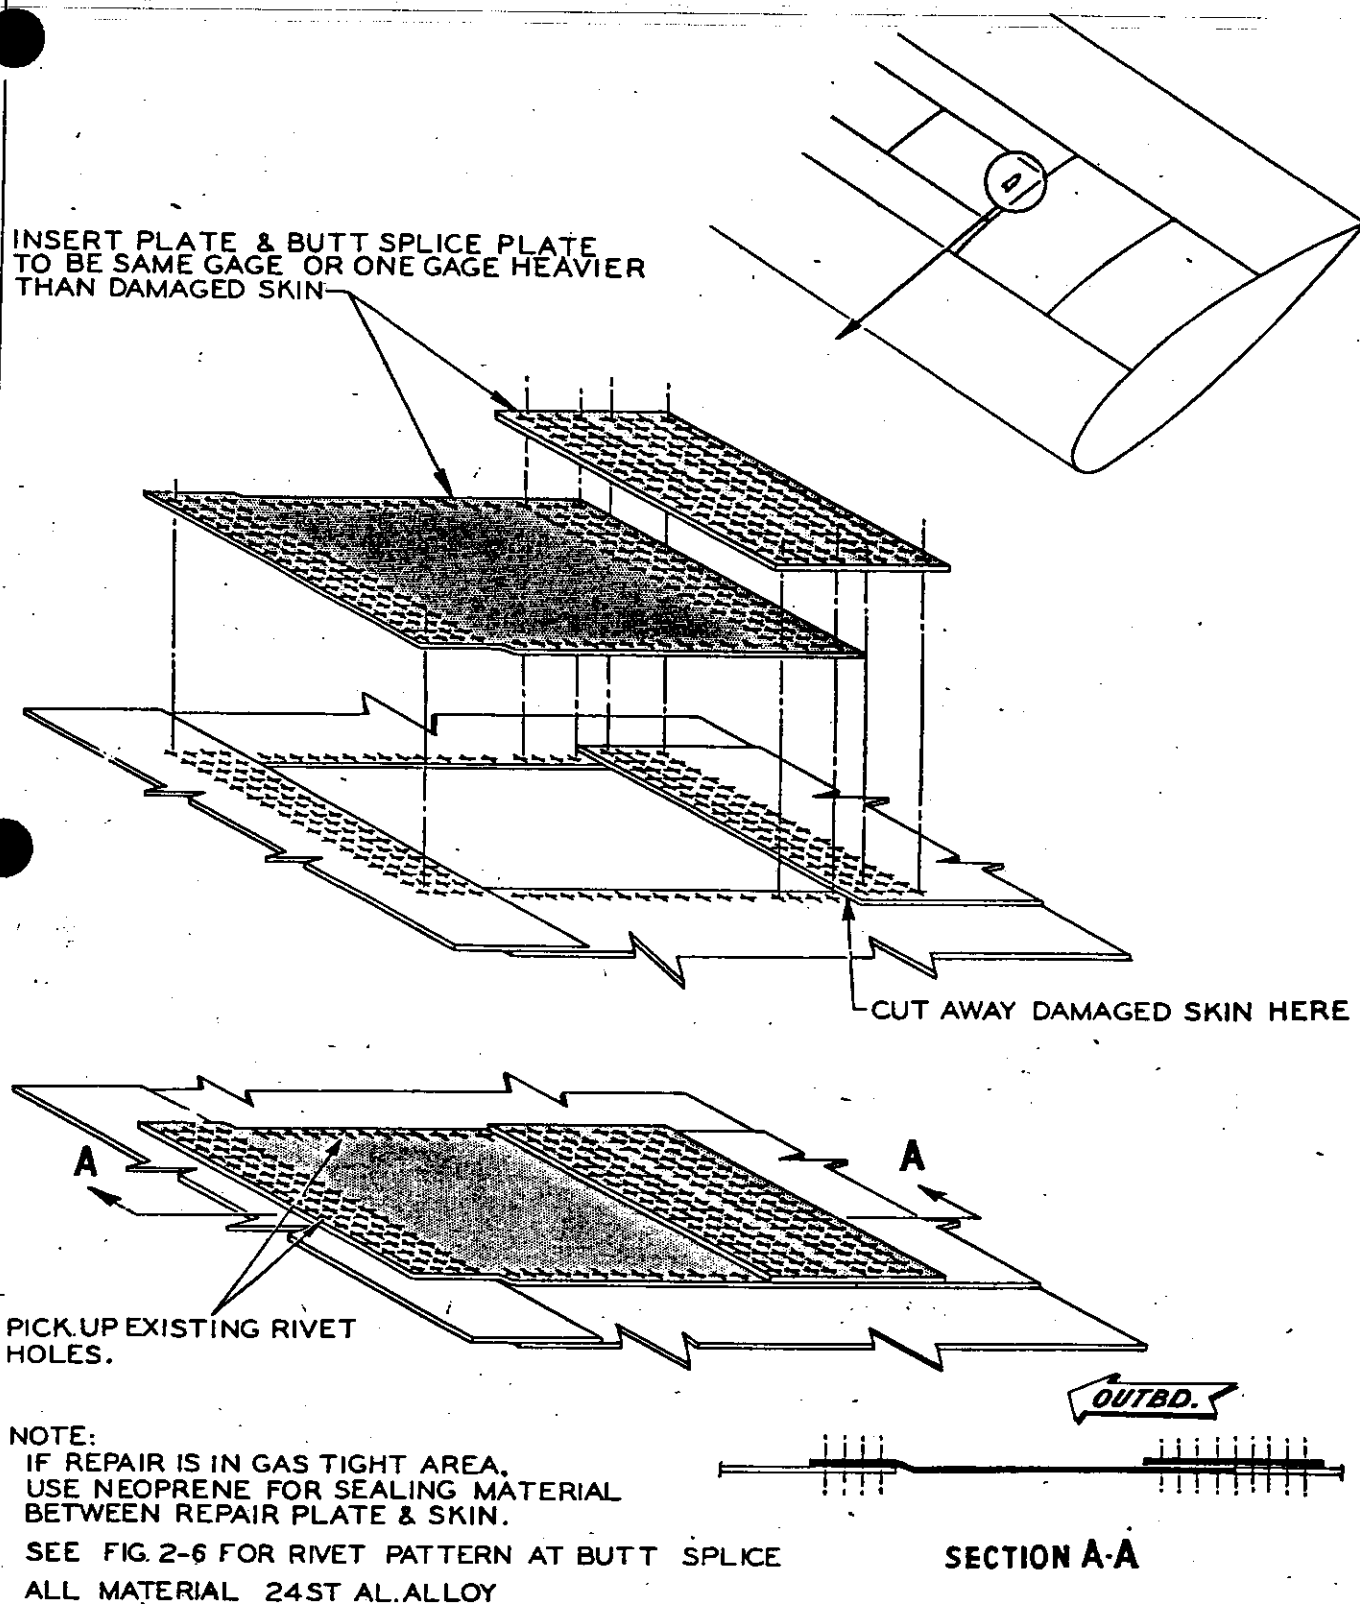
Figure 2-10—Wing Skin Insertion Repair

such a repair may be defined as an insertion. A typical insertion repair is exemplified by figure 2-10. The original splices utilized should pick up the old rivet pattern while the new splices should duplicate corresponding existing splices.

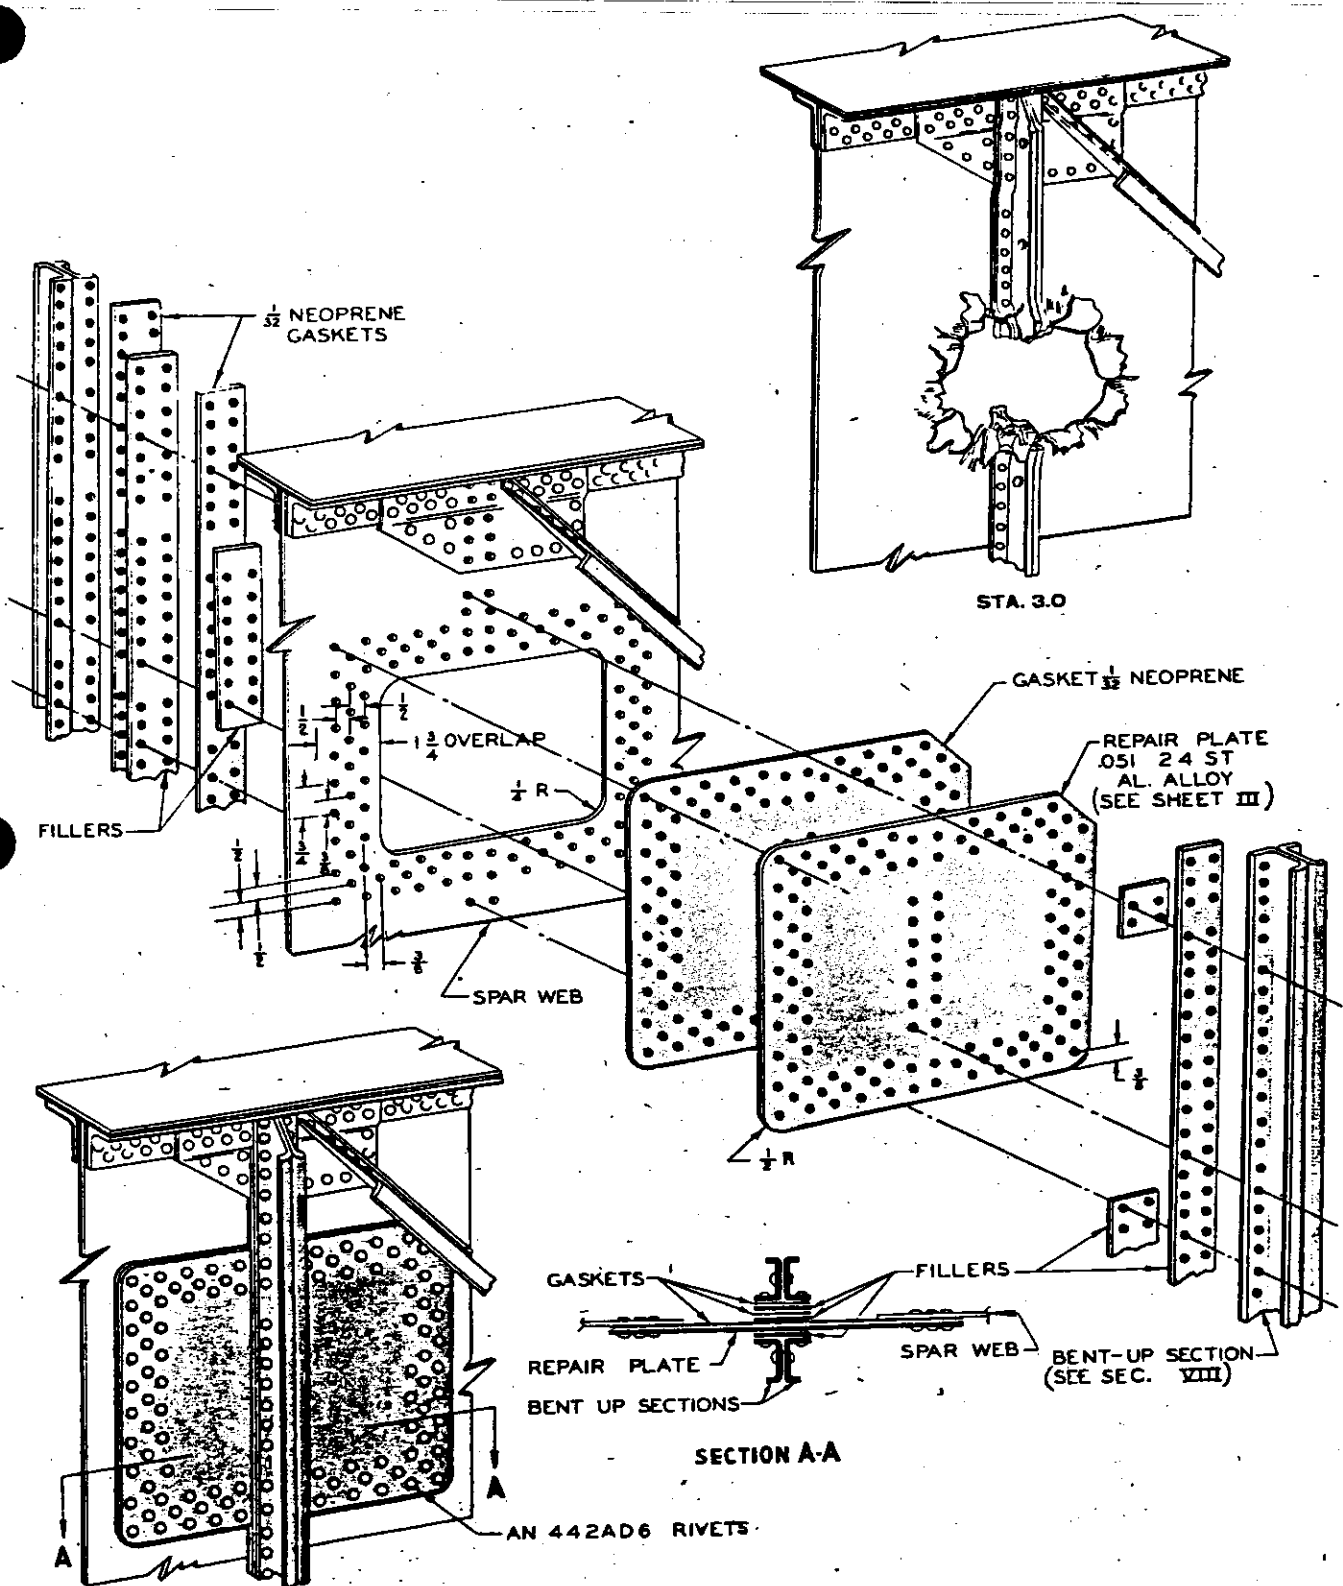
Figure 2-13—Spar Web Repair-Gas Tight Area

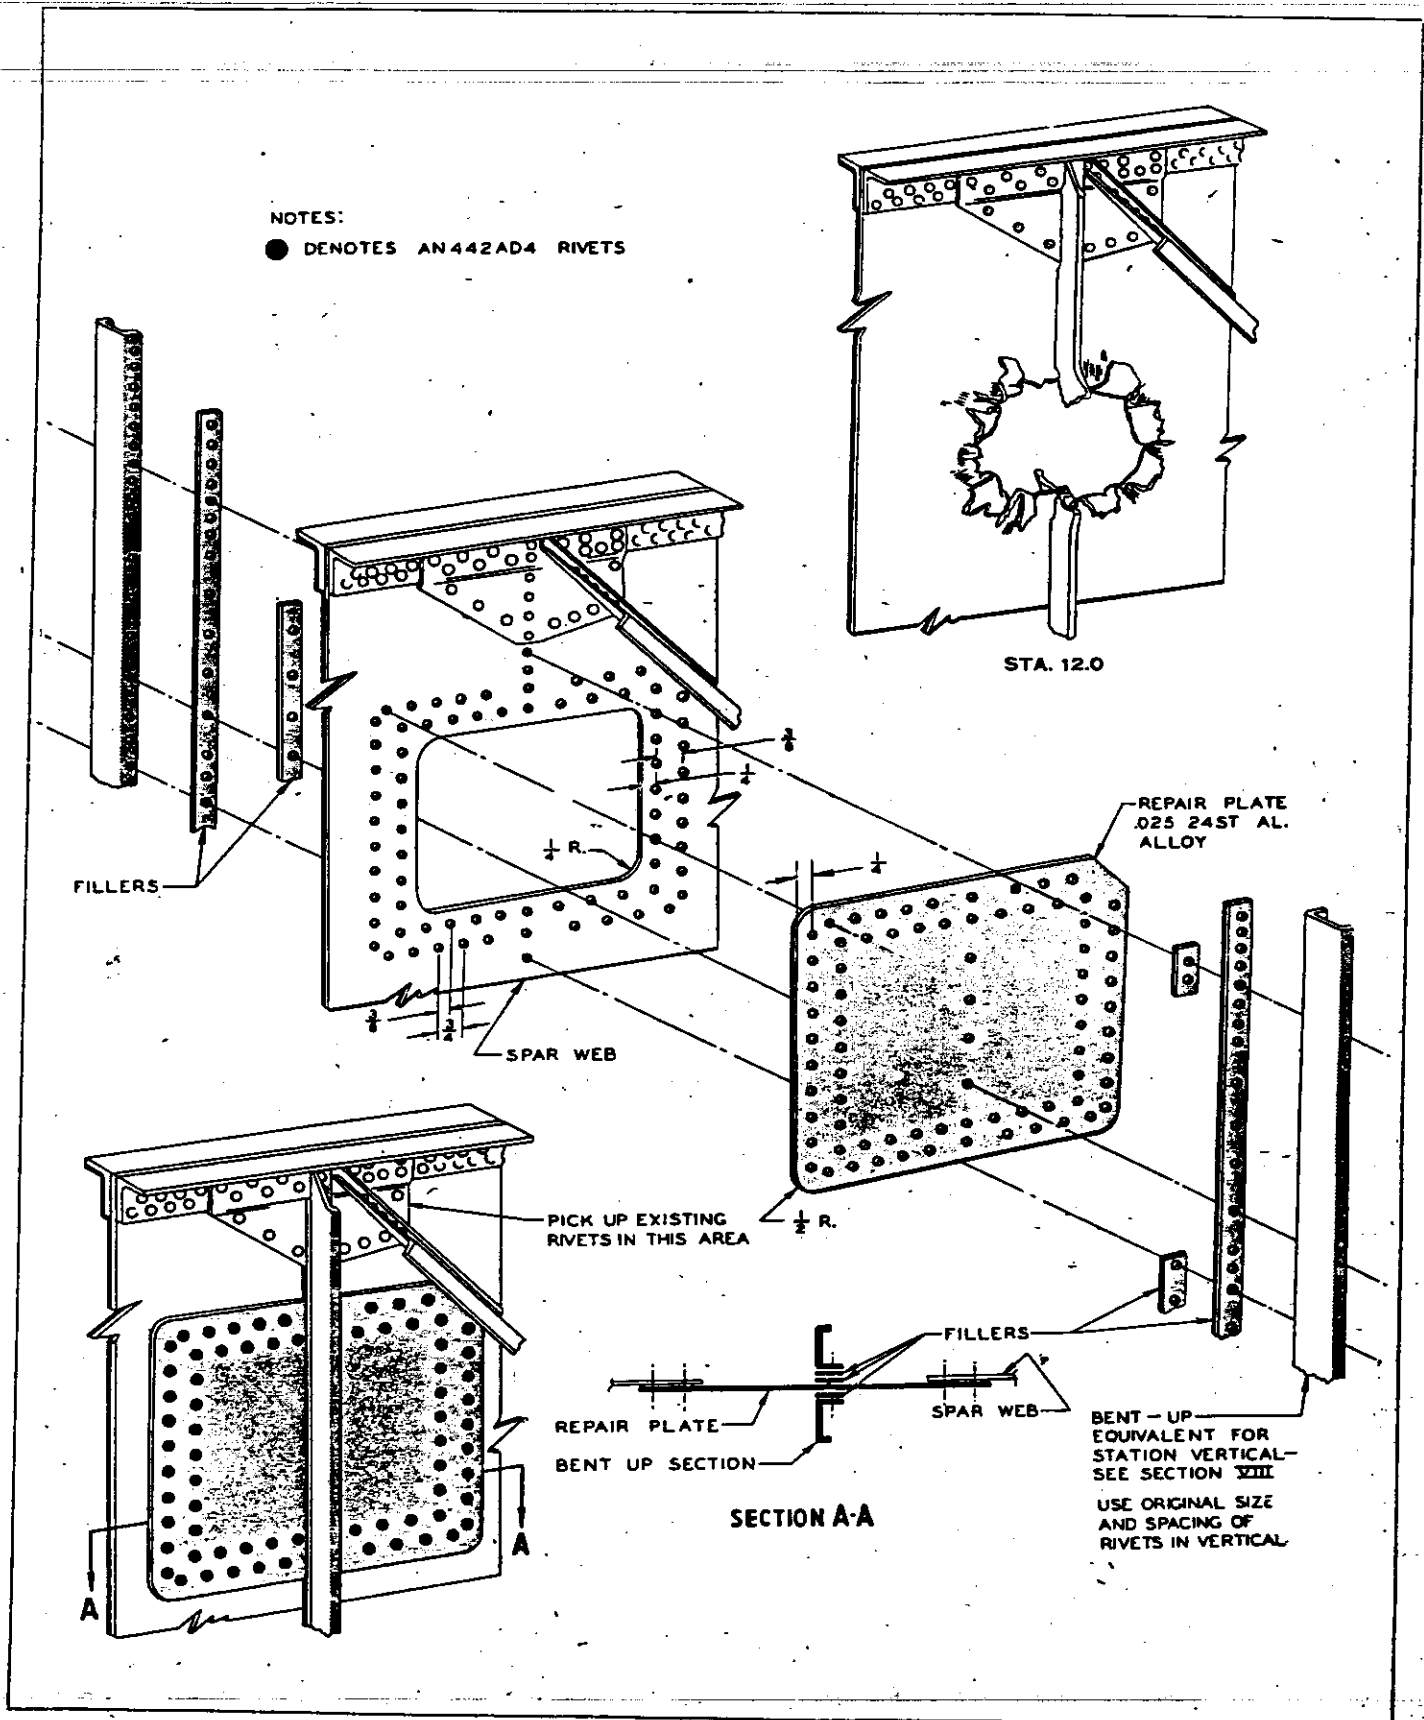
Figure 2-14—Typical Spar Web Repair

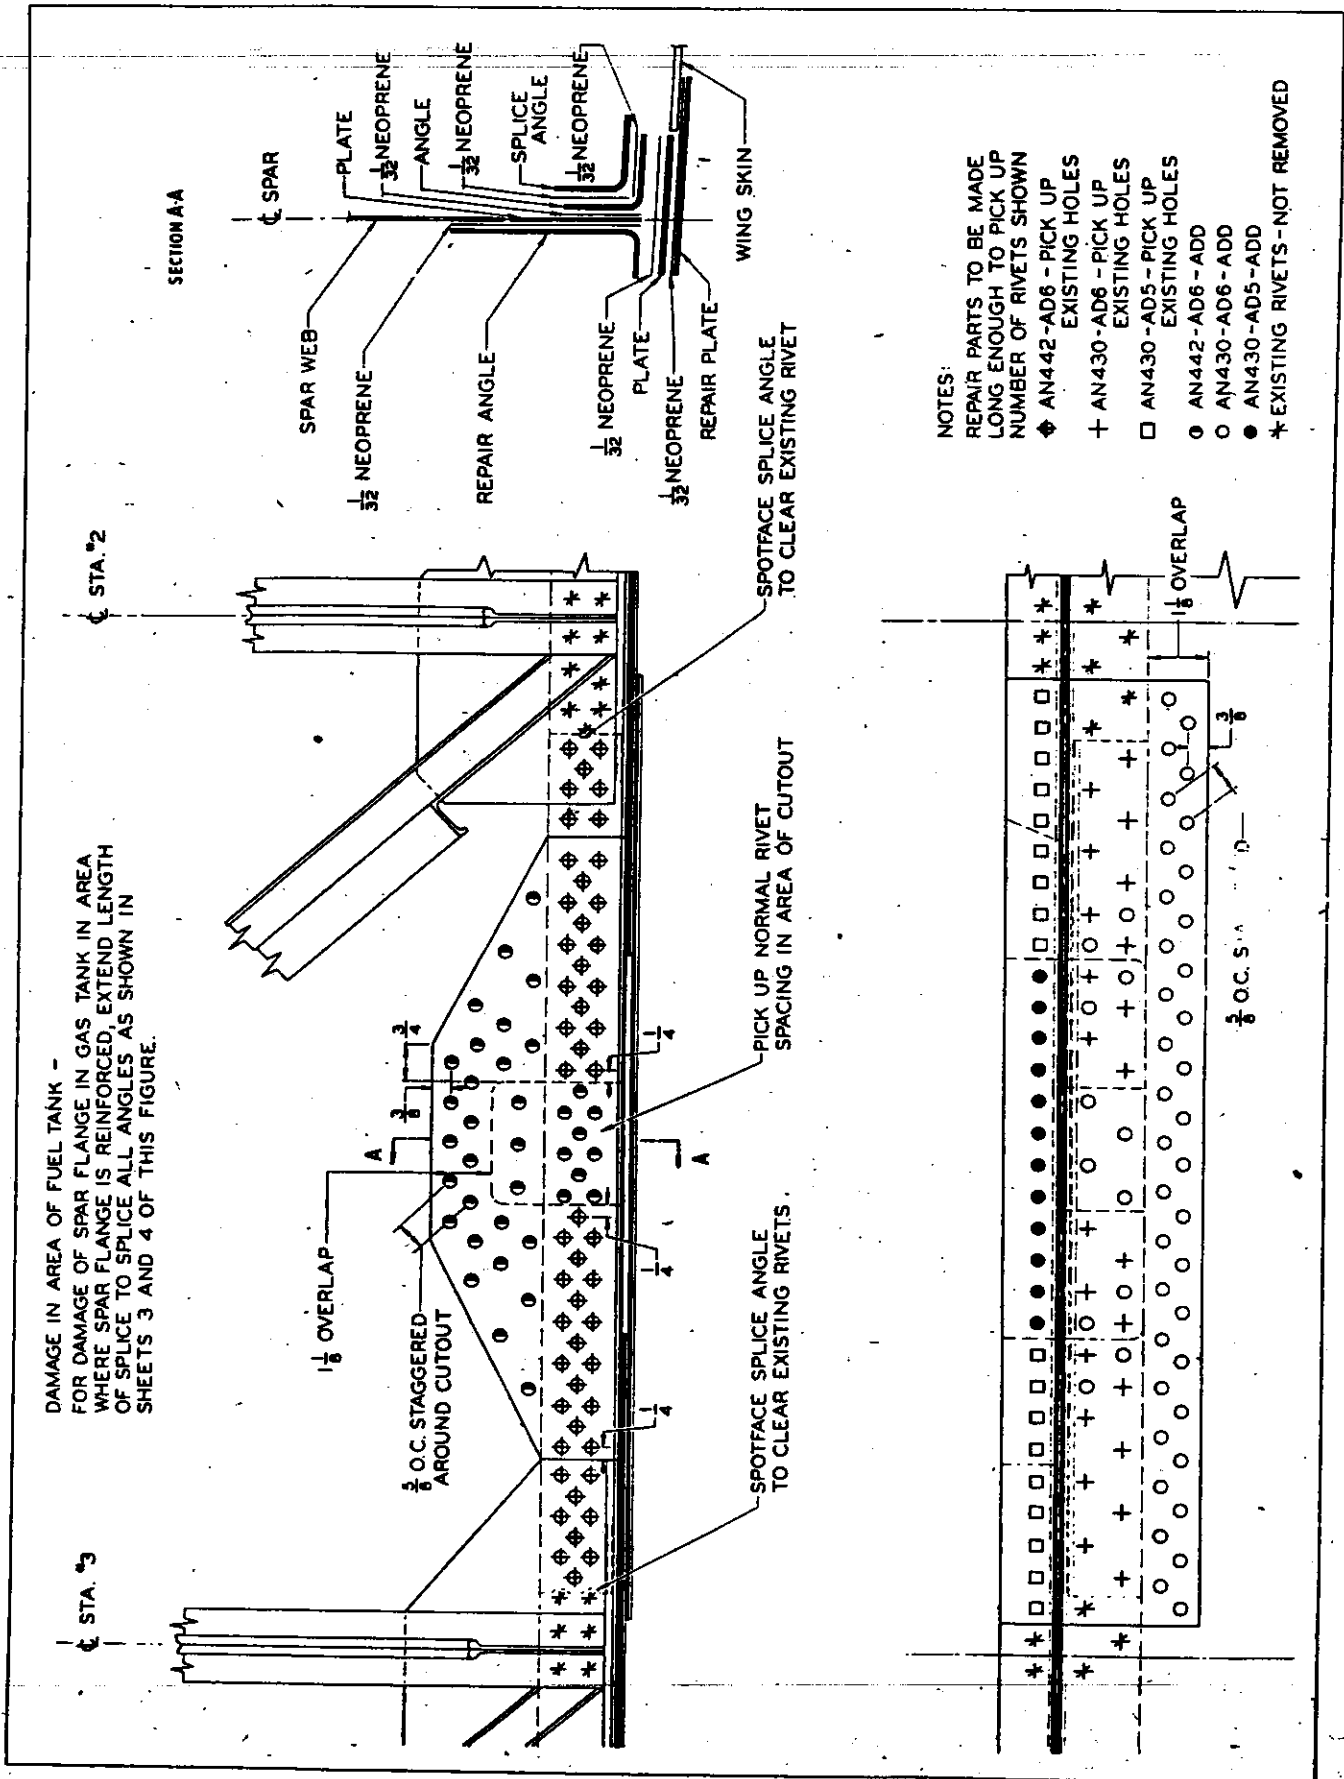
Figure 2-15 (Sheet 2 of 4 Sheets)—Spar Flange Repair-Gas Tight Area

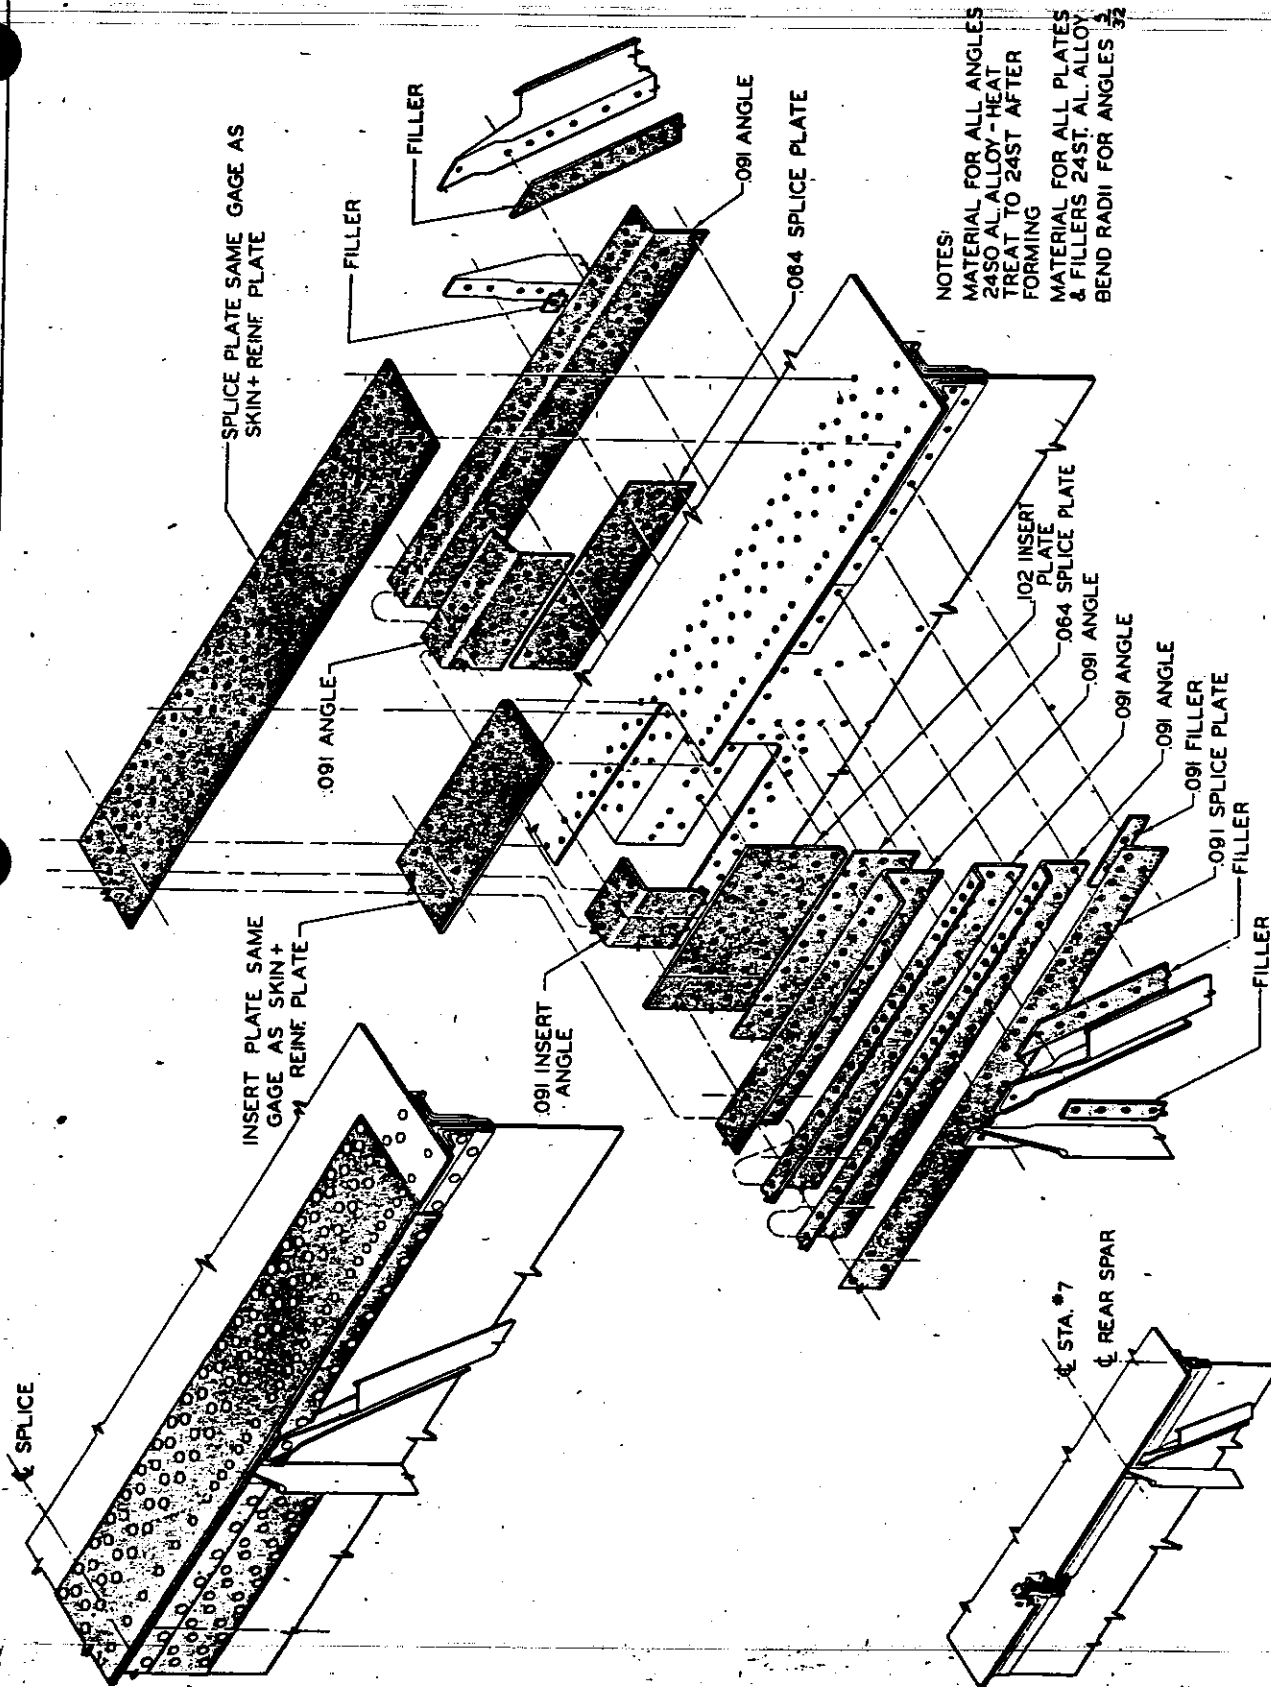
Figure 2-15 (Sheet 3 of 4 Sheets)—Spar Flange Repair

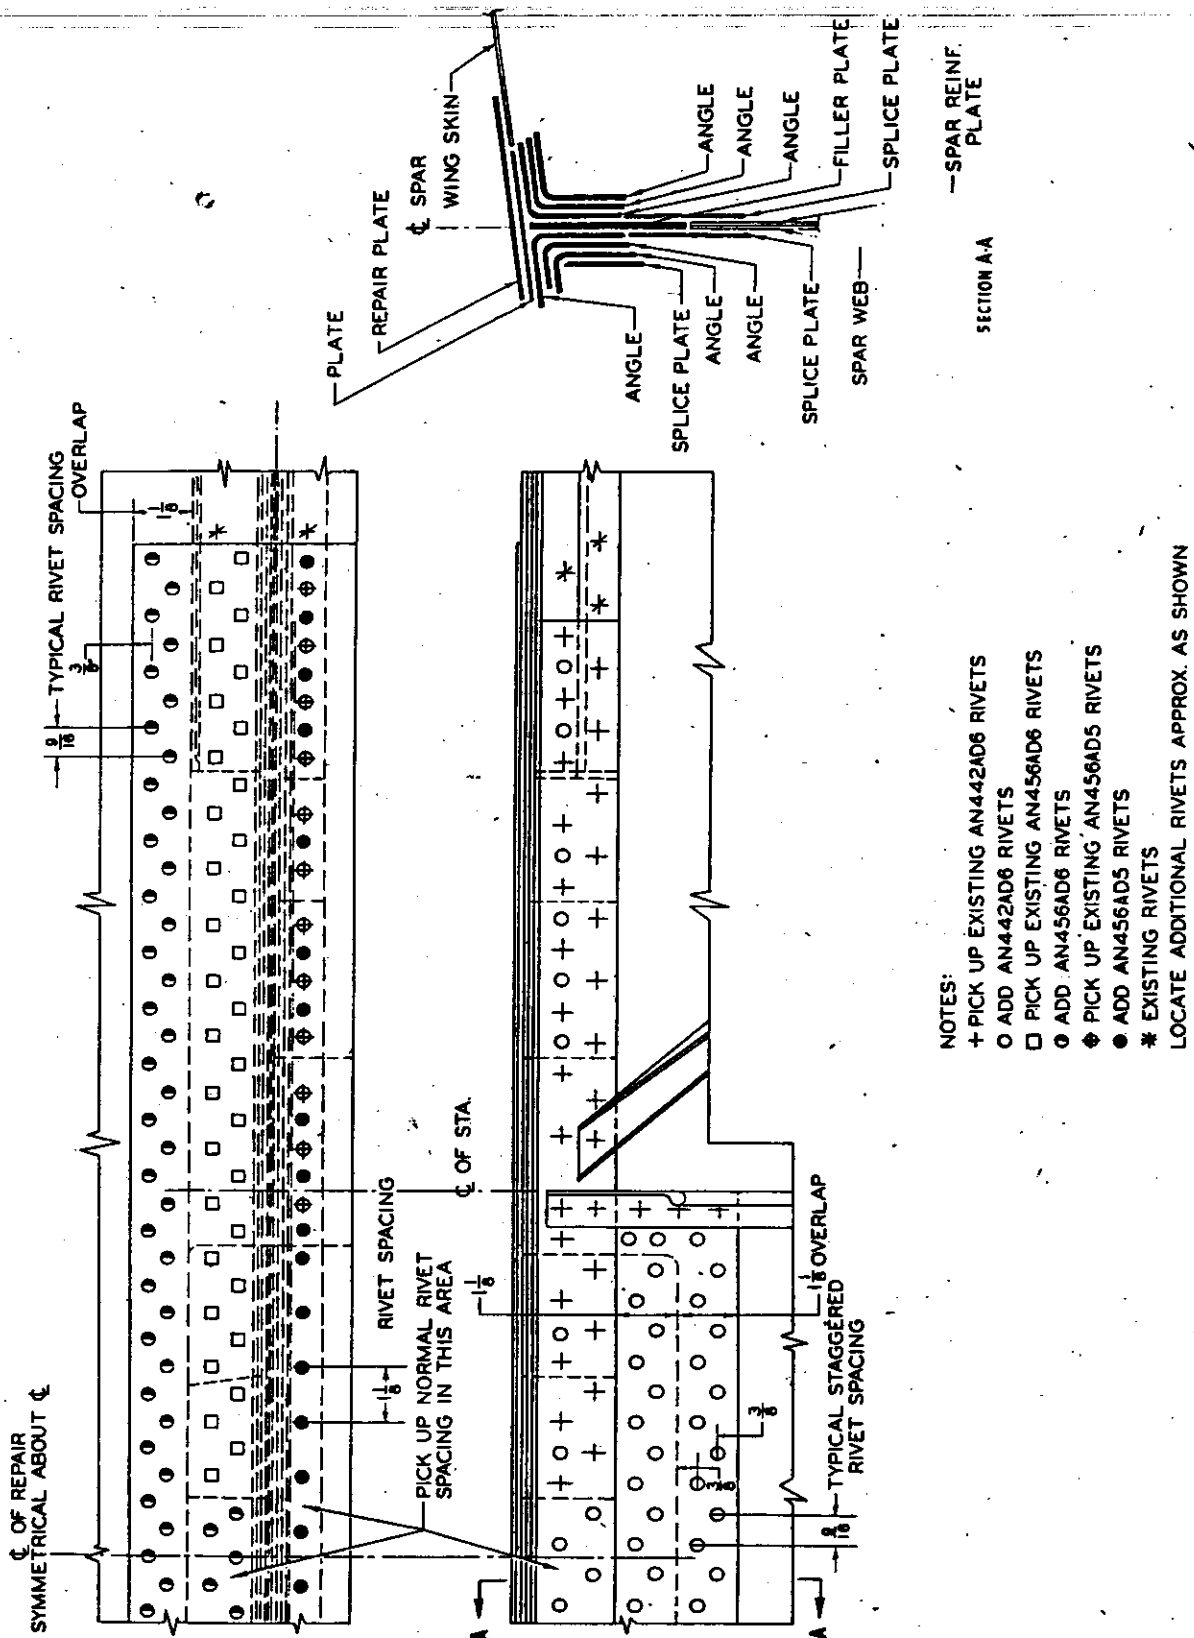
Figure 2-15 (Sheet 4 of 4 Sheets)—Spar Flange Repair

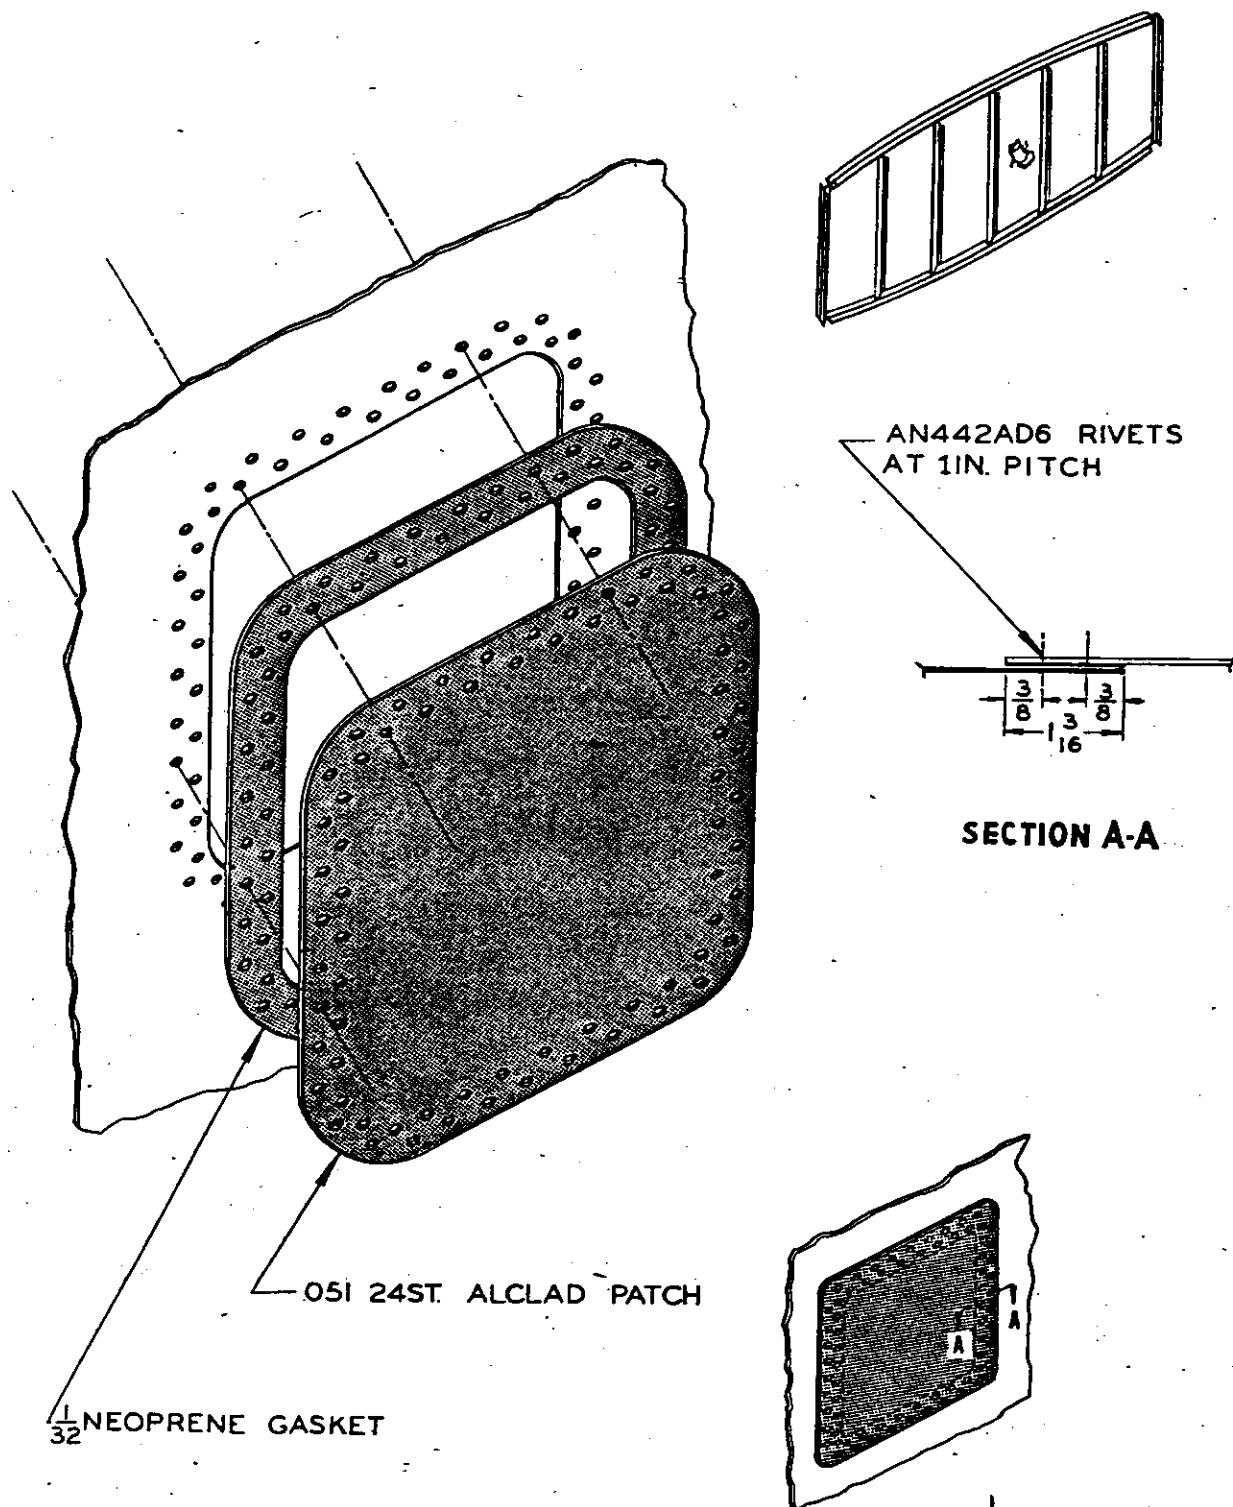
Figure 2-18—Bulkhead Web Patch

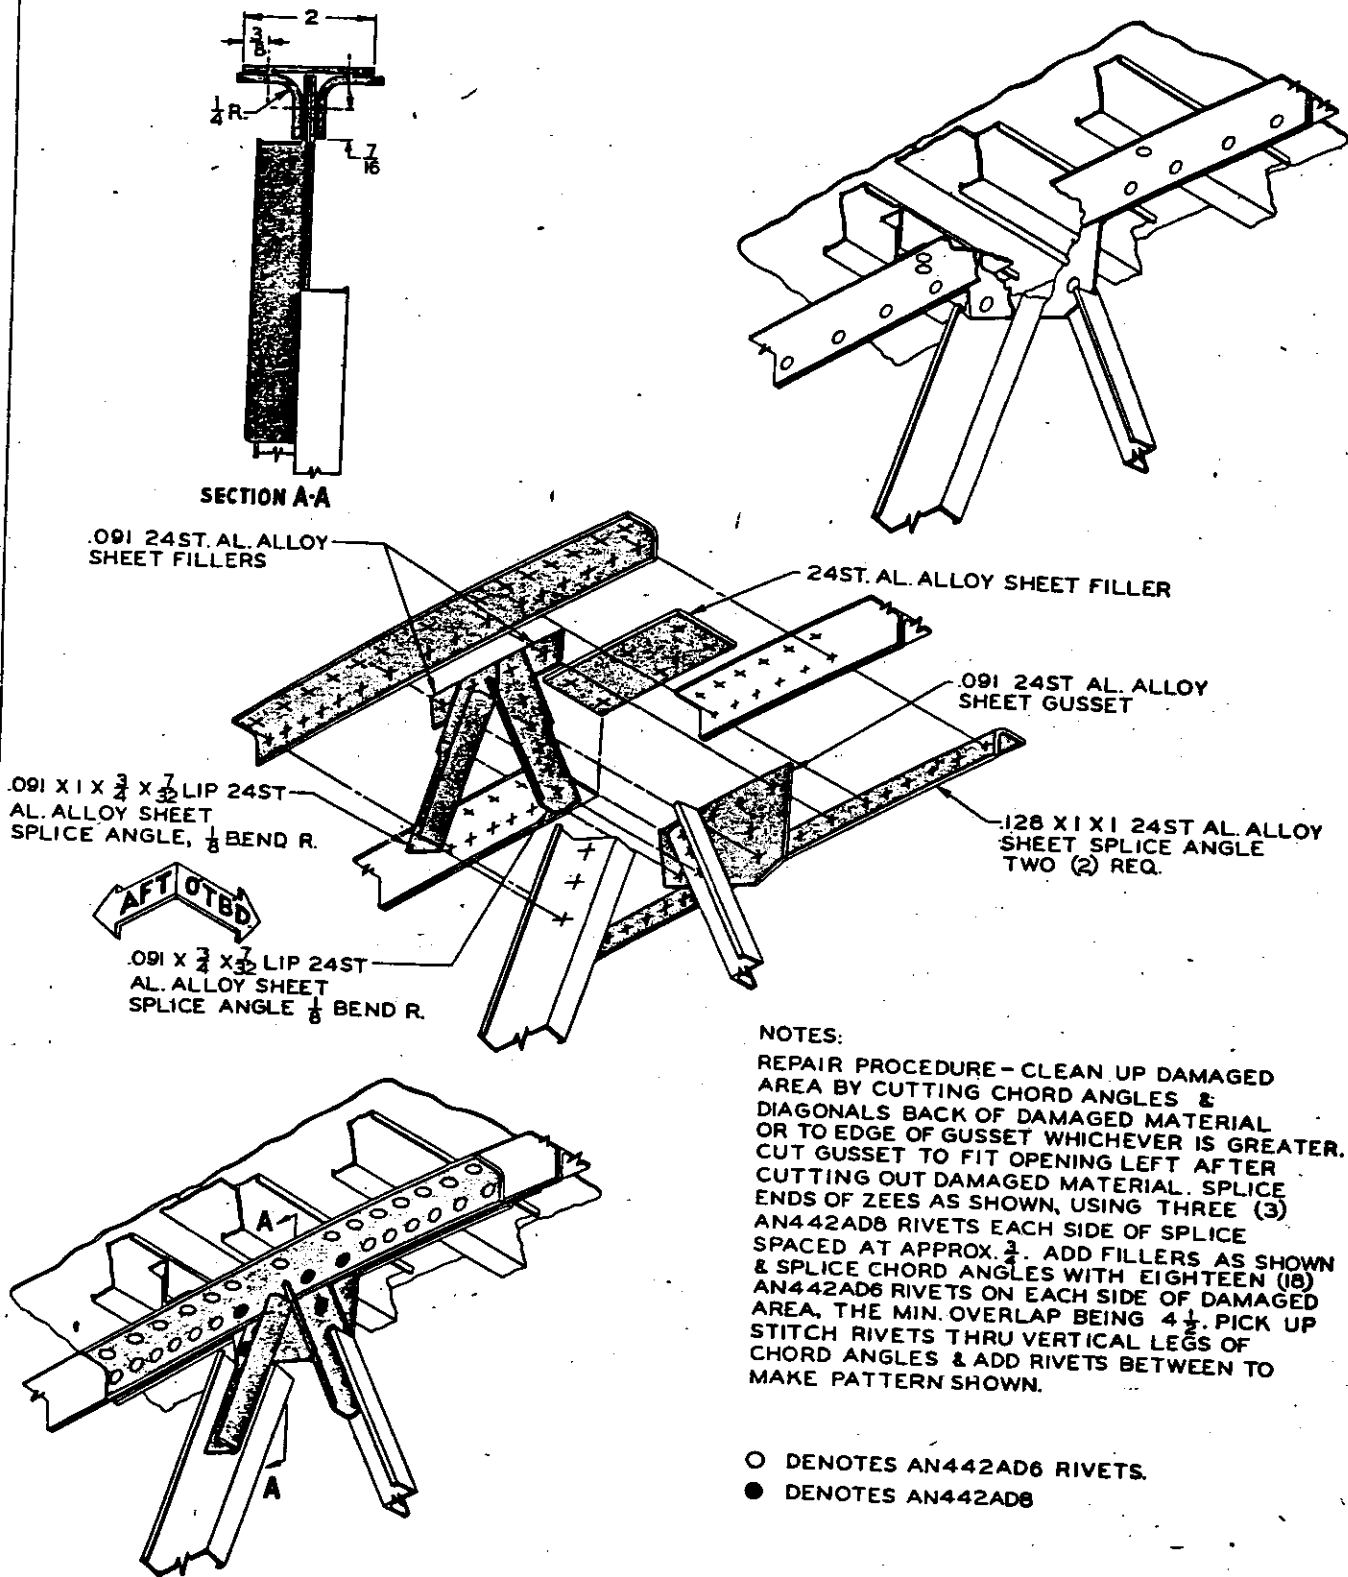
NOTES:  
REPAIR PROCEDURE - CLEAN UP DAMAGED AREA BY CUTTING CHORD ANGLES & DIAGONALS BACK OF DAMAGED MATERIAL OR TO EDGE OF GUSSET WHICHEVER IS GREATER. CUT GUSSET TO FIT OPENING LEFT AFTER CUTTING OUT DAMAGED MATERIAL. SPLICE ENDS OF ZEES AS SHOWN, USING THREE (3) AN442AD8 RIVETS EACH SIDE OF SPLICE SPACED AT APPROX. 3". ADD FILLERS AS SHOWN & SPLICE CHORD ANGLES WITH EIGHTEEN (18) AN442AD6 RIVETS ON EACH SIDE OF DAMAGED AREA, THE MIN. OVERLAP BEING 4 1/2". PICK UP STITCH RIVETS THRU VERTICAL LEGS OF CHORD ANGLES & ADD RIVETS BETWEEN TO MAKE PATTERN SHOWN.

O DENOTES AN442AD6 RIVETS.  
● DENOTES AN442AD8

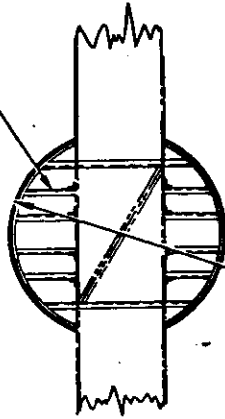
5" DIA. HOLES BETWEEN RIBS  
PERMITTED PROVIDED THEY  
ARE AT LEAST 10" APART —  
CENTER TO CENTER, TO  
PRESERVE AIR FLOW OVER  
NACELLE PATCH SKIN  
HOLES WITH .032 24 ST  
ALUMINUM ALLOY PLATE.  
RIVET WITH  $\frac{5}{32}$  CHERRY RIVETS  
SPACED @ 1" O.C.
