**Handbook of  
Structural Repair  
PBY 5**

AN 01-5M-3

# Handbook of Structural Repair

• **PBY-5 • PBY-5A • PBY-6A**

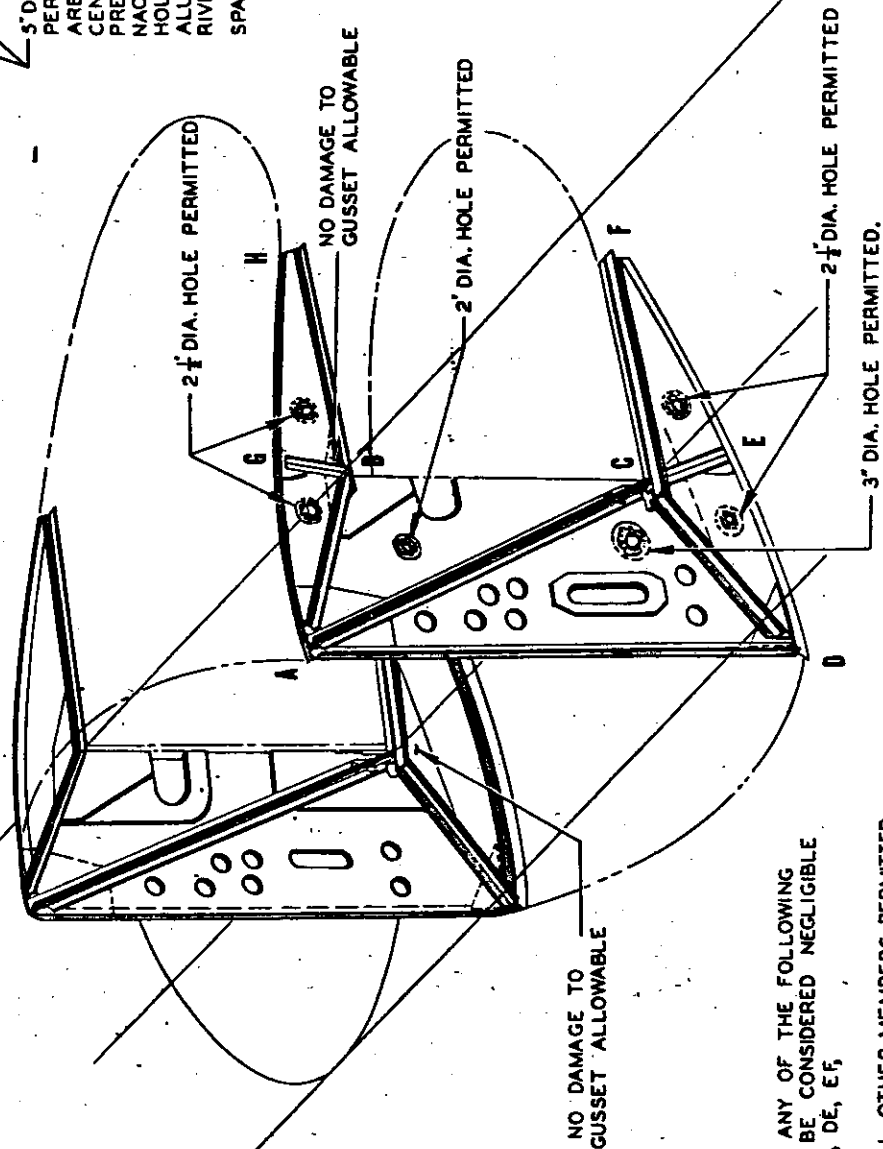
NO DAMAGE TO ANY OF THE FOLLOWING  
MEMBERS MAY BE CONSIDERED NEGLIGIBLE  
AB, AC, AD, DC, DE, EF,

1" DAMAGE TO ALL OTHER MEMBERS PERMITTED

Figure 2-20—Nacelle-Negligible Damage

2-58. Figure 2-20 shows the main structural members of the nacelle and describes what damage may be allowed to exist without repairing.

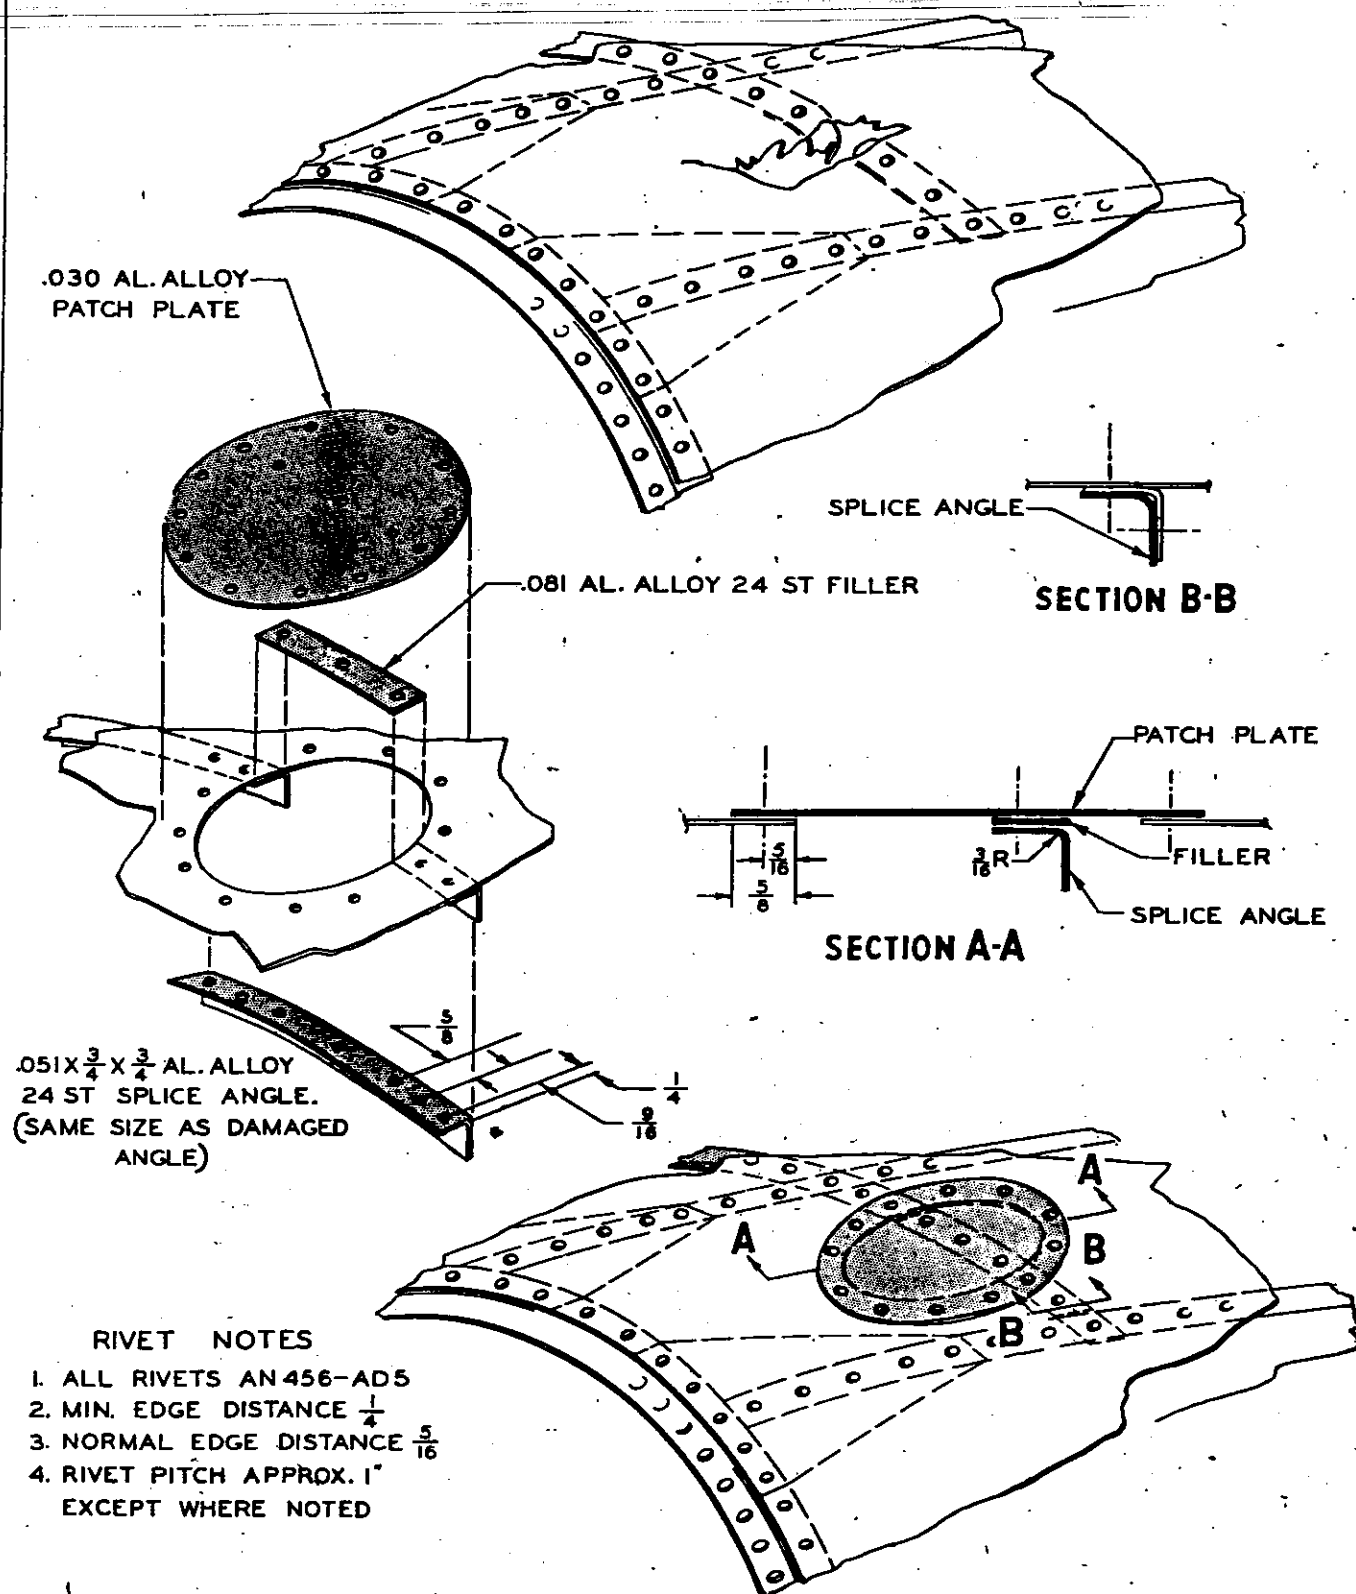
Figure 2-21—Nacelle Skin Patch

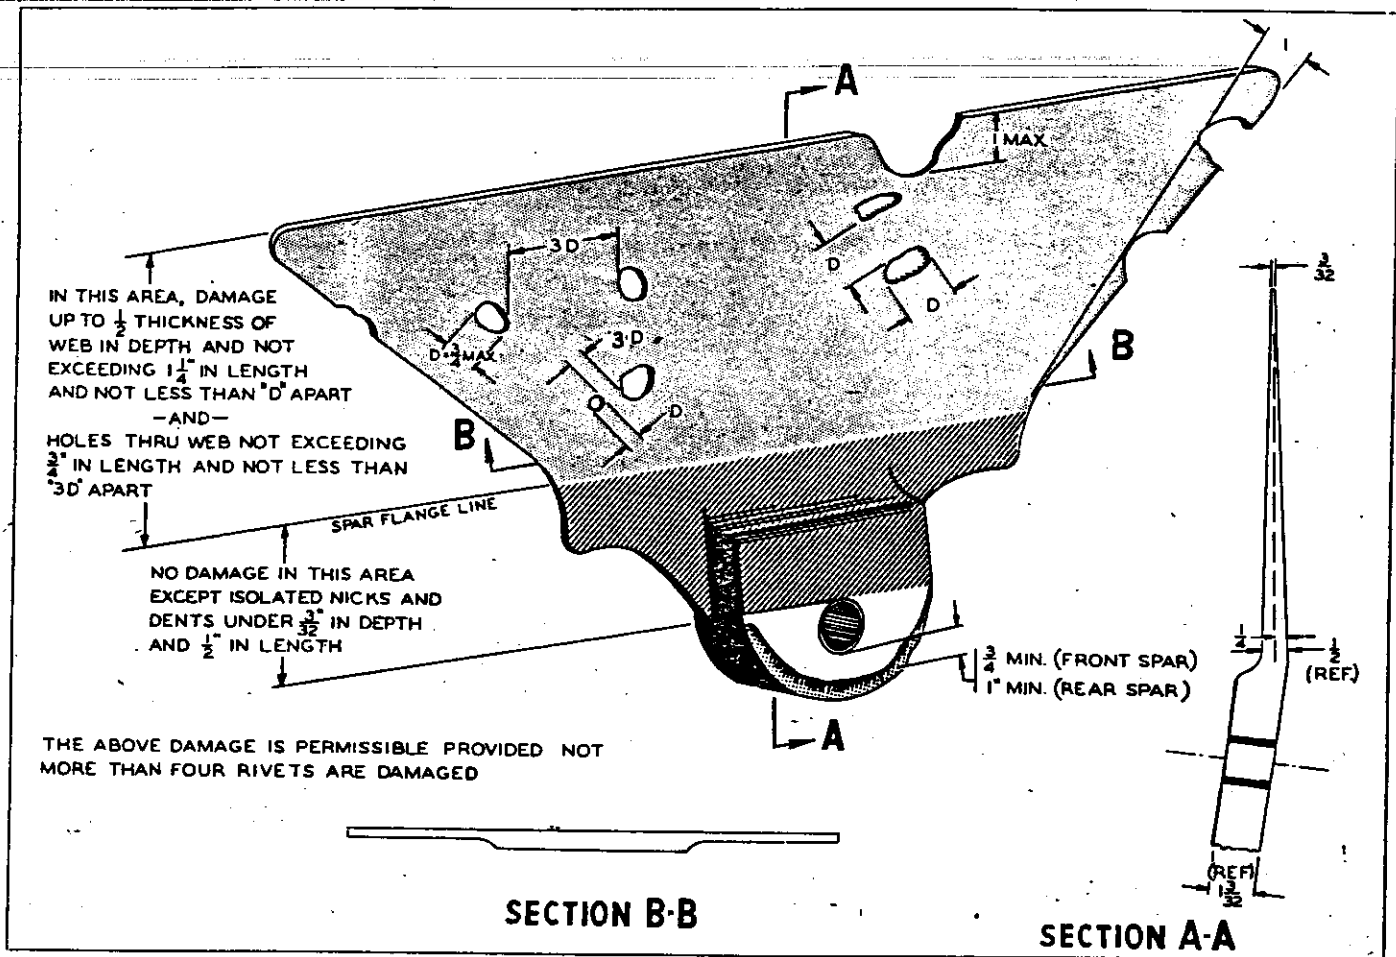
Figure 2-23—Wing-Hull Fitting-Negligible Damage

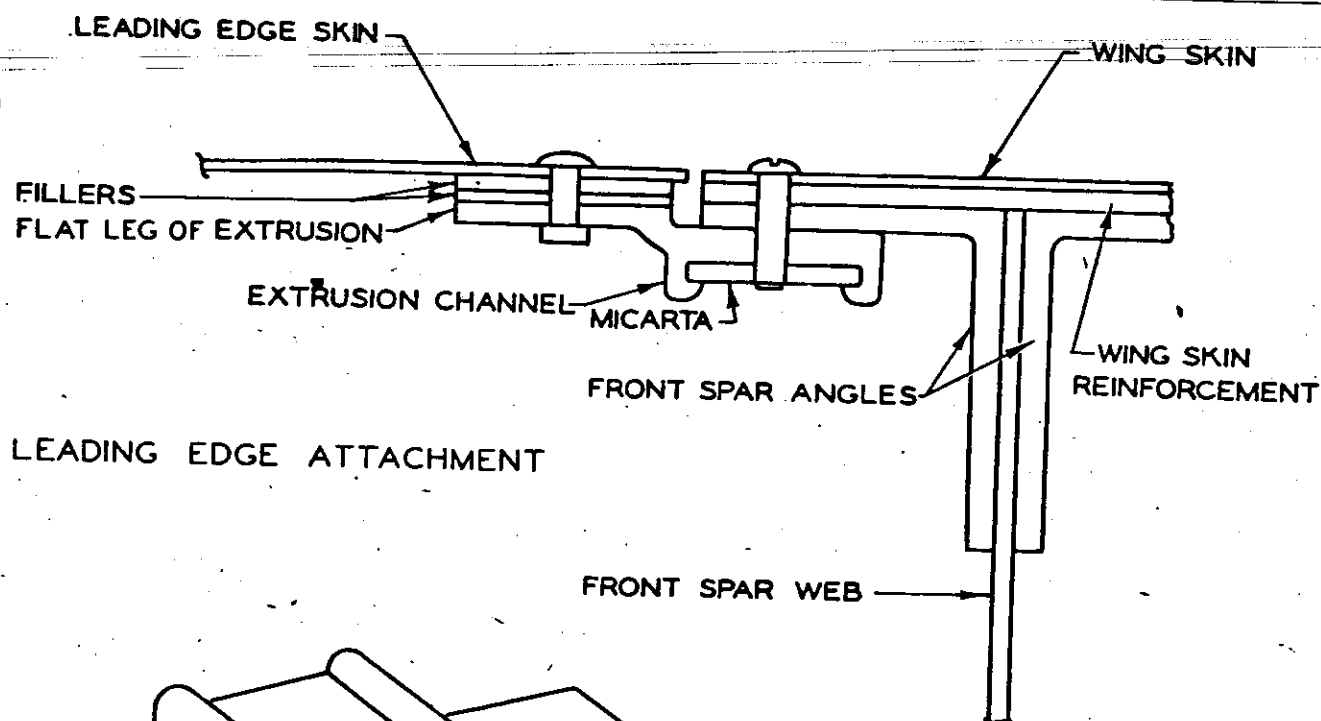
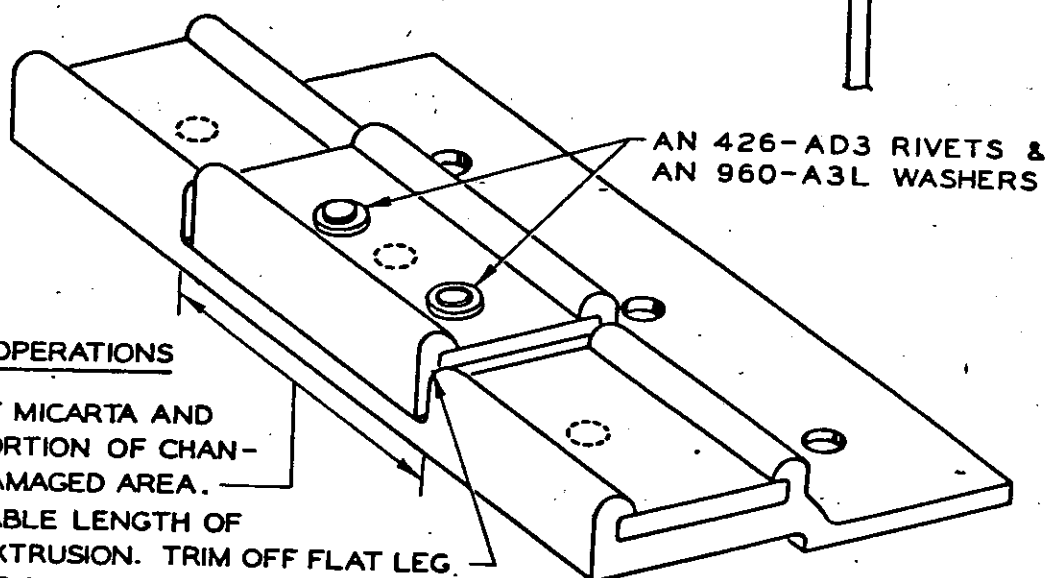
Figure 2-27—Leading Edge Attaching Strip Repair

1. TRIM OUT MICARTA AND UPPER PORTION OF CHANNEL IN DAMAGED AREA.
2. CUT SUITABLE LENGTH OF REPAIR EXTRUSION. TRIM OFF FLAT LEG.
3. DRILL OUT STRIPPED THREADS.
4. TAP NEW PIECE #10-32
5. DRILL HOLE IN MICARTA STRIP #22(.157) AND INSERT IN EXTRUSION.
6. RIVET REPAIR EXTRUSION IN PLACE.

THIS REPAIR IS FOR USE WHEN THE THREADS HAVE BEEN STRIPPED

WHEN DAMAGED AREA IS ACCESSIBLE THROUGH HAND HOLES DRILL OUT STRIPPED THREADS AND INSTALL SCREW AND AN365-D1032 NUT

VIEW SHOWING THE ATTACHING STRIP  
WITH REPAIR SECTION INSTALLED

**2-73. DAMAGE REPAIRABLE BY PATCHING.** The leading edge skin in any area should be patched in accordance with figure 2-28. Figure 2-27 outlines the method of repairing an attaching strip in which the threads have been stripped. Leading edge stringers are to be patched in accordance with the typical repairs outlined in Appendix II.

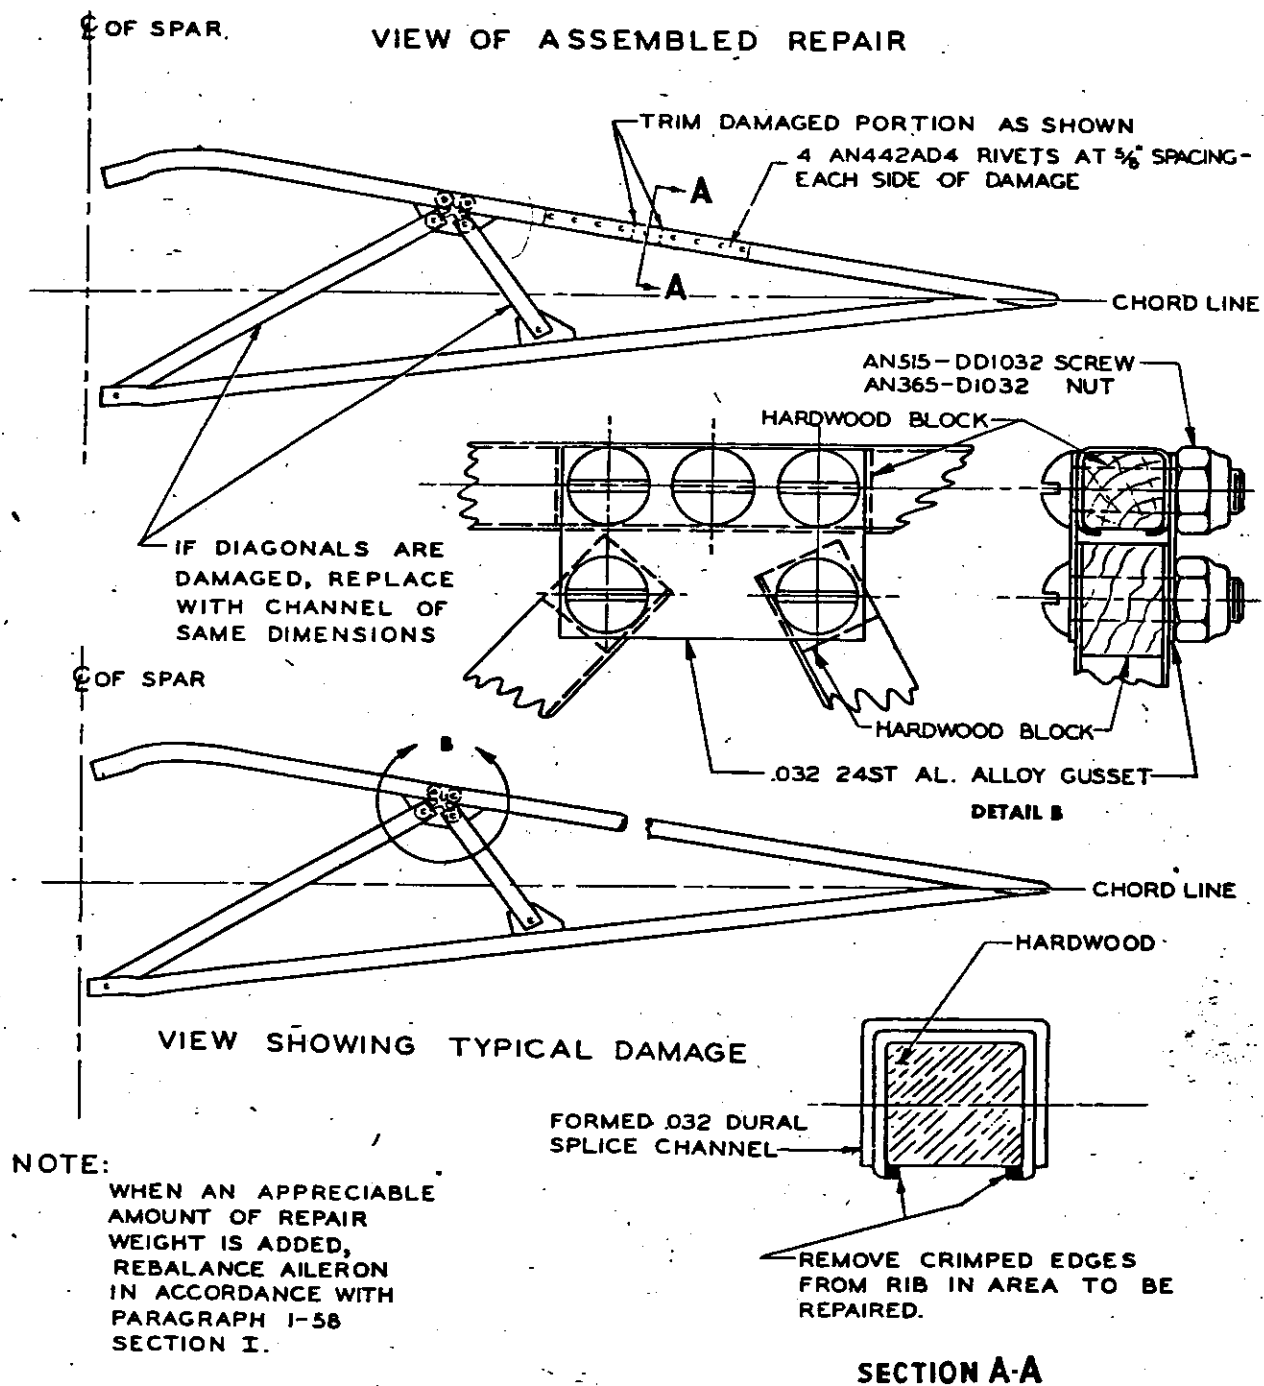
Figure 2-30—Trailing Edge Rib Repair

① DENOTES AN4 56AD4 RIVETS

REMOVE SUFFICIENT FABRIC FROM  
AROUND DAMAGED AREA TO BUCK  
RIVETS. REPLACE FABRIC IN ACCORD-  
ANCE WITH SECTION 13 OF THE  
GENERAL MANUAL FOR STRUCTURAL  
REPAIR (AN01-1A-1)

**2-79.** Damage to rib members may be repaired in accordance with figure 2-30.

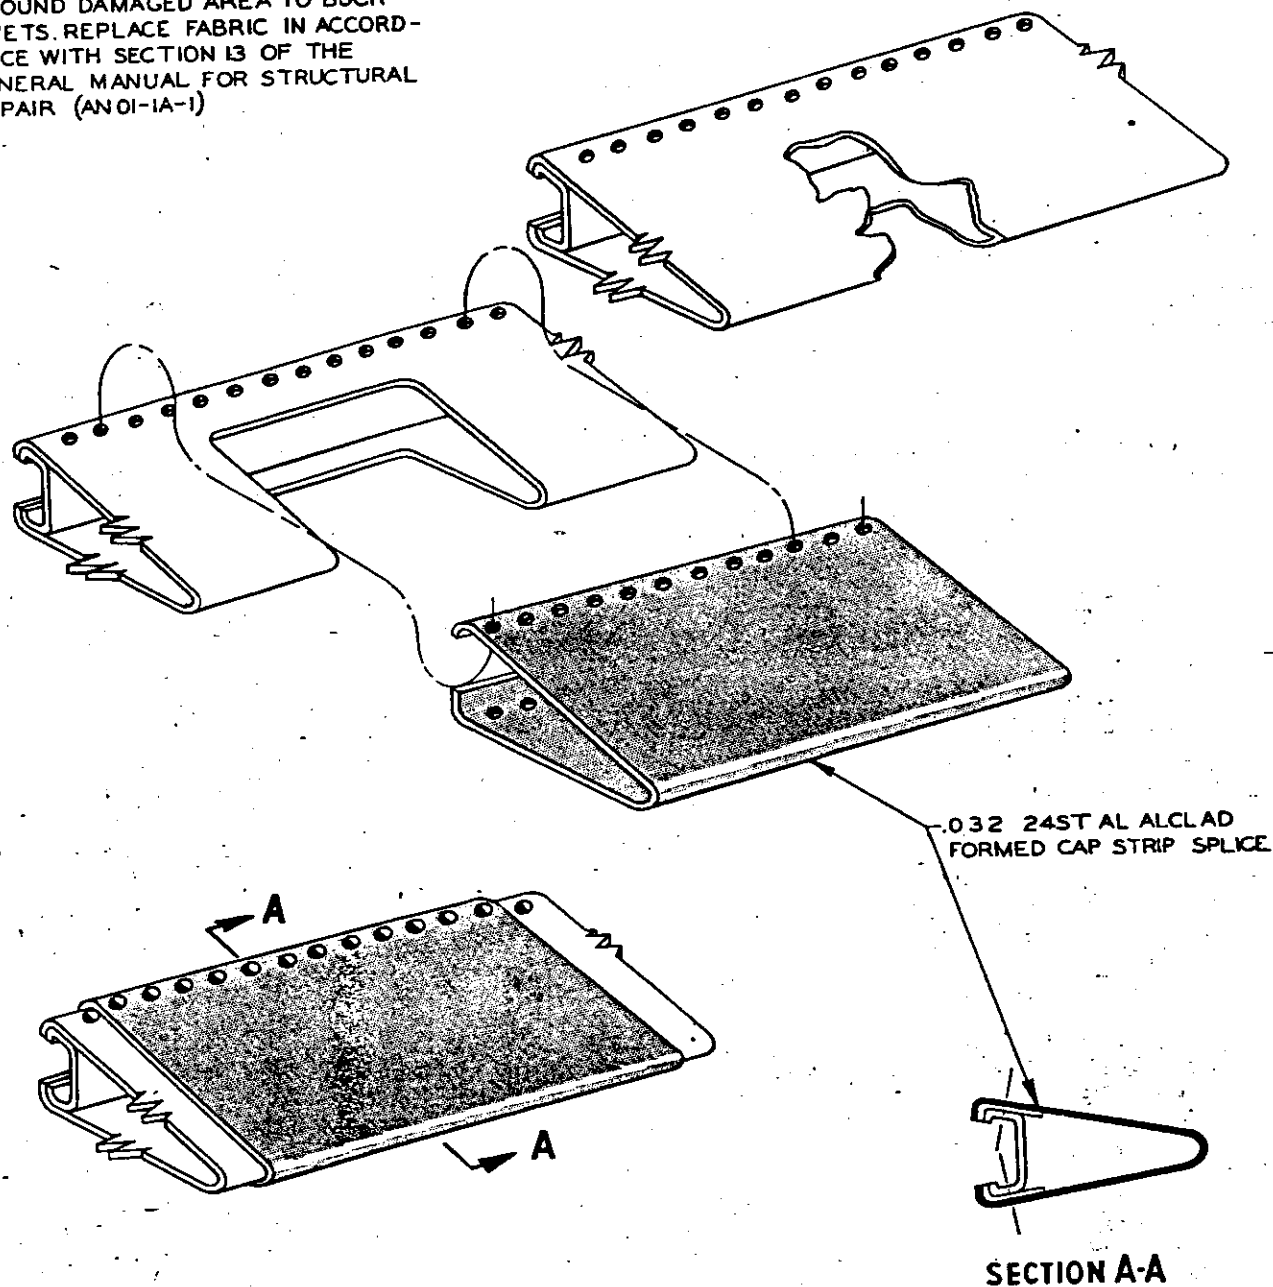
Figure 2-31—Formed Trailing Edge Repair

REPAIR PROCEDURE FOR HOLES OVER 3 WIDE

TRIM AWAY SKIN BETWEEN RIBS  
ATTACH REPAIR PLATE TO RIBS  
WITH CHERRY RIVETS NAF-1195-5A  
USE ORIGINAL RIVET SPACING

REPAIR PROCEDURE FOR SMALL  
HOLES OR CRACKS

DRILL NO. 50 STOP HOLES AT EXTREMITIES  
OF CRACKS.

CUT PATCH PLATE LARGE ENOUGH TO  
OVERLAP EXTREMITIES OF CRACK OR EDGE  
OF HOLE A SUFFICIENT DISTANCE TO ADD  
ONE ROW OF RIVETS ALL AROUND PATCH  
USING  $\frac{1}{4}$ " EDGE DISTANCE.

ATTACH REPAIR PLATE WITH CHERRY RIVETS  
NAF1195-4A USE  $\frac{3}{4}$ " RIVET SPACING.

**2-80.** Damage to the formed trailing edge may be repaired in accordance with figure 2-31.

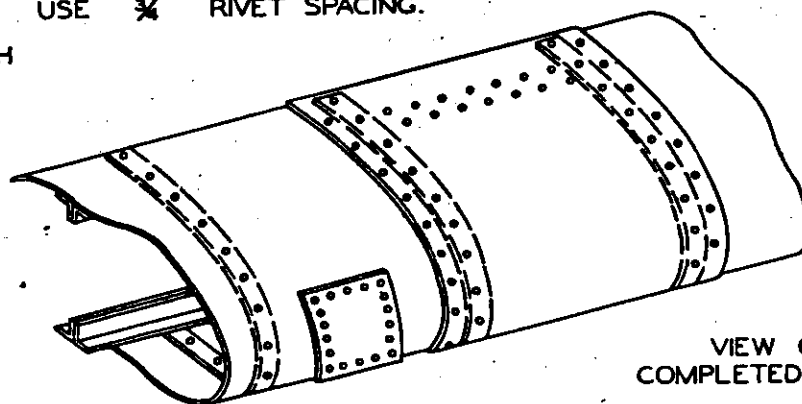
Figure 2-32—Aileron Leading Edge Repair

VIEW OF  
COMPLETED REPAIR

**2-88. DAMAGE REPAIRABLE BY PATCHING.** A typical patch repair to the aileron leading edge is shown in figure 2-32.

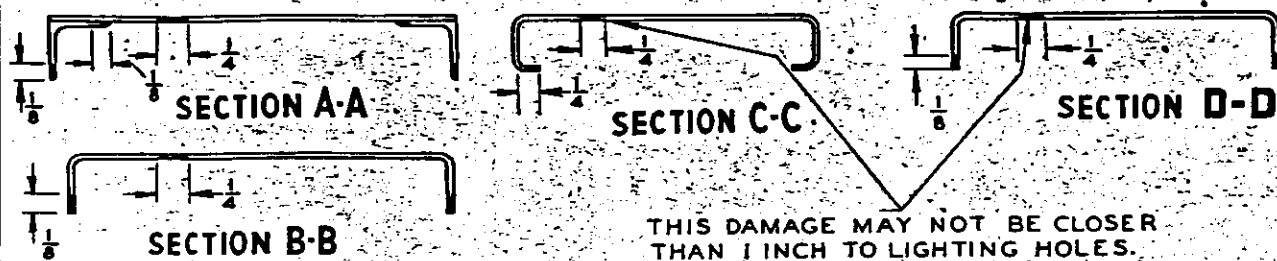
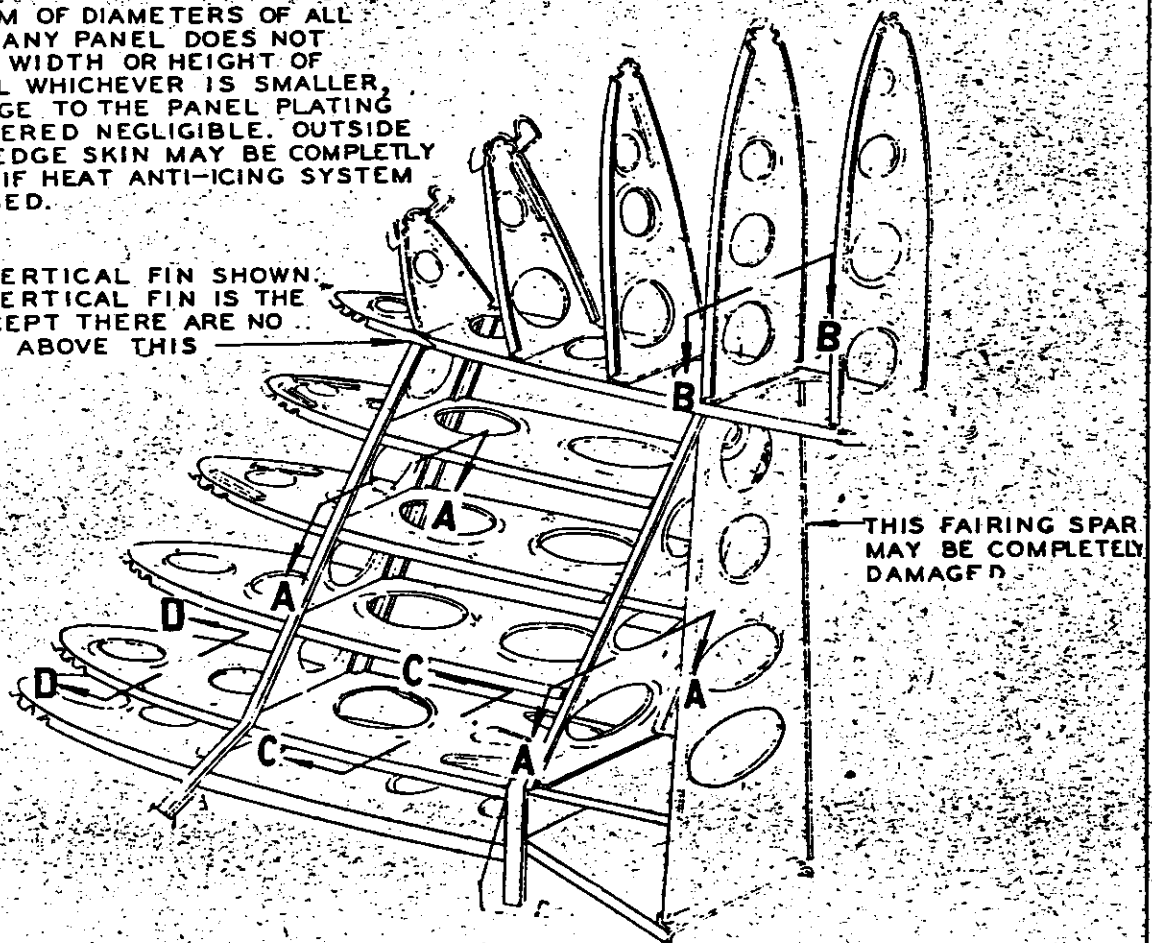
Figure 3-4-Vertical Stabilizer-Negligible Damage

NEGLECTIBLE DAMAGE TO SPARS & RIBS IS SHOWN BY SHADED AREAS. THIS AREA MAY BE COMPLETELY DAMAGED.

IF THE SUM OF DIAMETERS OF ALL HOLES IN ANY PANEL DOES NOT EXCEED  $\frac{1}{3}$  WIDTH OR HEIGHT OF THE PANEL WHICHEVER IS SMALLER, THE DAMAGE TO THE PANEL PLATING IS CONSIDERED NEGLECTIBLE. OUTSIDE LEADING EDGE SKIN MAY BE COMPLETELY DAMAGED IF HEAT ANTI-ICING SYSTEM IS NOT USED.

PBY-5A VERTICAL FIN SHOWN. PBY-6A VERTICAL FIN IS THE SAME EXCEPT THERE ARE NO MEMBERS ABOVE THIS POINT.

NOTE:  
A PANEL IS A PLATING AREA BOUND BY ADJACENT RIBS OR SPARS

3-8. NEGLIGIBLE DAMAGE. All permissible negligible damage to the horizontal and vertical stabilizers is shown in figures 3-3 and 3-4, respectively. In airplanes that are not equipped with heat anti-icing, complete destruction of the outer leading edge skin is considered as negligible, requiring no repair.

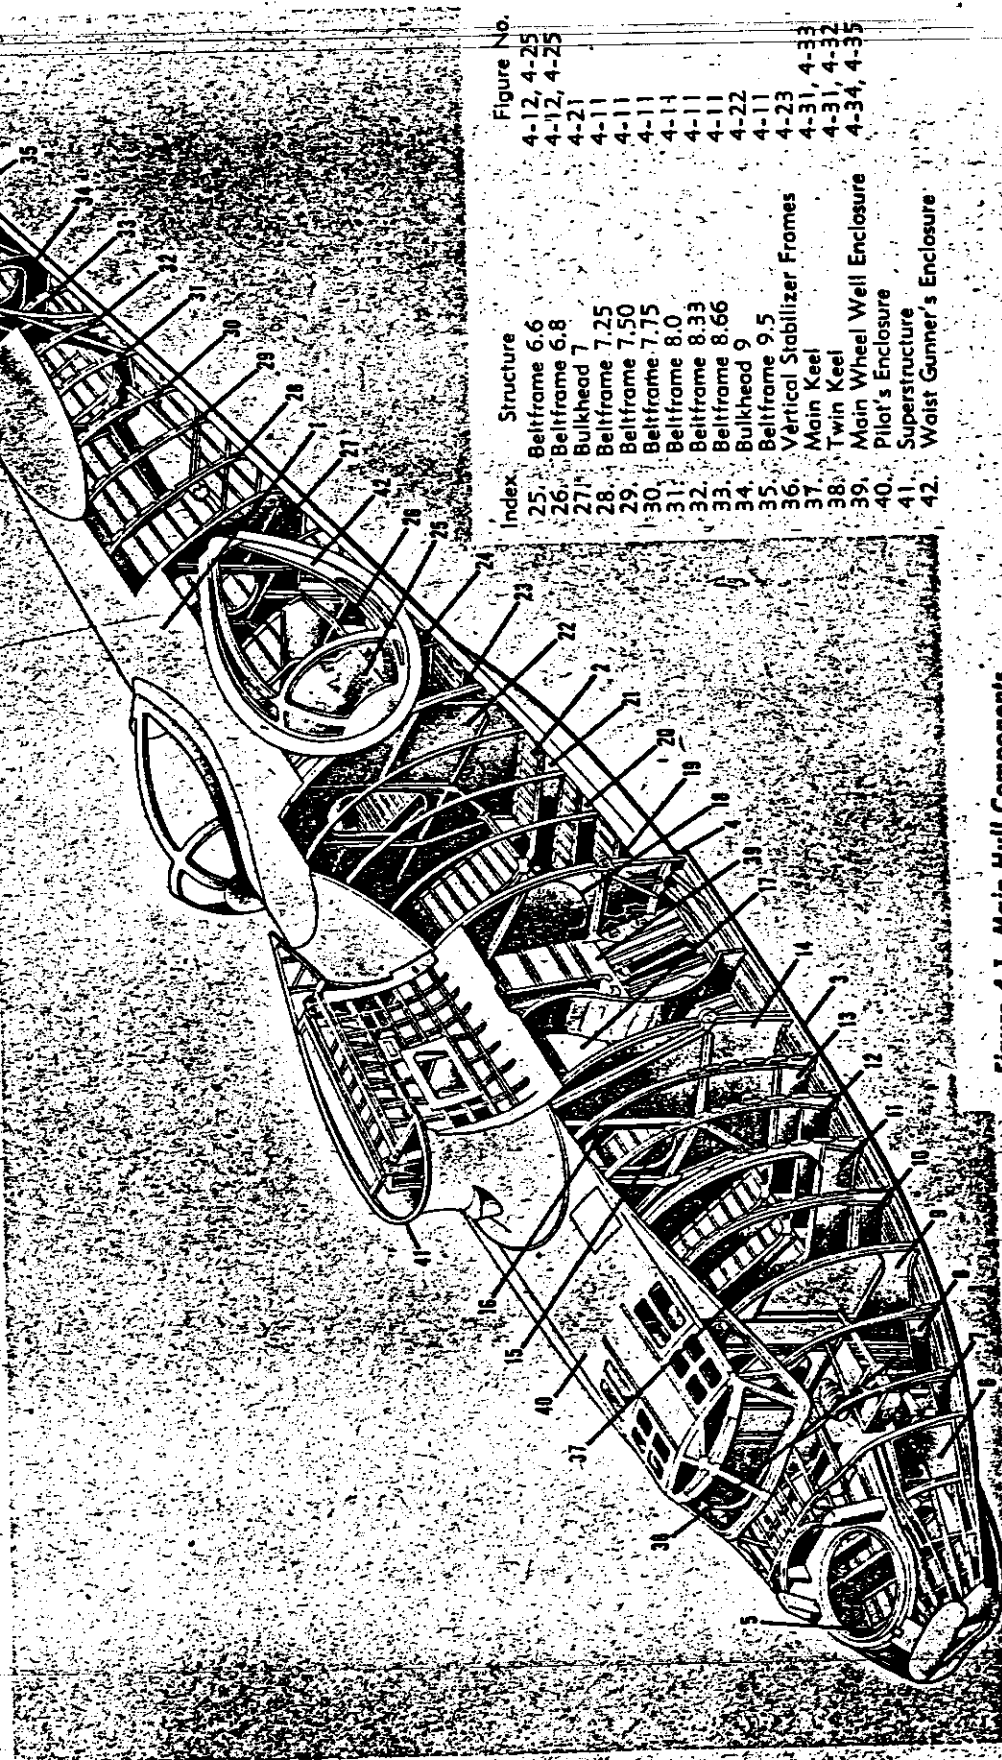
Figure 4-1—Main Hull Components

Index	Structure	Figure No.	Index	Structure	Figure No.
1.	Plating	4-4 thru 4-6	15.	Beltframe 4-1	4-13, 4-26
2.	Stringer	4-5, 4-7, 4-8	16.	Beltframe 4-2	4-14, 4-29
3.	Chine	4-9	17.	Beltframe 4-3	4-15, 4-26
4.	Step	4-10	18.	Bulkhead 5	4-20, 4-30
5.	Beltframes 0.33 and 0.66	4-11	19.	Beltframe 5.25	4-12, 4-25
6.	Bulkhead 1	4-16, 4-24	20.	Beltframe 5.50	4-12, 4-25
7.	Beltframe 1.33	4-12, 4-25	21.	Beltframe 5.75	4-12, 4-25
8.	Beltframe 1.66	4-12, 4-25	22.	Bulkhead 6	4-21
9.	Bulkhead 2	4-17	23.	Beltframe 6.2	4-12, 4-25
10.	Beltframe 2.5	4-12, 4-26	24.	Beltframe 6.4	4-12, 4-25
11.	Bulkhead 3	4-18			
12.	Beltframe 3.33	4-12, 4-27			
13.	Beltframe 3.66	4-12, 4-27			
14.	Bulkhead 4	4-19, 4-28

Index	Structure	Figure No.
25.	Beltframe 6.6	4-12, 4-25
26.	Beltframe 6.8	4-12, 4-25
27.	Bulkhead 7	4-21
28.	Beltframe 7.25	4-11
29.	Beltframe 7.50	4-11
30.	Beltframe 7.75	4-11
31.	Beltframe 8.0	4-11
32.	Beltframe 8.33	4-11
33.	Beltframe 8.66	4-11
34.	Bulkhead 9	4-22
35.	Beltframe 9.5	4-11
36.	Vertical Stabilizer Frames	4-23
37.	Main Keel	4-31, 4-33
38.	Twin Keel	4-31, 4-33
39.	Main Wheel Well Enclosure	4-31, 4-33
40.	Pilot's Enclosure	4-34, 4-35
41.	Superstructure	
42.	Waist Gunner's Enclosure

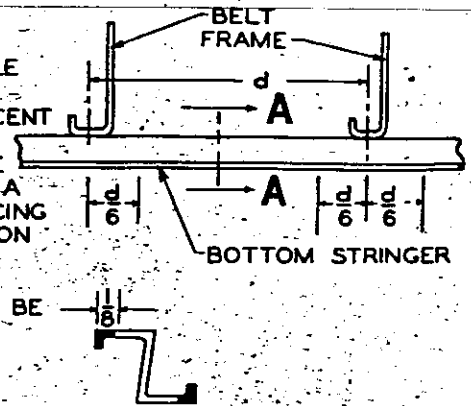
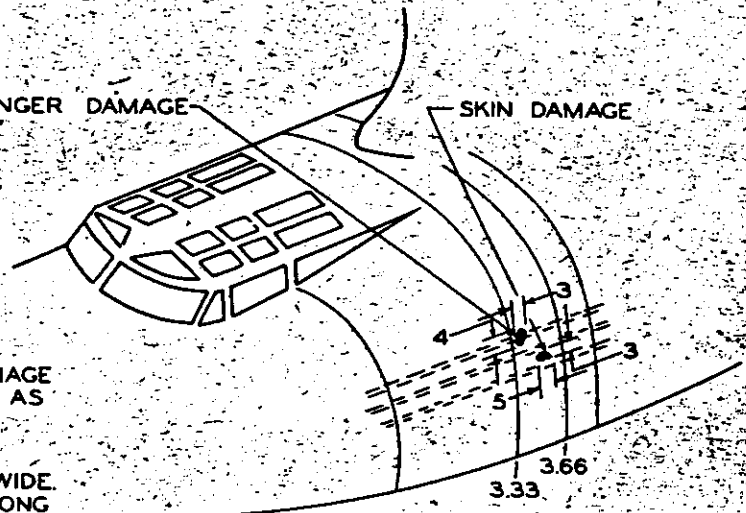
Figure 4-5—Hull Plating and Stringer-Negligible Damage

### SECTION A-A

NO DAMAGE ALLOWED FOR A DISTANCE OF  $\frac{1}{4}$ " FROM BELT FRAME OR BULKHEAD FOR BOTTOM STRINGERS. SEE SEC. AA FOR DAMAGE TO BOTTOM STRINGERS IN OTHER AREA.

USE OF FORMULA FOR DETERMINING DAMAGE TO SKIN AND STRINGERS PERMISSIBLE AS NEGLIGIBLE DAMAGE.

DAMAGE: ONE SKIN DAMAGE 5" LONG X 3" WIDE.  
ONE SKIN STRINGER DAMAGE 3" LONG X 4" WIDE.

S = TOTAL TRANSVERSE LENGTH IN INCHES OF DAMAGED SKIN.

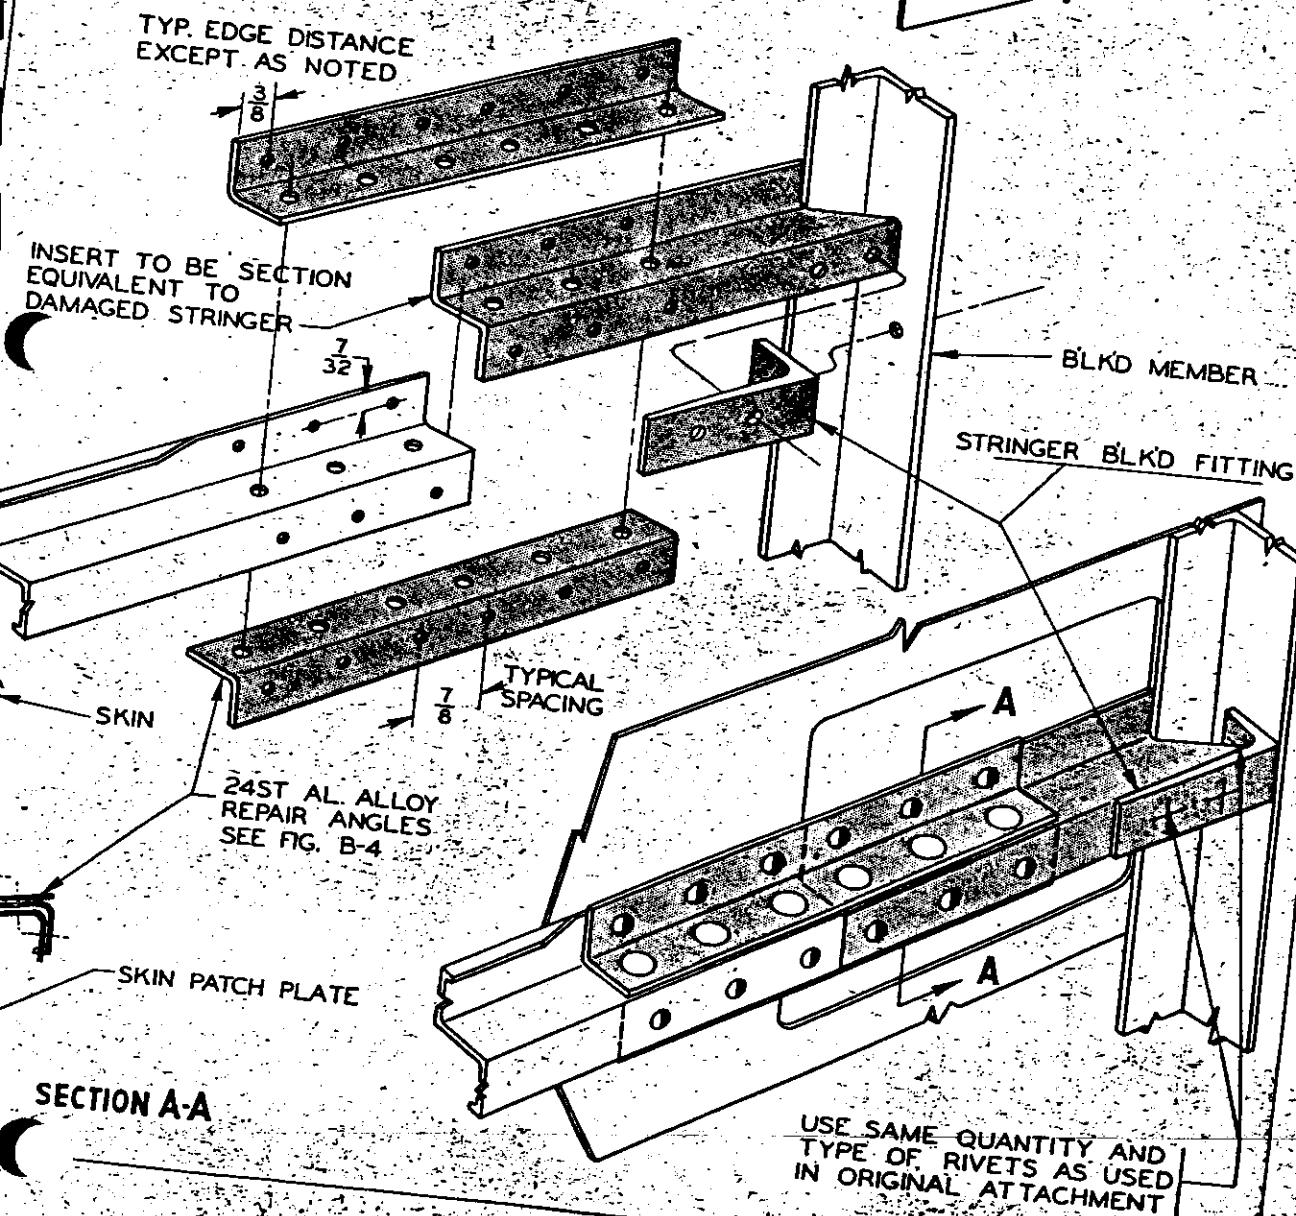
Figure 4-8—Typical Hull Stringer Repair

- INDICATES AN442AD4 RIVETS
- INDICATES AN442AD6 RIVETS
- REPLACE DAMAGED BULKHEAD FITTING WITH NEW ONE.
- SEE FIGURE 4-6 FOR REPAIR OF DAMAGED SKIN.
- FILE OFF LIPS OF DAMAGED STRINGERS TO ALLOW ROOM FOR SPLICE ANGLES.
- USE AN456AD4 IN PLACE OF AN442AD4 RIVETS FOR SPLICE THRU SKIN.

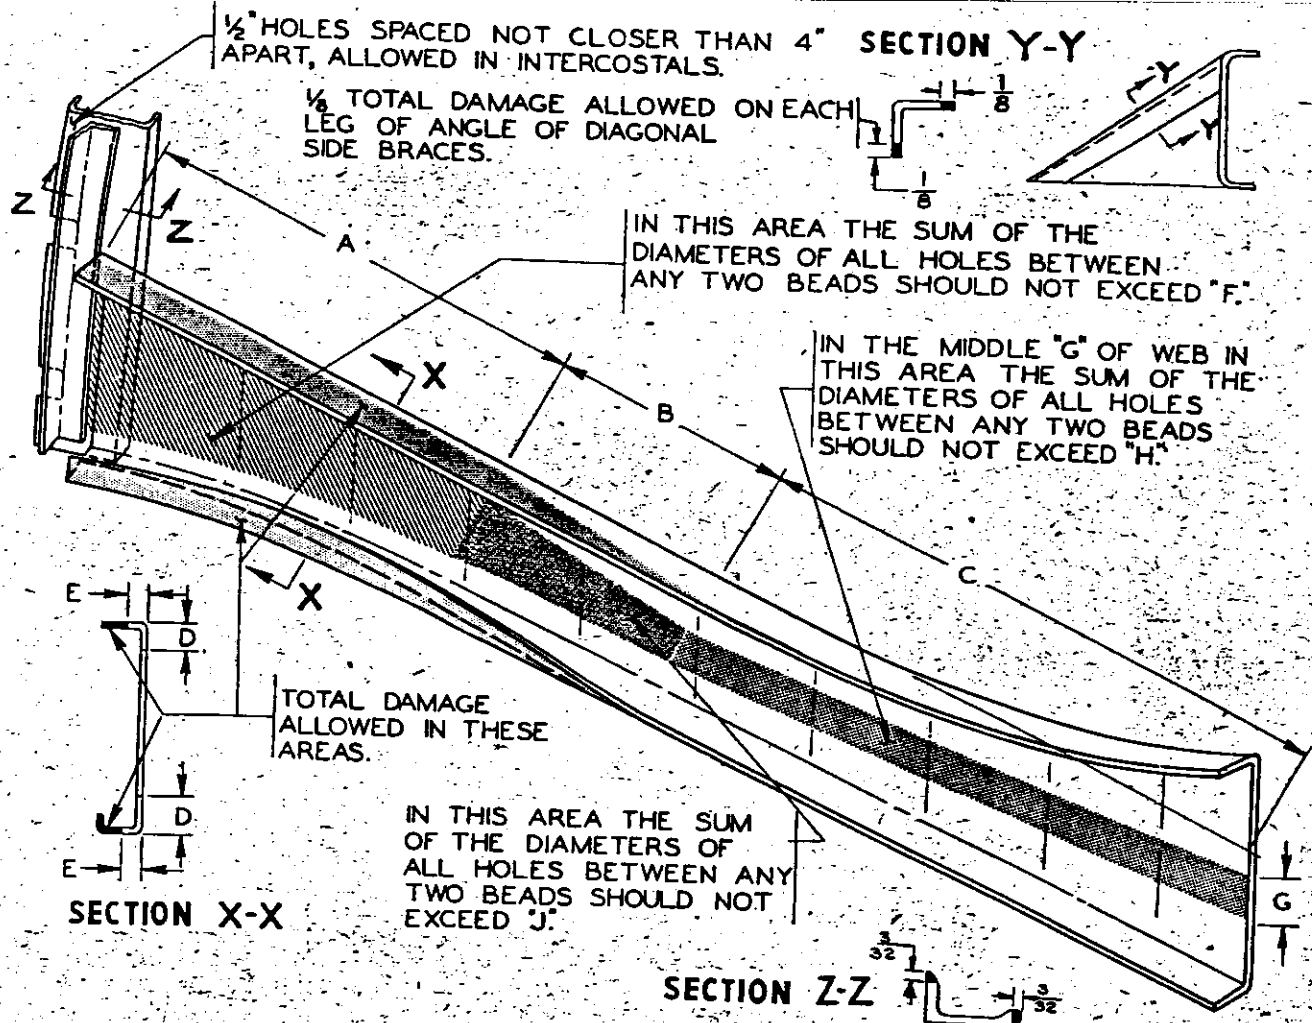
Figure 4-11—Negligible Damage—Non-Hydropress Type Beltframes

BELTFRAMES	A	B	C	D	E	F	G	H	J
1.33	42½	0	0	1	¾	3			
1.66	47	0	0	1	¾	3	4½	3	3
2.5	36	10	18½	¾	½	3	2	1	2
3.33	34	6	23½	¾	½	2¼	2	1	1½
3.66	34	6	23½	¾	½	2¼	2	1	1½
5.25	30	23½	10	1	½	3	3	1	2
5.50	30	23	10	1	½	3	3	1	2
5.75	30	20	10	1	½	3	3	1	2
6.20	23	8	18½	¾	½	1¾	2	1	1¾
6.40	19	11¾	10	¾	½	1	**	1	1
6.60	27½	0	0	1	¾	*	***		
6.80	15½	0	0	1	½	3	***

IN UNSHADED AREAS AND BEADS NEGLIGIBLE DAMAGE IS LIMITED TO ISOLATED NICKS AND DENTS NOT EXCEEDING  $\frac{1}{32}$ " IN DEPTH AND SPACED AT LEAST 1" APART

ALL CRACKS MUST BE CUT OUT TO SMOOTH ROUND HOLES OF A DIAMETER SLIGHTLY GREATER THAN THE LENGTH OF THE CRACK. IF THE CLEANED UP HOLE EXCEEDS NEG. DAMAGE SIZE SHOWN IN TABLE REPAIRS MUST BE MADE.

**4-26. NEGLIGIBLE DAMAGE.** Cracks after stop drilling and nicks after filing out and also dents not exceeding a certain area and depth are considered as negligible damage in beltframes and bulkheads. (See figures 4-11 through 4-23.)

**4-27.** Also considered as negligible damage in bulkheads and beltframes are holes of certain size and location. (See figures 4-11 through 4-23.)

**4-28.** Scratches except as noted in figures 4-11 through 4-23 may be classed as negligible damage provided they are less than 1/32 inch deep and 3/4 inch long.

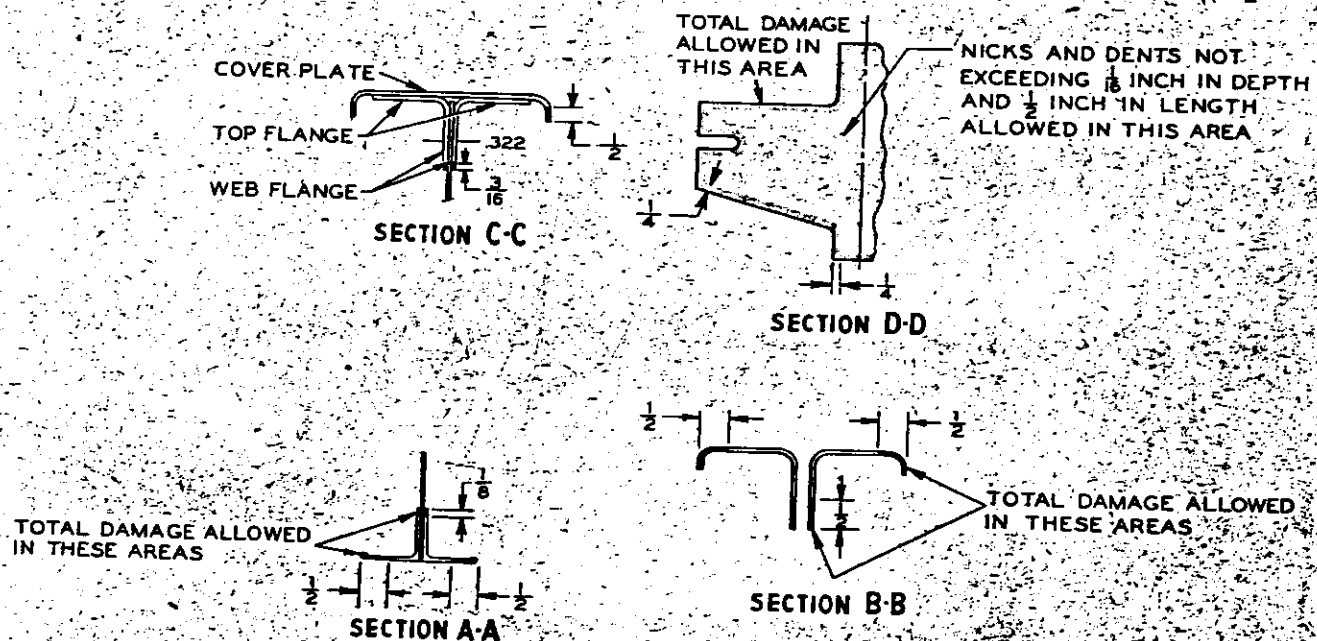
NEGLECTIBLE DAMAGE TO ANY PART OF THIS MEMBER IS LIMITED TO ONE OF THE FOLLOWING: SEE SECTION C-C  
HOLES NOT EXCEEDING  $\frac{3}{4}$  INCH IN DIAMETER, SPACED AT LEAST TWO DIAMETERS APART IN BOTH THE COVER PLATE AND TOP FLANGE.

NO DAMAGE ALLOWED TO BEADS.

ALL CRACKS MUST BE CUT OUT TO SMOOTH ROUND HOLES OF A DIAMETER SLIGHTLY GREATER THAN THE LENGTH OF THE CRACK. IF THE CLEANED UP HOLE EXCEEDS NEG. DAMAGE SIZE SHOWN IN TABLE, REPAIRS MUST BE MADE.

IN THIS AREA NEGLECTIBLE DAMAGE IS LIMITED TO NICKS AND DENTS NOT EXCEEDING  $\frac{1}{16}$  INCH IN DEPTH AND  $\frac{1}{4}$  IN LENGTH

$\frac{1}{2}$  INCH HOLES SPACED AT LEAST 2 INCHES APART ALLOWED IN INTERCOSTALS

IN THIS AREA HOLES NOT TO EXCEED 1 INCH IN DIAMETER AND SPACED NO LESS THAN 2 INCHES APART.

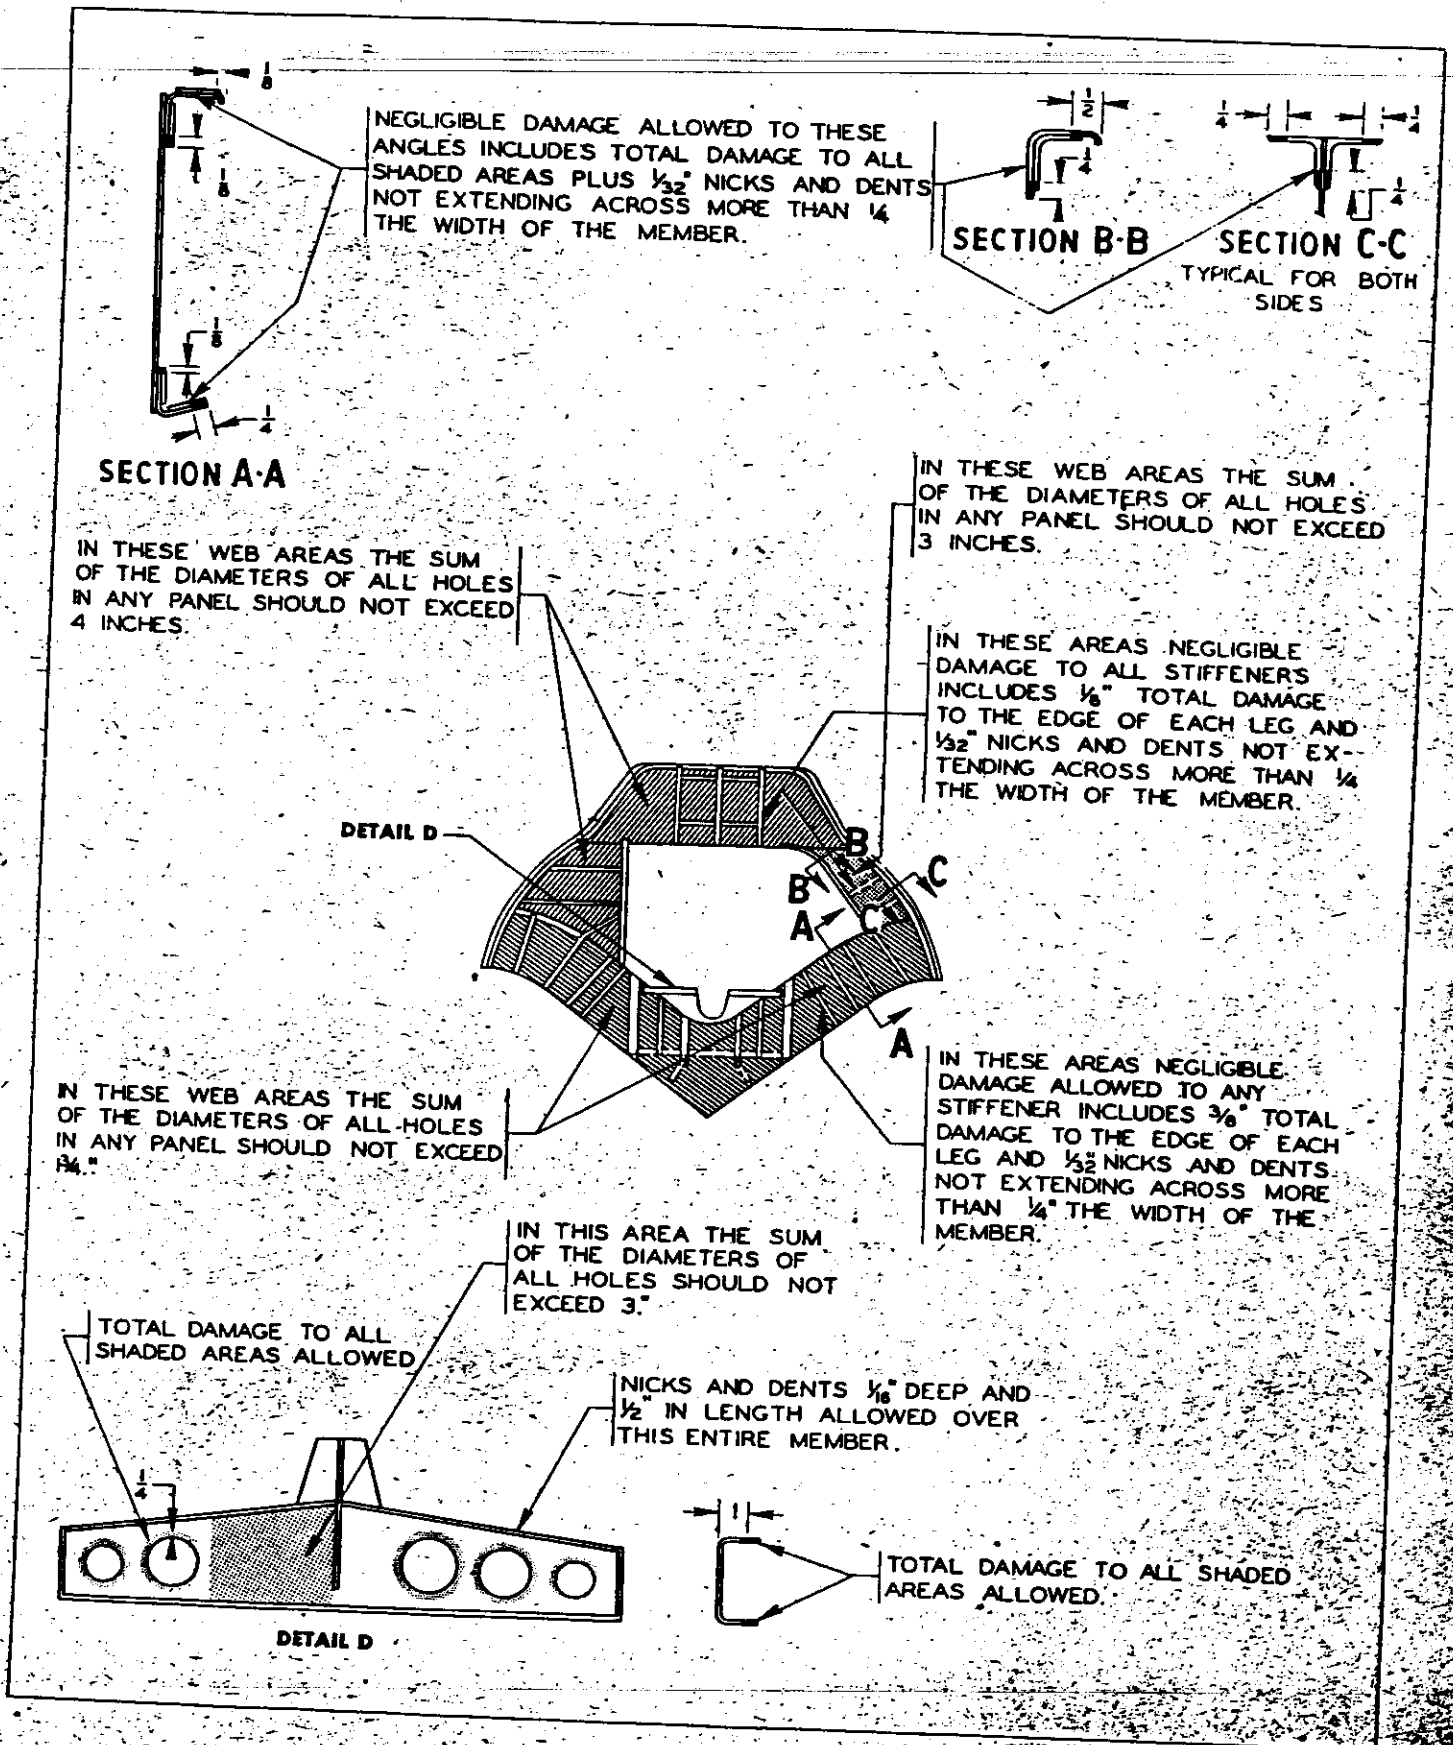
Figure 4-16-Bulkhead 1-Negligible Damage

NEGLIGIBLE DAMAGE ALLOWED TO ALL ANGLES INCLUDES:  
 $\frac{1}{8}$ " TOTAL DAMAGE TO EDGE OF EACH LEG.  
 $\frac{1}{32}$ " NICKS AND DENTS NOT EXTENDING ACROSS MORE THAN  $\frac{1}{4}$  THE WIDTH OF THE MEMBER.

IN THE AREAS BELOW THIS W.L. 41 $\frac{3}{16}$  A WATERTIGHT PATCH MUST BE INSTALLED OVER ALL HOLES.

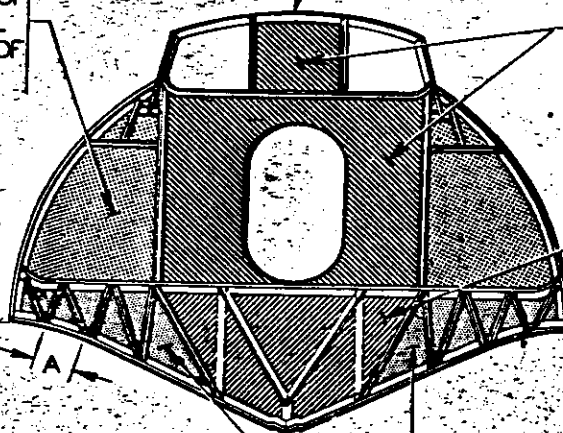
IN THESE WEB AREAS THE SUM OF THE DIAMETERS OF ALL HOLES IN ANY PANEL SHOULD NOT EXCEED  $\frac{3}{4}$  OF THE PANEL WIDTH.

IN THESE WEB AREAS THE SUM OF THE DIAMETERS OF ALL HOLES IN ANY PANEL SHOULD NOT EXCEED  $\frac{1}{3}$  OF THE DIMENSION "A".
