**Handbook of  
Structural Repair  
PBY 5**

AN 01-5M-3

# Handbook of Structural Repair

• **PBY-5 • PBY-5A • PBY-6A**

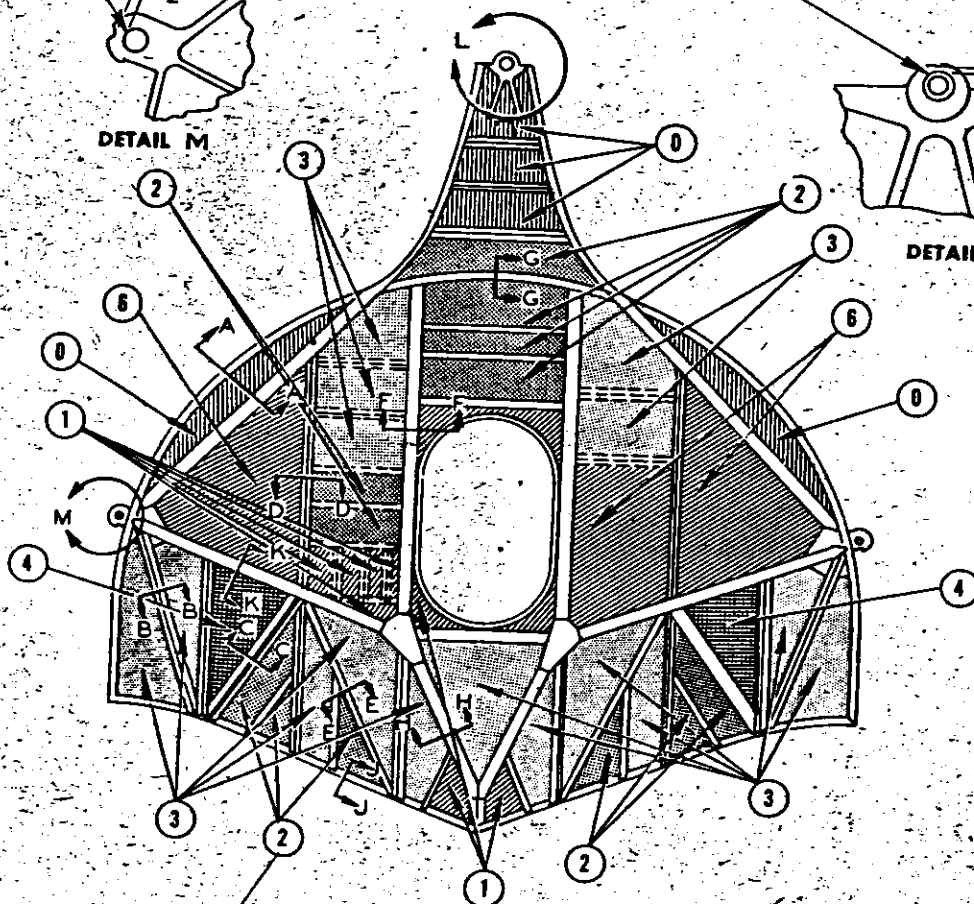
THE SUM OF DIAMETERS OF HOLE DAMAGES PERMITTED AS NEGLIGIBLE DAMAGE IN THE VARIOUS SHADED AREAS MUST NOT EXCEED THE AMOUNT IN INCHES INDICATED BY THE CIRCLED NUMBERS.

NICKS AND DENTS  $\frac{1}{32}$ " DEEP AND  $\frac{3}{8}$ " IN LENGTH ARE ALLOWED AS NEGLIGIBLE DAMAGE IN ANGLES AND TEE MEMBERS BETWEEN SUPERSTRUCTURE AND WING STRUT FITTING.

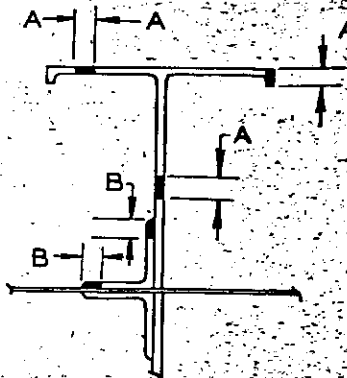
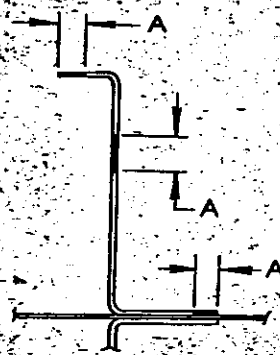
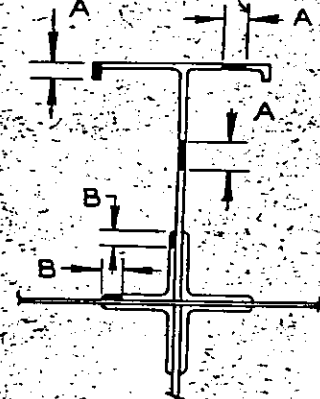
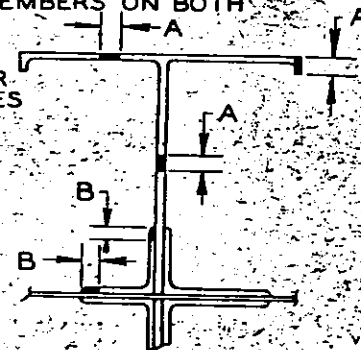
Figure 4-19-Bulkhead 4-Negligible Damage (sheet 2 of 2)

DAMAGE IN SHADED AREAS WHICH LEAVES MINIMUM EDGE DISTANCE FOR ALL RIVETS AND BOLTS ( $1\frac{1}{2} \times$  DIAMETER OF THE RIVET OR BOLT) IS CONSIDERED NEGLIGIBLE.

MEMBERS FOR WHICH DAMAGE IS NOT SHOWN IN THE CROSS SECTIONS MAY BE DAMAGED  $\frac{3}{8}$  INCH IN EACH LEG.

NEGLIGIBLE DAMAGE, SHOWN IN SHADED AREAS OF THE CROSS SECTIONS, IS LISTED IN THE TABLE.

NEGLIGIBLE DAMAGE SHOWN IN THE VARIOUS CROSS SECTIONS MAY BE PERMITTED SIMULTANEOUSLY IN SIMILAR MEMBERS ON BOTH SIDES OF THE BULKHEAD.

IF THE SUM OF THE A DIMENSIONS AND THE SUM OF THE B DIMENSIONS FOR EACH MEMBER IN EACH SECTION, DO NOT EXCEED THE VALUES GIVEN IN THE TABLE BELOW, THE DAMAGE IS CONSIDERED NEGLIGIBLE.

SECTIONS	A	B
AA	SEE SECTION NOTE	
BB	$\frac{1}{2}$	
CC	SEE SECTION NOTE	
DD	$\frac{1}{8}$	
EE	$\frac{3}{4}$	
FF	$\frac{1}{2}$	$\frac{1}{8}$
GG	$1\frac{1}{2}$	
HH	$\frac{3}{4}$	$\frac{3}{8}$
JJ	$\frac{1}{4}$	
KK	$\frac{5}{16}$	$\frac{3}{32}$

THE SUM OF HOLE DIAMETERS PERMITTED AS NEGLIGIBLE DAMAGE IN THE VARIOUS SHADED REGIONS MUST NOT EXCEED THE AMOUNT IN INCHES INDICATED BY THE CIRCLED NUMBER.

THE DAMAGE TO MEMBERS AS SHOWN IN THE VARIOUS SECTIONS IS NOT TO EXIST OVER A TOTAL LENGTH OF 2" ALONG THE MEMBER.

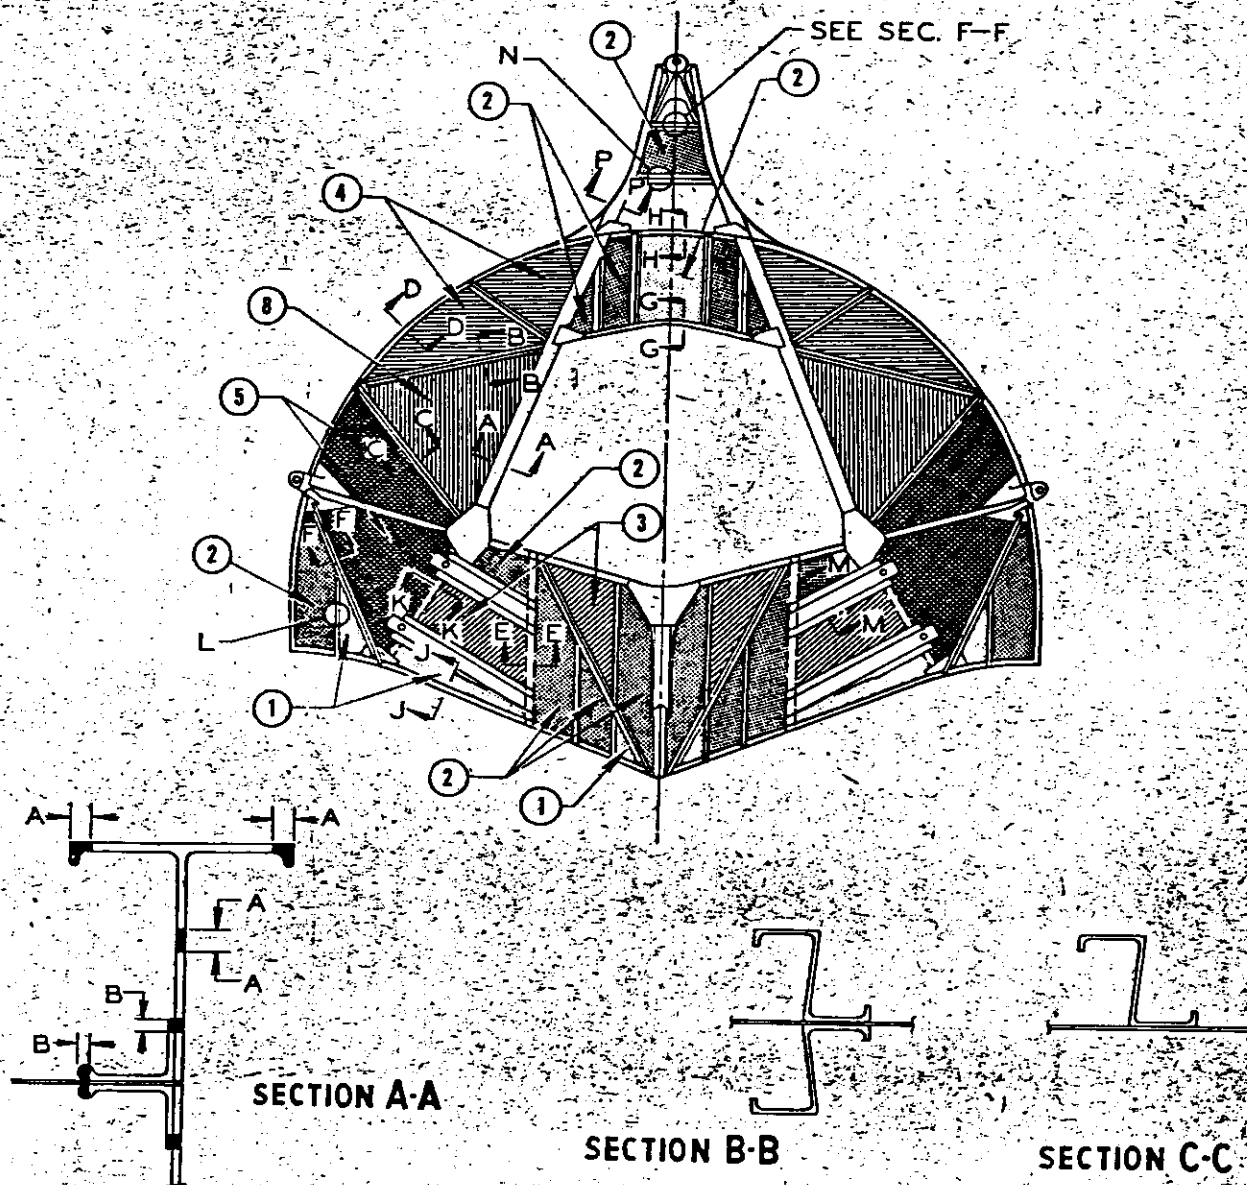
Figure 4-20-Bulkhead 5-Negligible Damage (sheet 1 of 2)

FOR TEE SECTION, THE TOTAL SUM OF 'A' DIMENSIONS NOT TO EXCEED  $\frac{3}{8}$  PER TEE SECTION.

NICKS & DENTS IN THE ABOVE ZEE MEMBERS NOT TO EXCEED  $\frac{1}{32}$  INCH DEPTH.

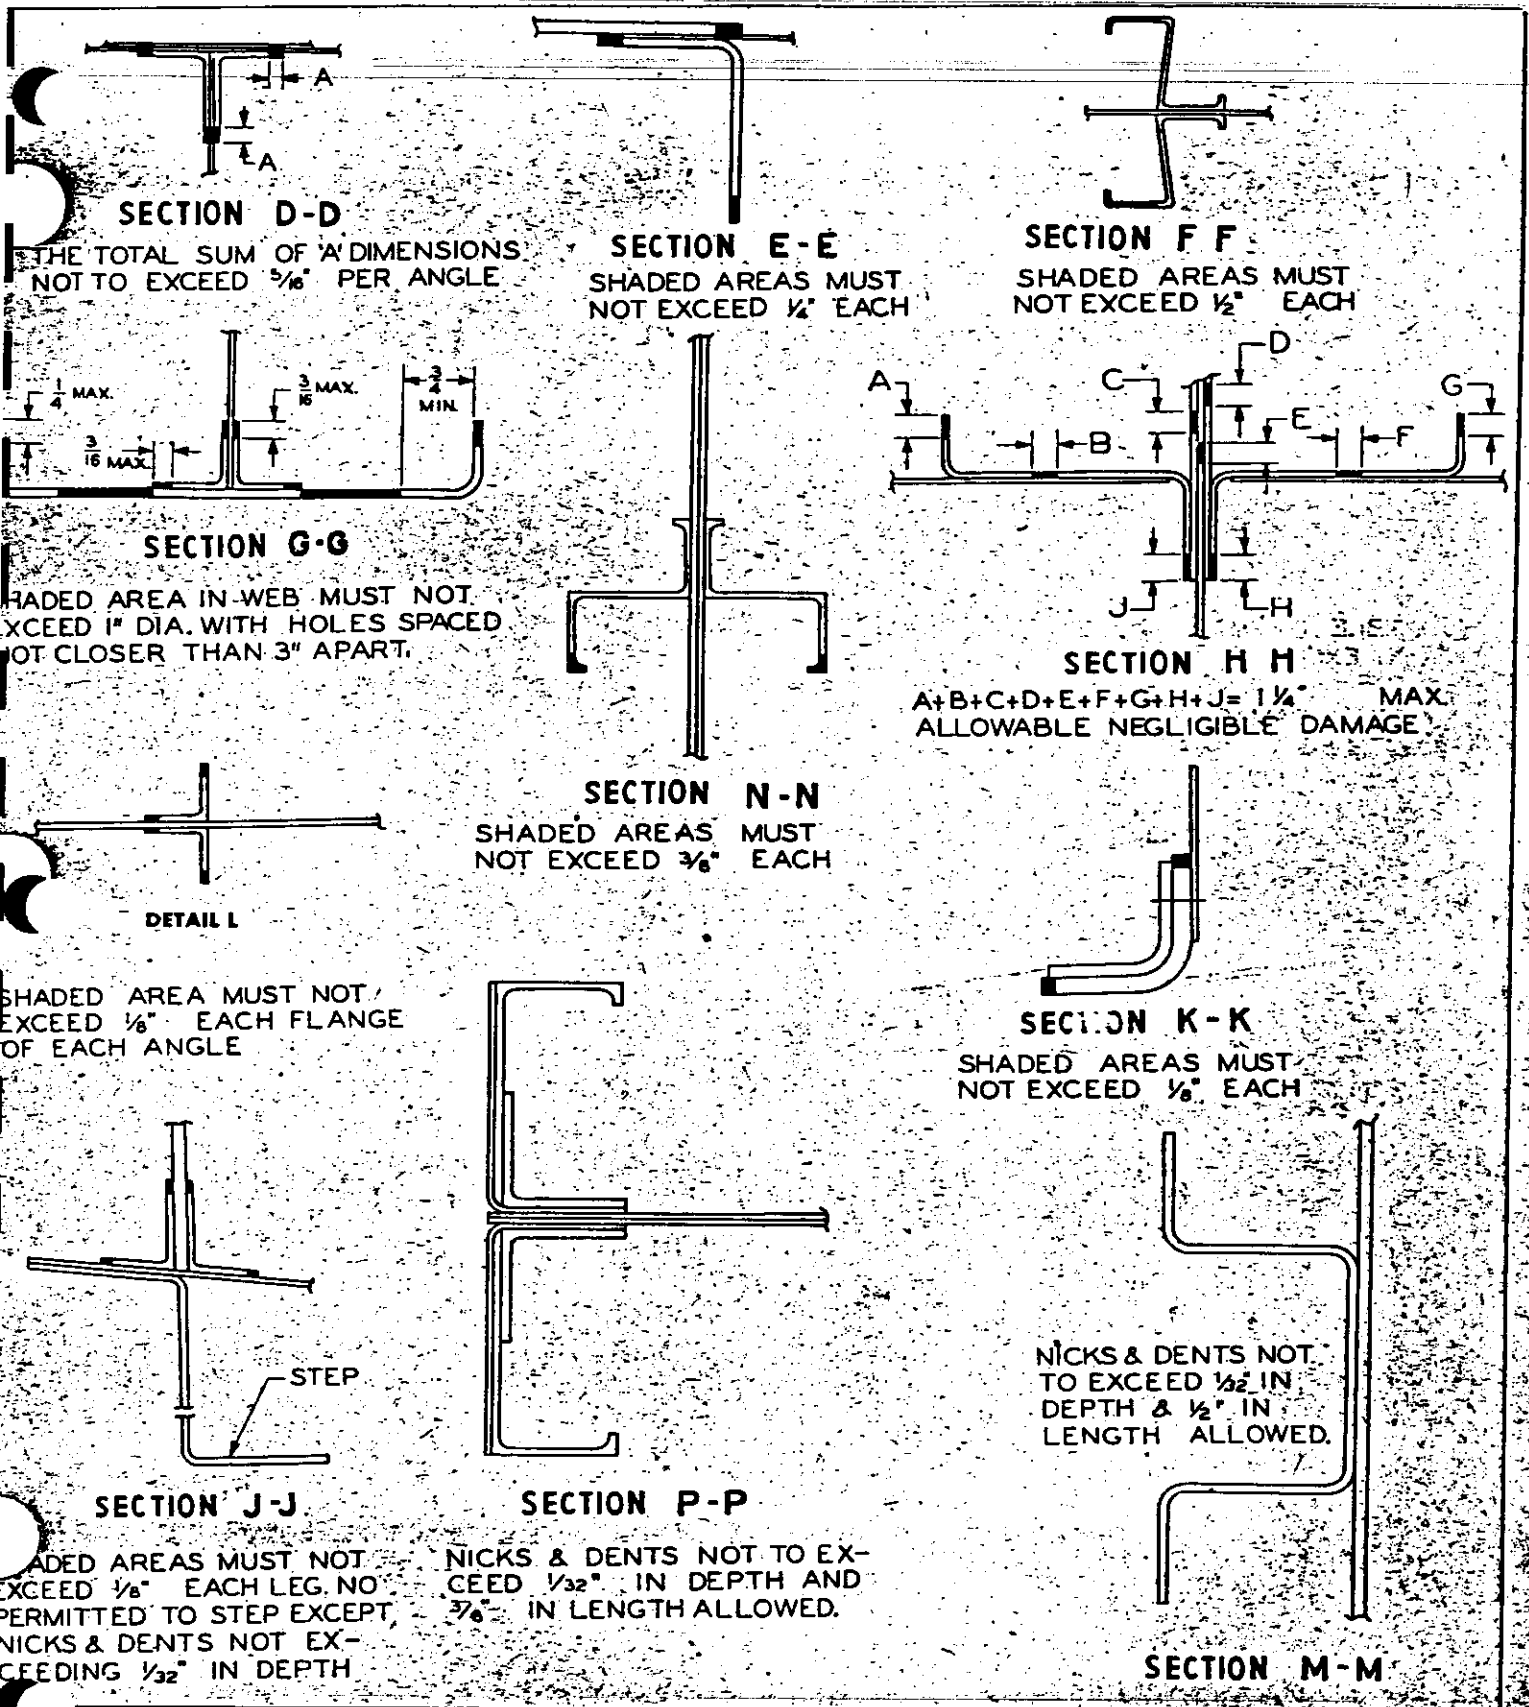
Figure 4-20—Bulkhead 5—Negligible Damage (sheet 2 of 2)

IN THIS AREA THE SUM OF THE DIAMETERS OF ALL HOLES IN ANY PANEL SHOULD NOT EXCEED 3."

THE SUM OF THE CROSS-SECTION DAMAGE OF EACH ZEE SHOULD NOT EXCEED  $\frac{1}{2}$ "

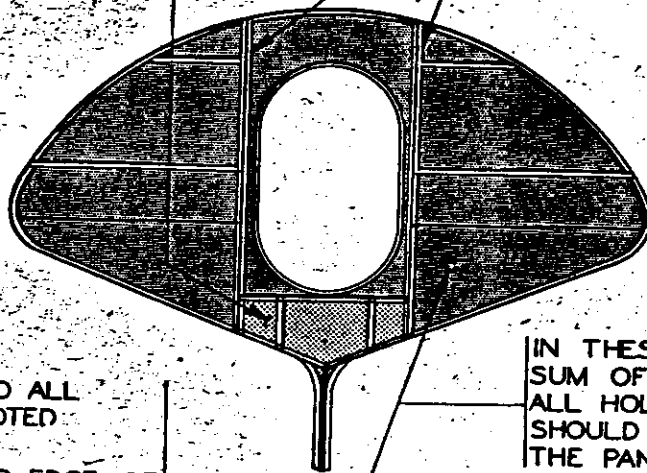
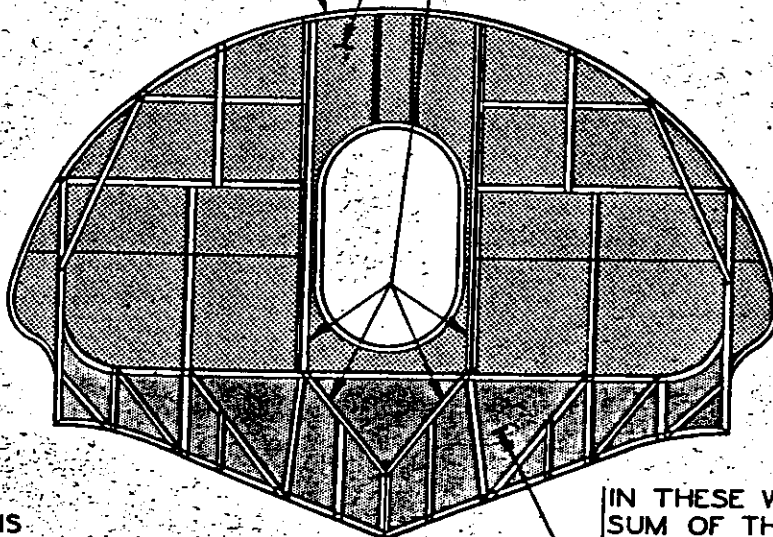
Figure 4-21—Bulkheads 6 and 7—Negligible Damage

NEGLIGIBLE DAMAGE TO ALL ANGLES EXCEPT AS NOTED INCLUDES:

$\frac{1}{8}$ " TOTAL DAMAGE TO EDGE OF EACH LEG.

IN THESE WEB AREAS THE SUM OF THE DIAMETERS OF ALL HOLES IN ANY PANEL SHOULD NOT EXCEED  $\frac{3}{4}$  OF THE PANEL WIDTH.

DAMAGE TO THESE MEMBERS IS LIMITED TO NICKS AND DENTS NOT MORE THAN  $\frac{1}{32}$ " IN DEPTH AND NOT MORE THAN  $\frac{1}{4}$ " ACROSS THE MEMBER.

NOTE:  
WIDTH OF PANELS IS MEASURED BETWEEN THE RIVET LINES OF ADJACENT STIFFENERS

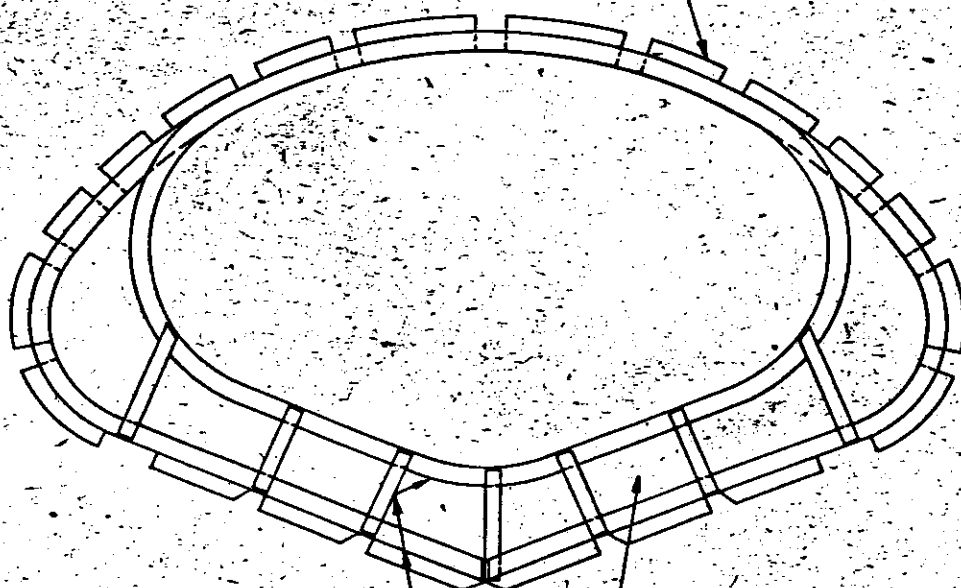
Figure 4-22—Bulkhead 9—Negligible Damage

DAMAGE TO INTERCOSTALS IS NOT TO EXCEED  $\frac{1}{2}$  THE WIDTH OF THE INTERCOSTAL WIDTH AND NOT LESS THAN 3 DIAMETERS APART.

NEGLIGIBLE DAMAGE ALLOWED TO ANY ANGLE MEMBER INCLUDES  $\frac{3}{32}$  IN. TOTAL DAMAGE TO EDGE OF EACH LEG AND  $\frac{1}{32}$  IN. NICKS AND DENTS NOT EXTENDING ACROSS MORE THAN  $\frac{1}{4}$  OF THE WIDTH OF THE MEMBER.

IN WEB AREAS THE SUM OF THE DIAMETERS OF ALL HOLES IN ANY PANEL IS NOT TO EXCEED 2 IN.

NOTE:  
A PANEL IS CONSIDERED TO BE ANY WEB AREA BOUNDED BY TWO ADJACENT ANGLE STIFFENERS.

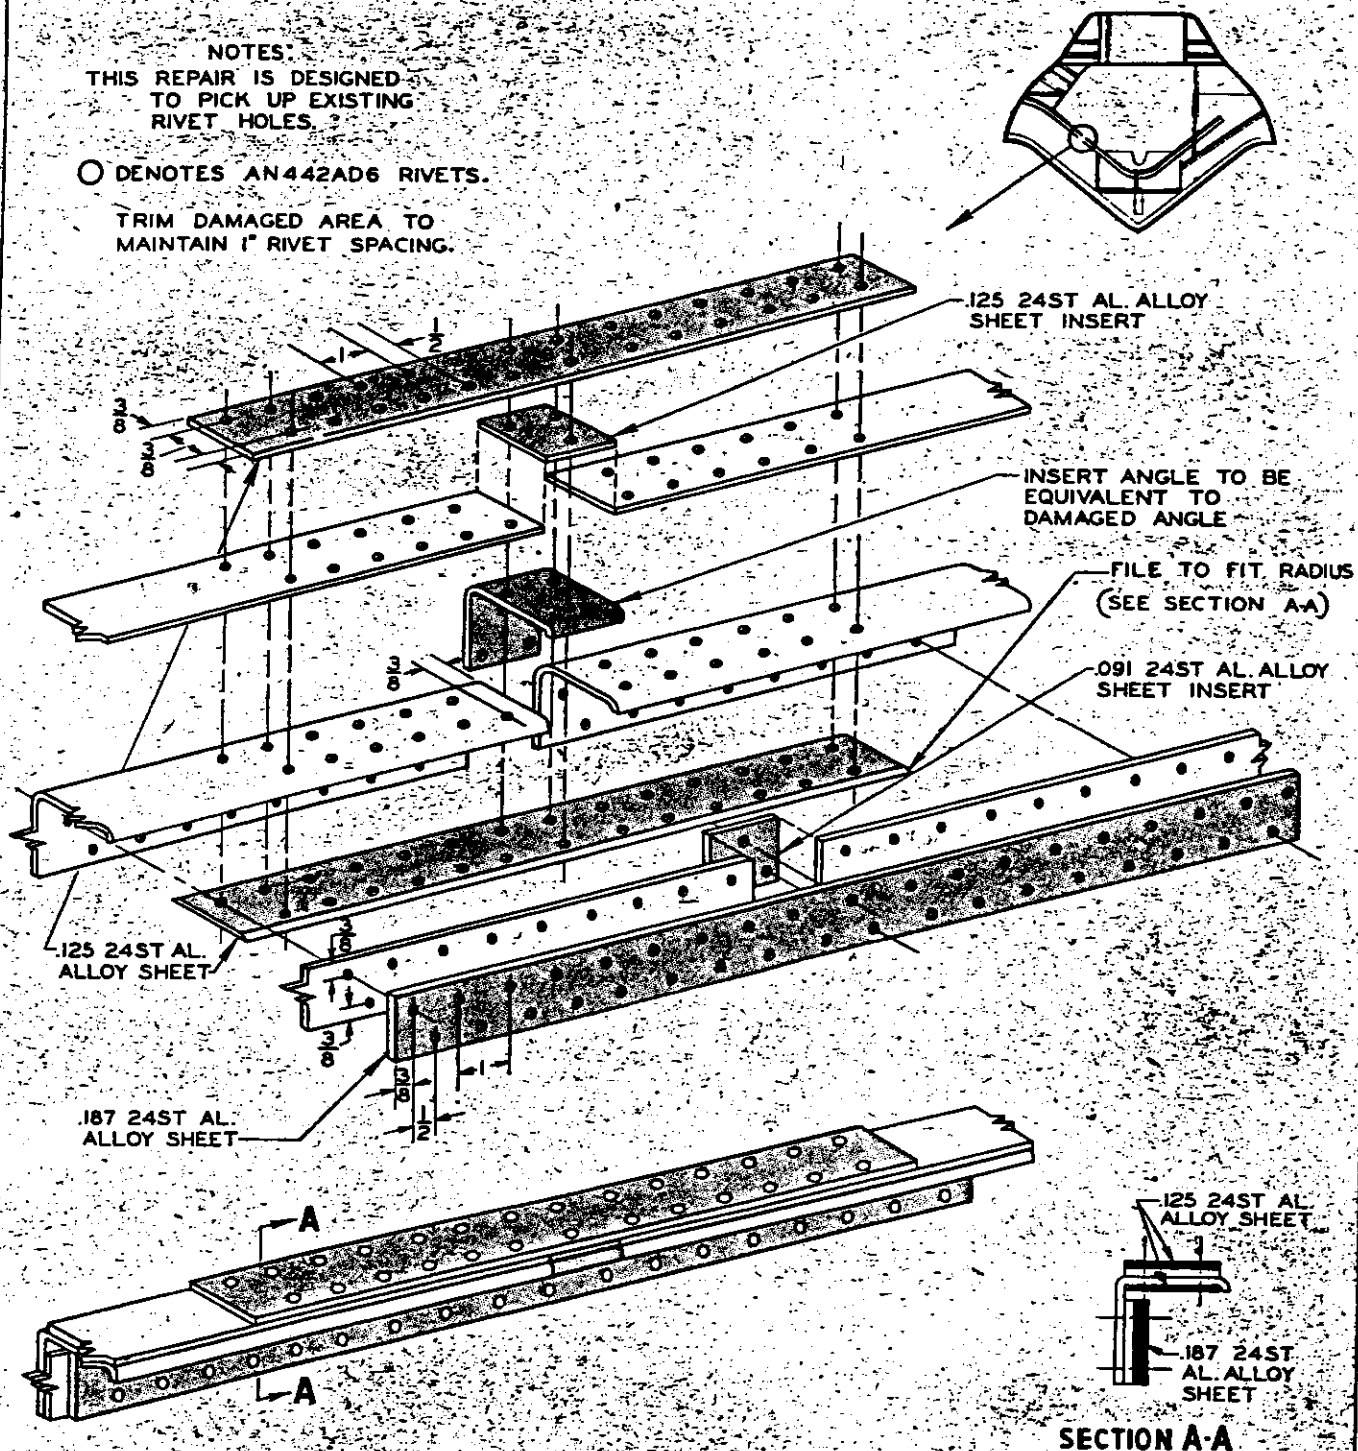
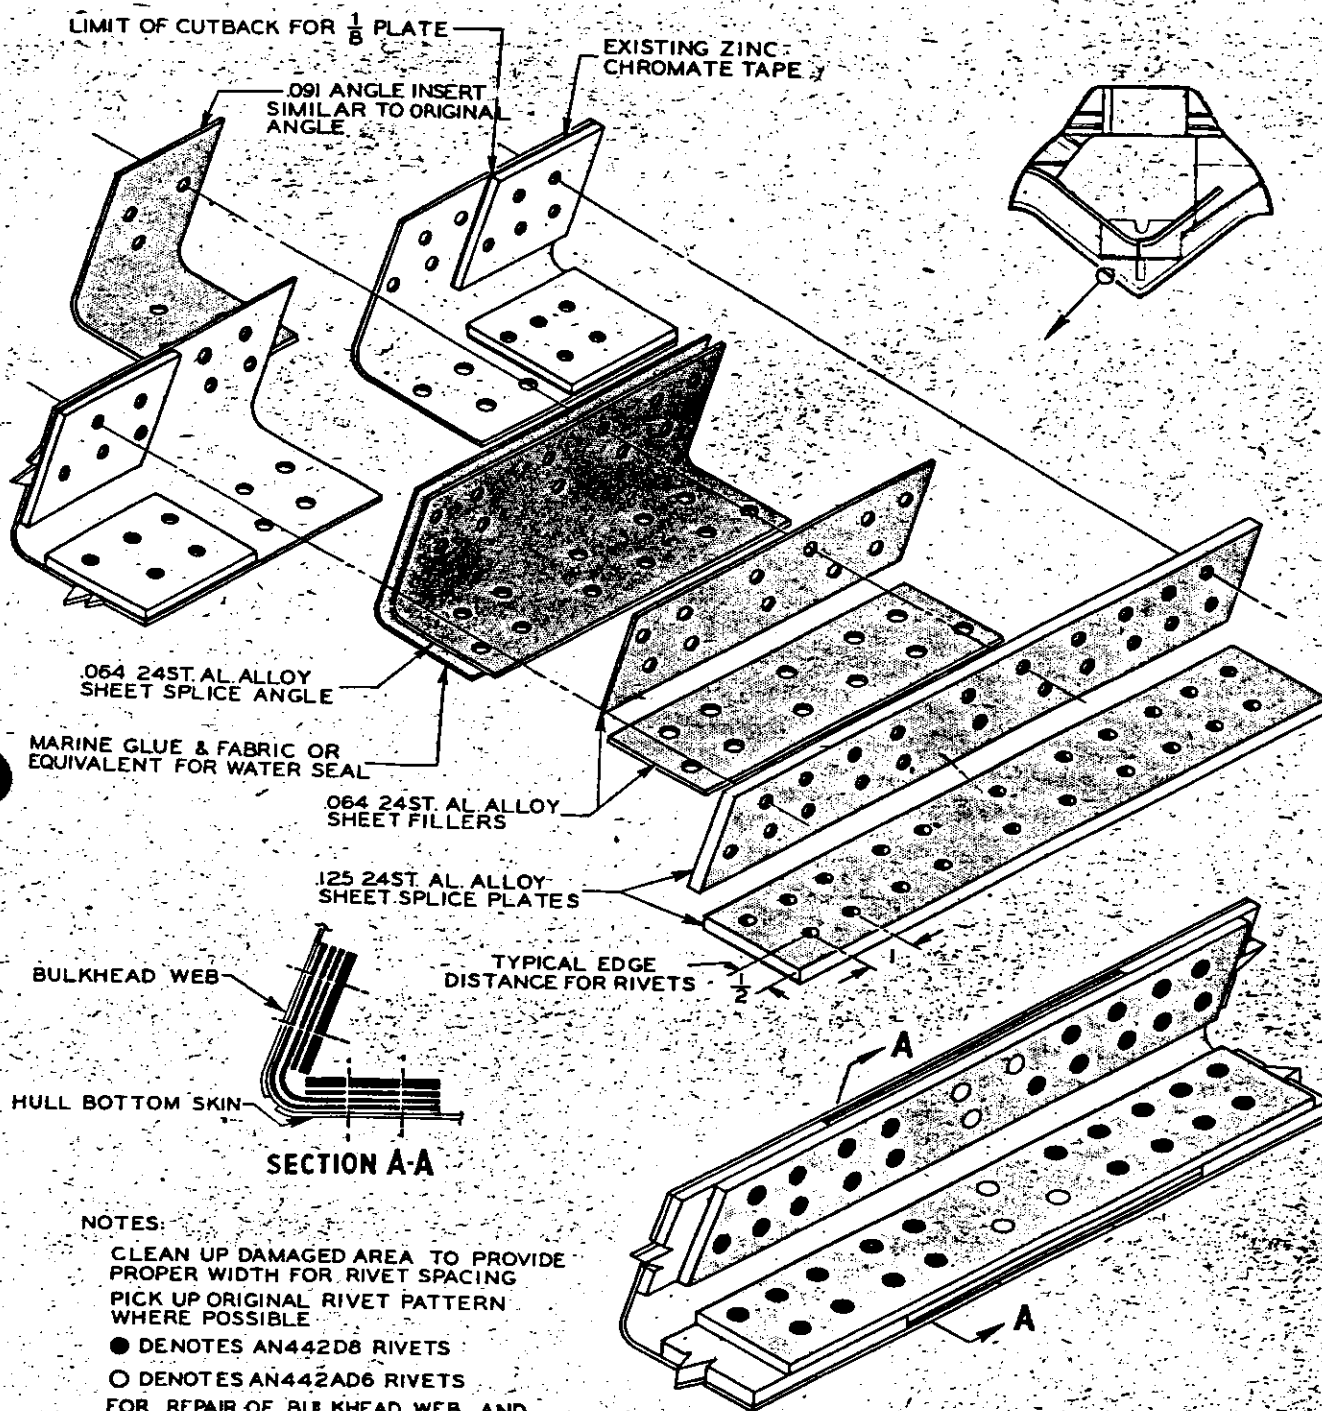
Figure 4-24 (Sheet 1 of 2 Sheets)—Bulkhead 1 Repairs

NOTES:  
THIS REPAIR IS DESIGNED  
TO PICK UP EXISTING  
RIVET HOLES.

○ DENOTES AN442AD6 RIVETS.

TRIM DAMAGED AREA TO  
MAINTAIN 1" RIVET SPACING.

4-31. Figures 4-24 through 4-30 give complete details of typical beltframe and bulkhead repairs. These repairs involve insertion as well as patching. The repairs for the large number of standard extruded sections used on bulkheads and beltframes are shown in Appendix II.

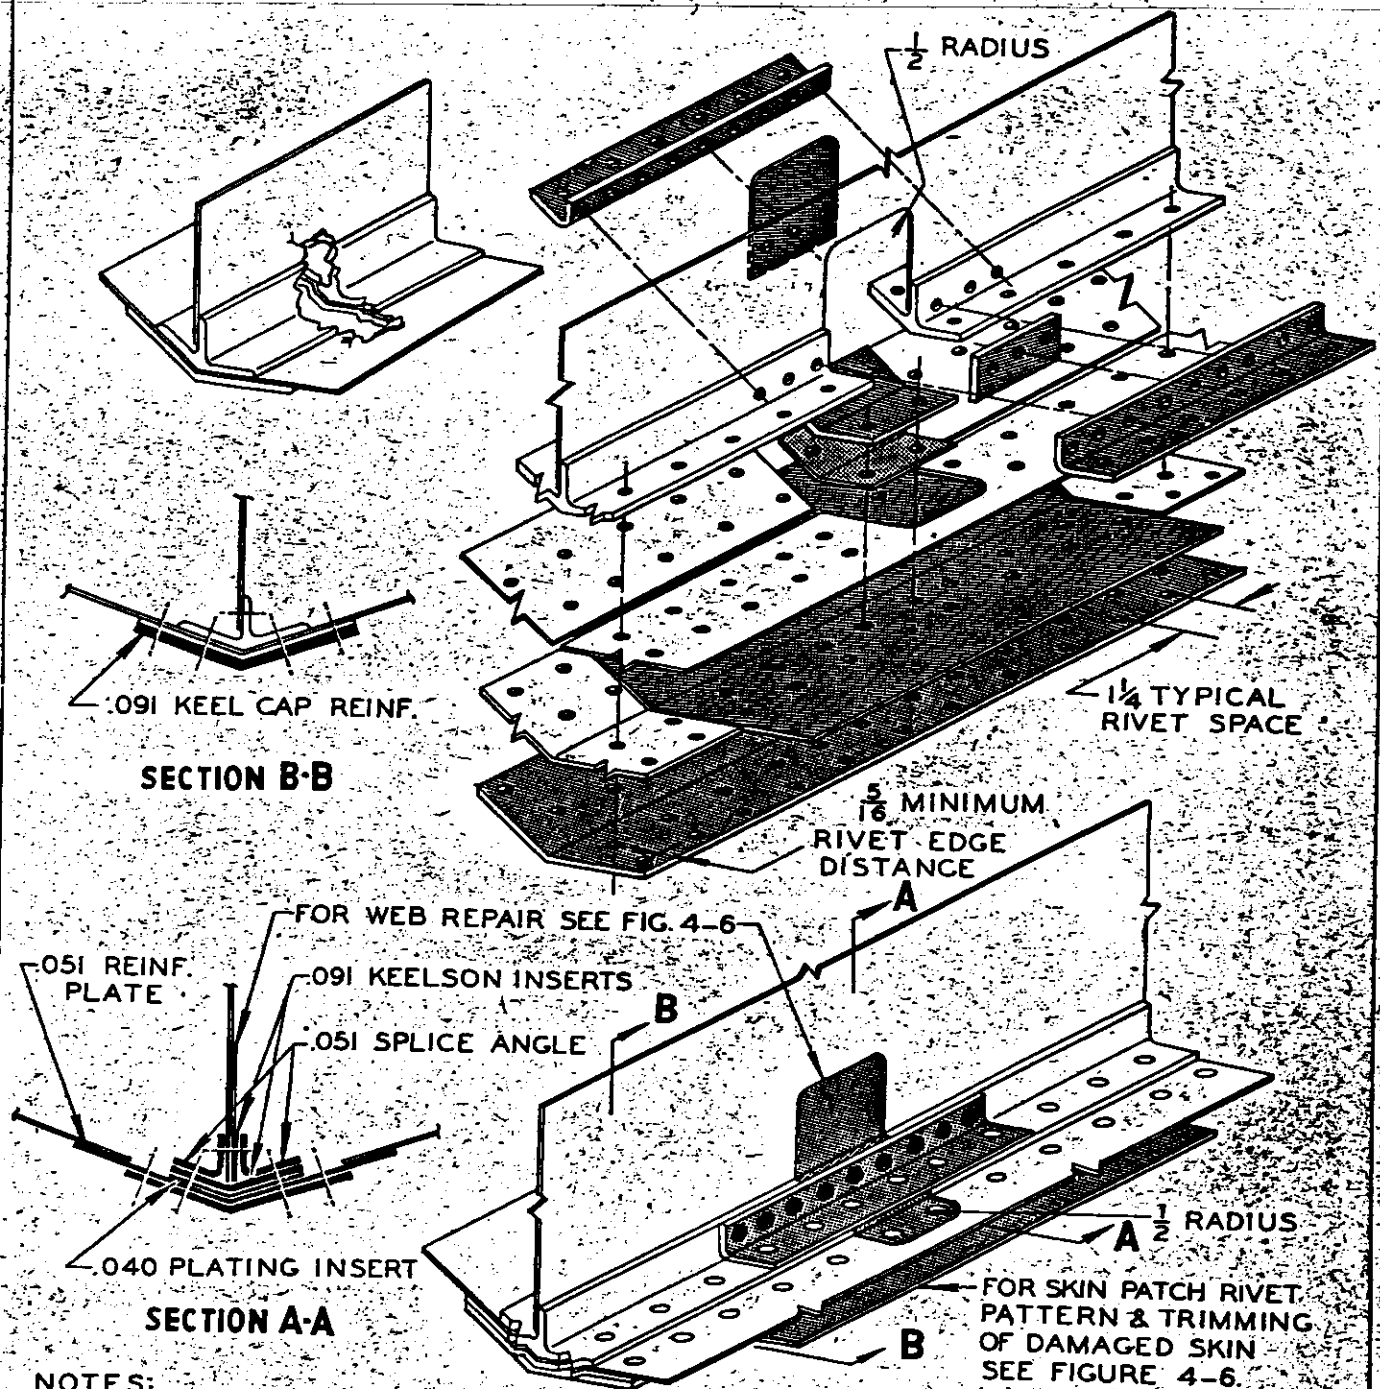
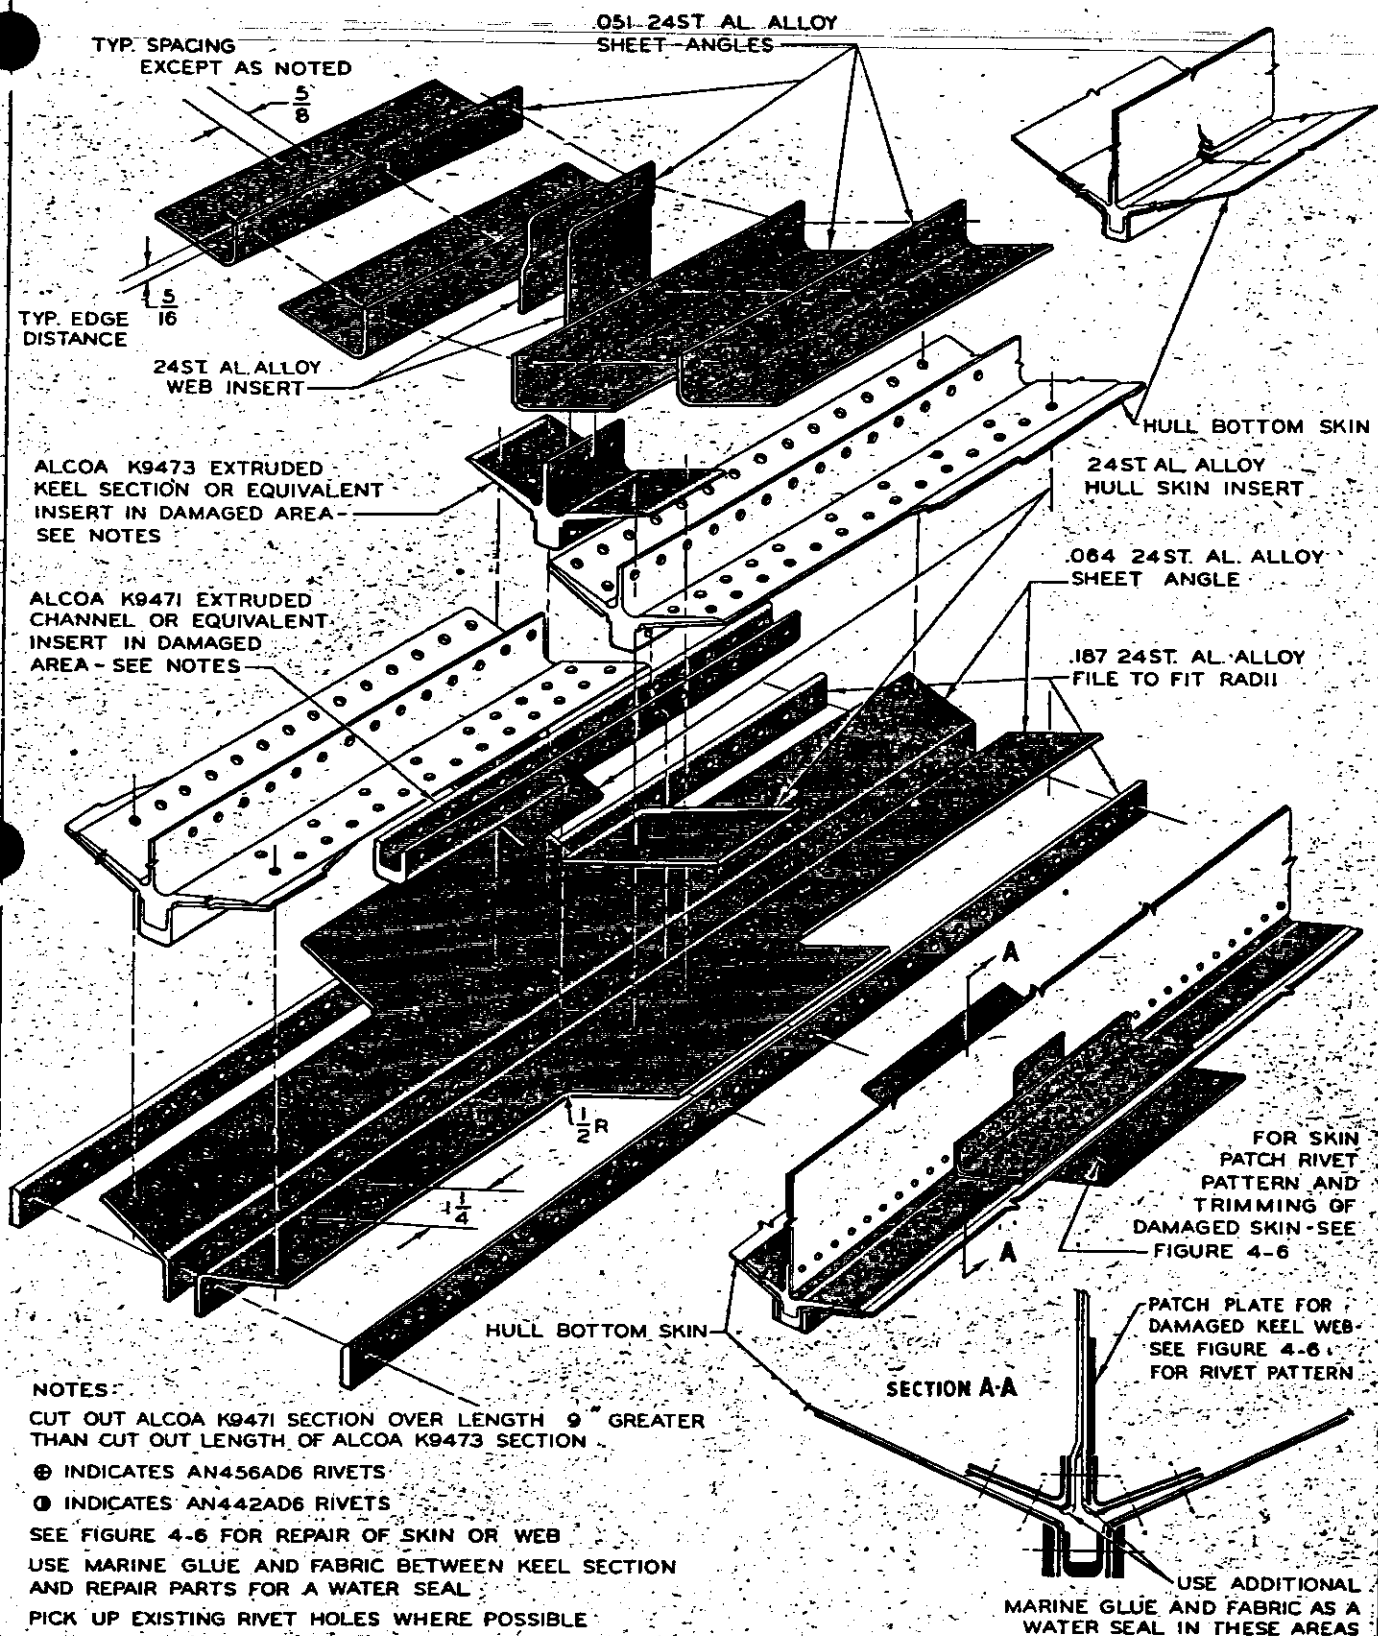
Figure 4-33 (Sheet 1 of 2 Sheets)—Main Keel Repair

○ DENOTES AN456AD6 RIVETS EXCEPT AS NOTED.

USE MARINE GLUE & FABRIC OR EQUIVALENT TO MAKE SKIN REPAIRS WATER TIGHT.

THIS REPAIR IS DESIGNED FOR THE KEELSON BETWEEN STA. 5.0 & 7.0.

ALL REPAIR MATERIAL IS 24ST AL ALLOY.

4-40. Repairs to keelson sections between stations 2.0 and 5.0 and between stations 5.0 and 7.0 are shown in figure 4-33, sheets 1 and 2 respectively. Repairs to the keelson forward of station 2.0 are similar to those on the keelson between stations 5.0 and 7.0.
