**Handbook of  
Structural Repair  
PBY 5**

AN 01-5M-3

# Handbook of Structural Repair

• **PBY-5 • PBY-5A • PBY-6A**

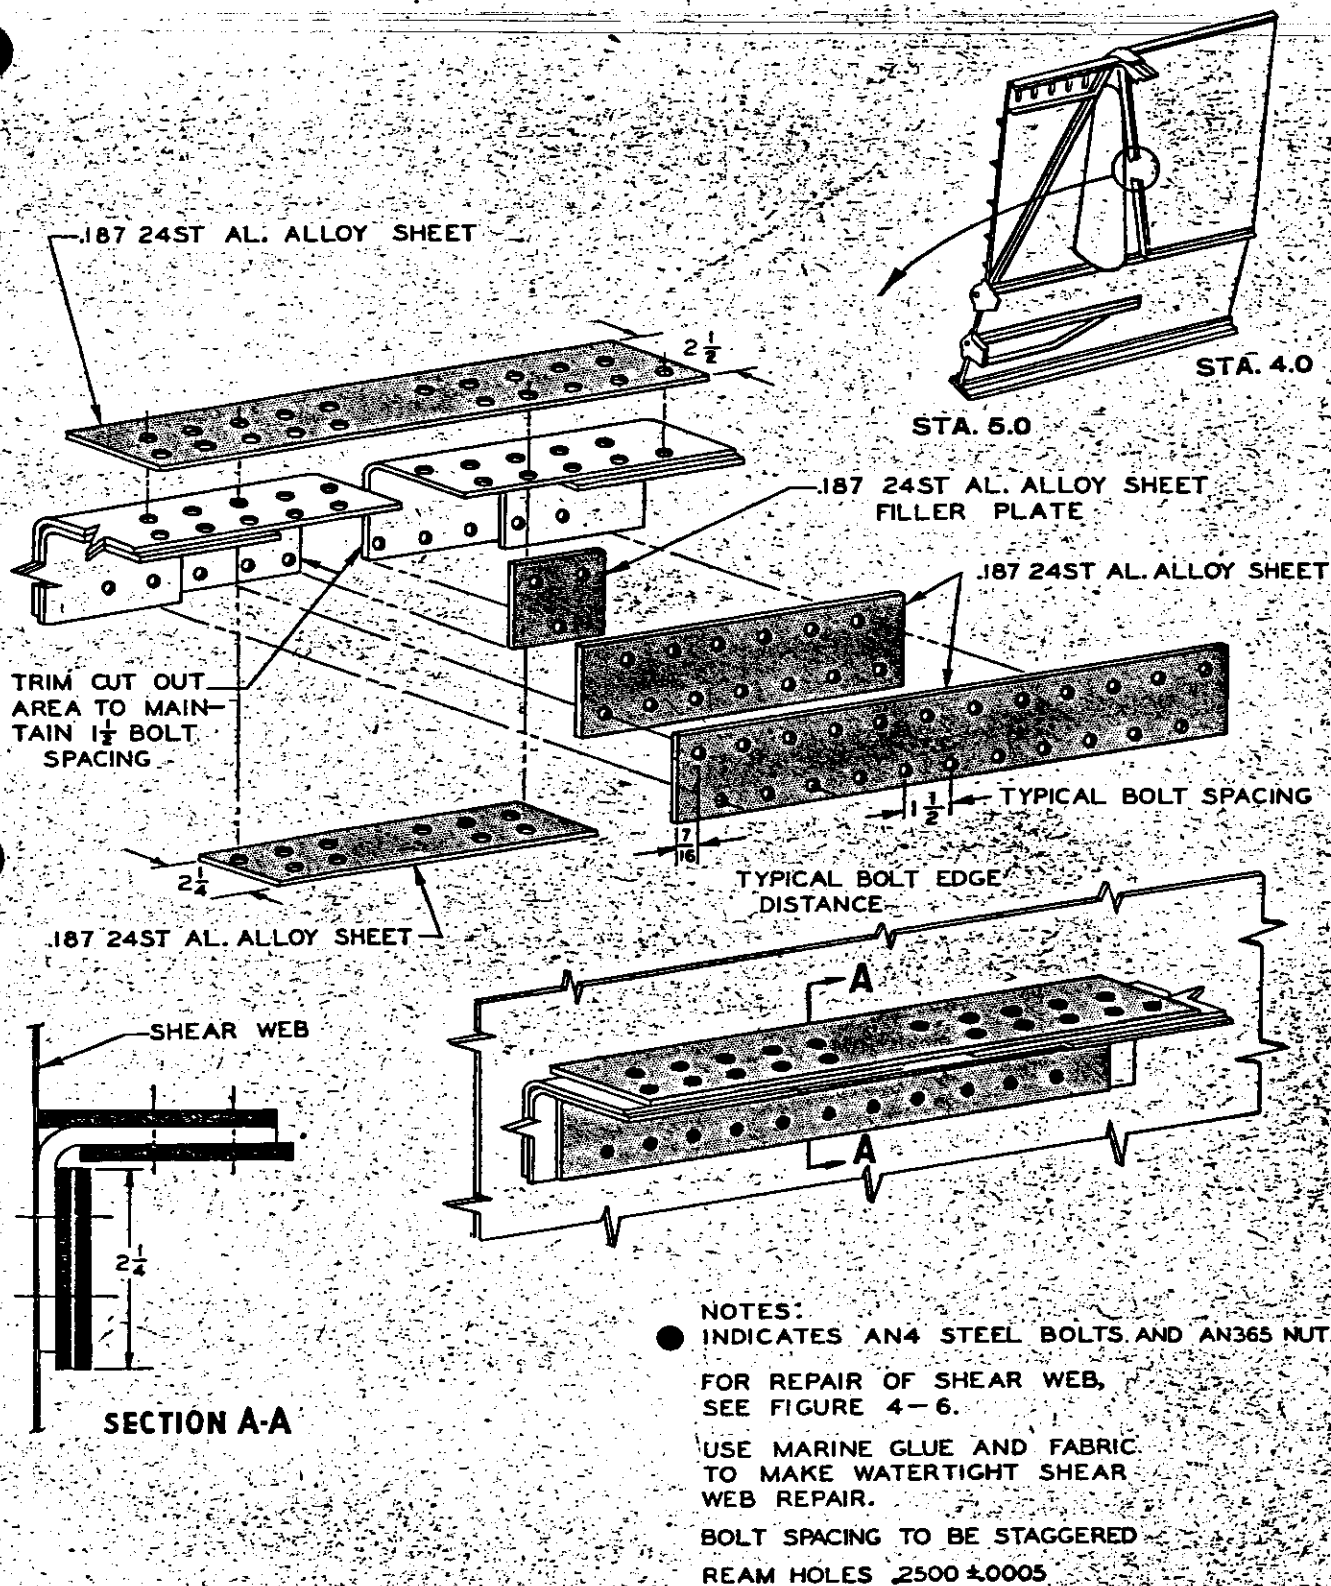
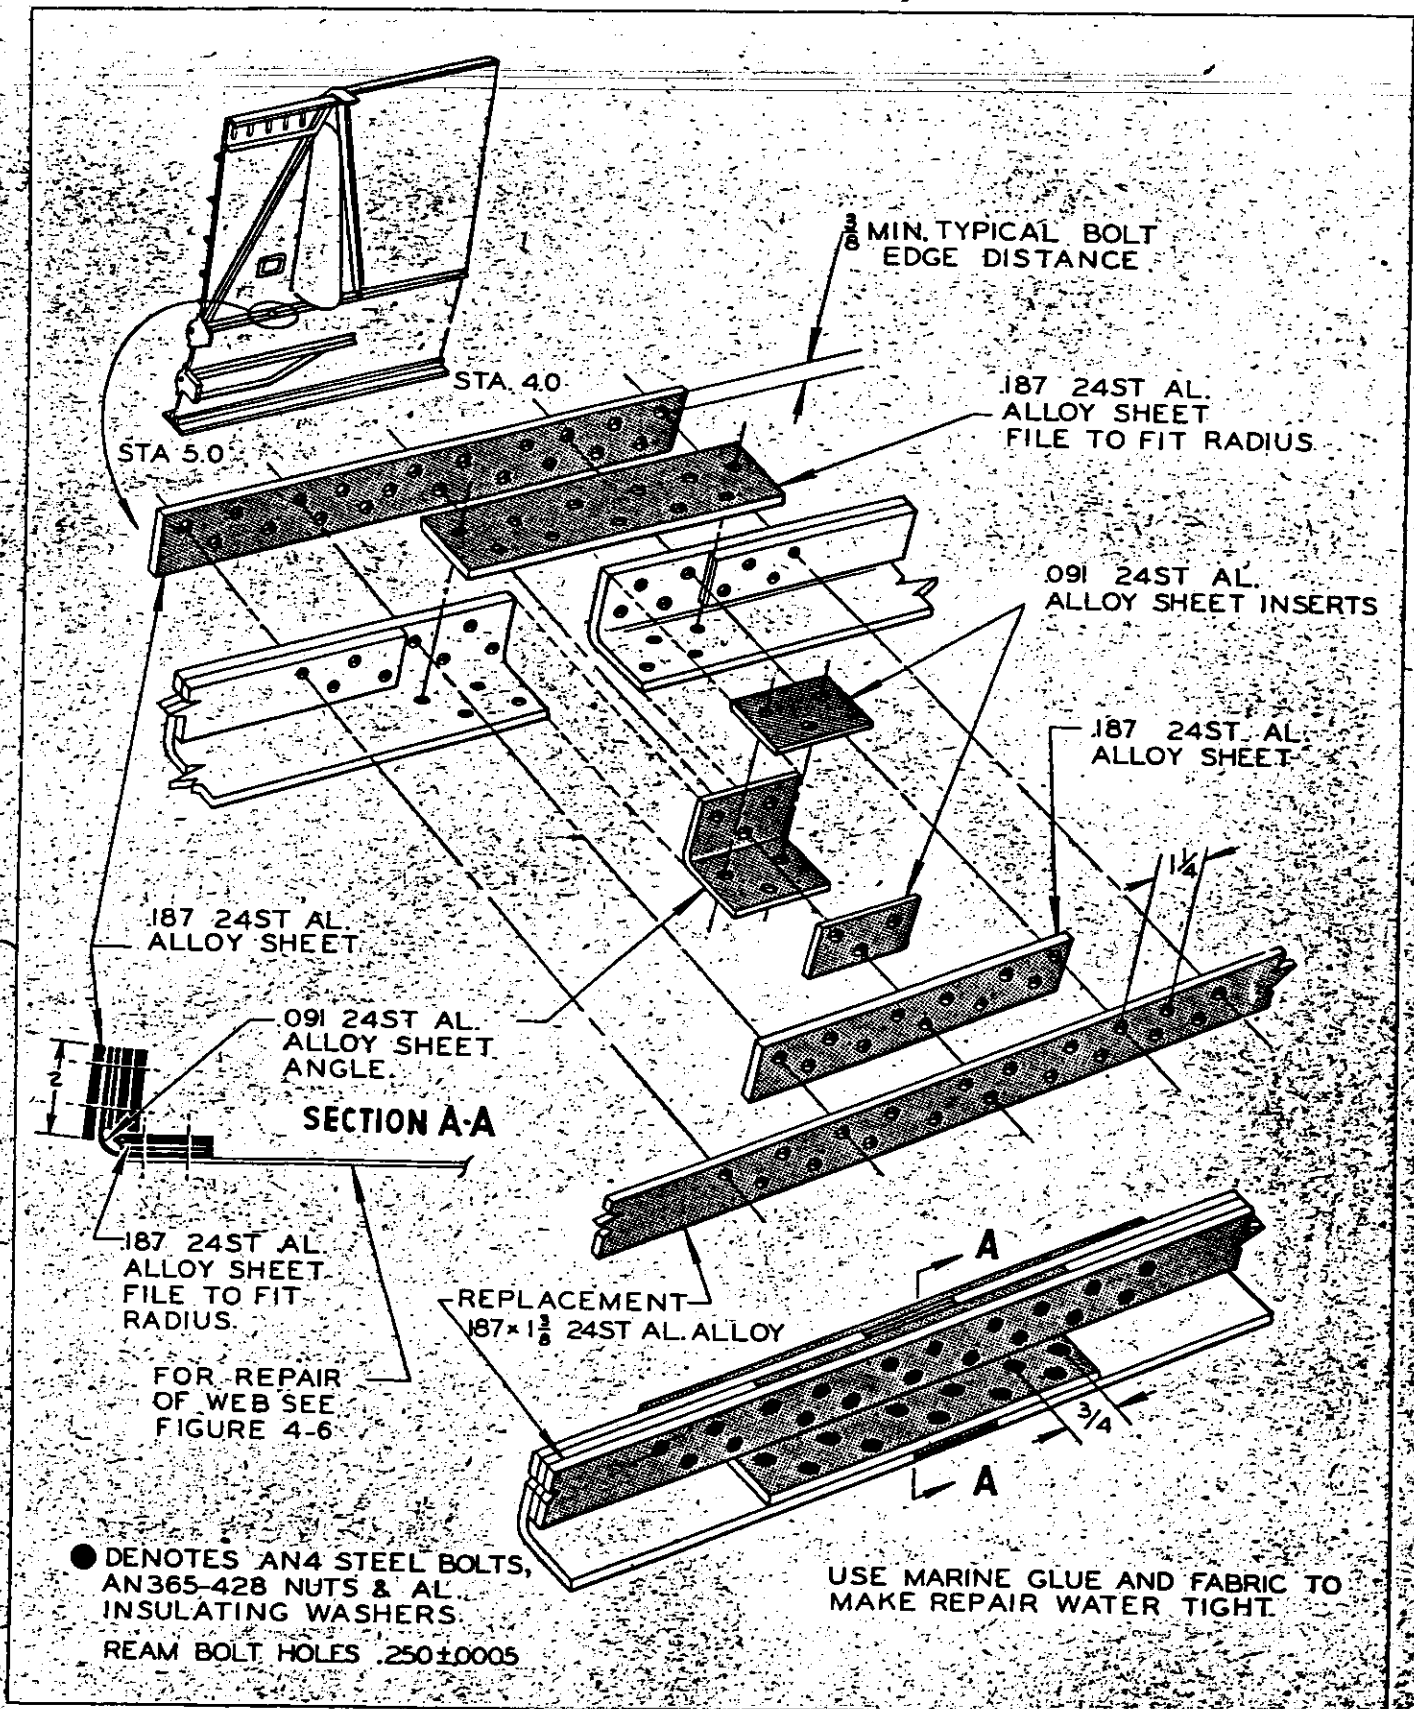
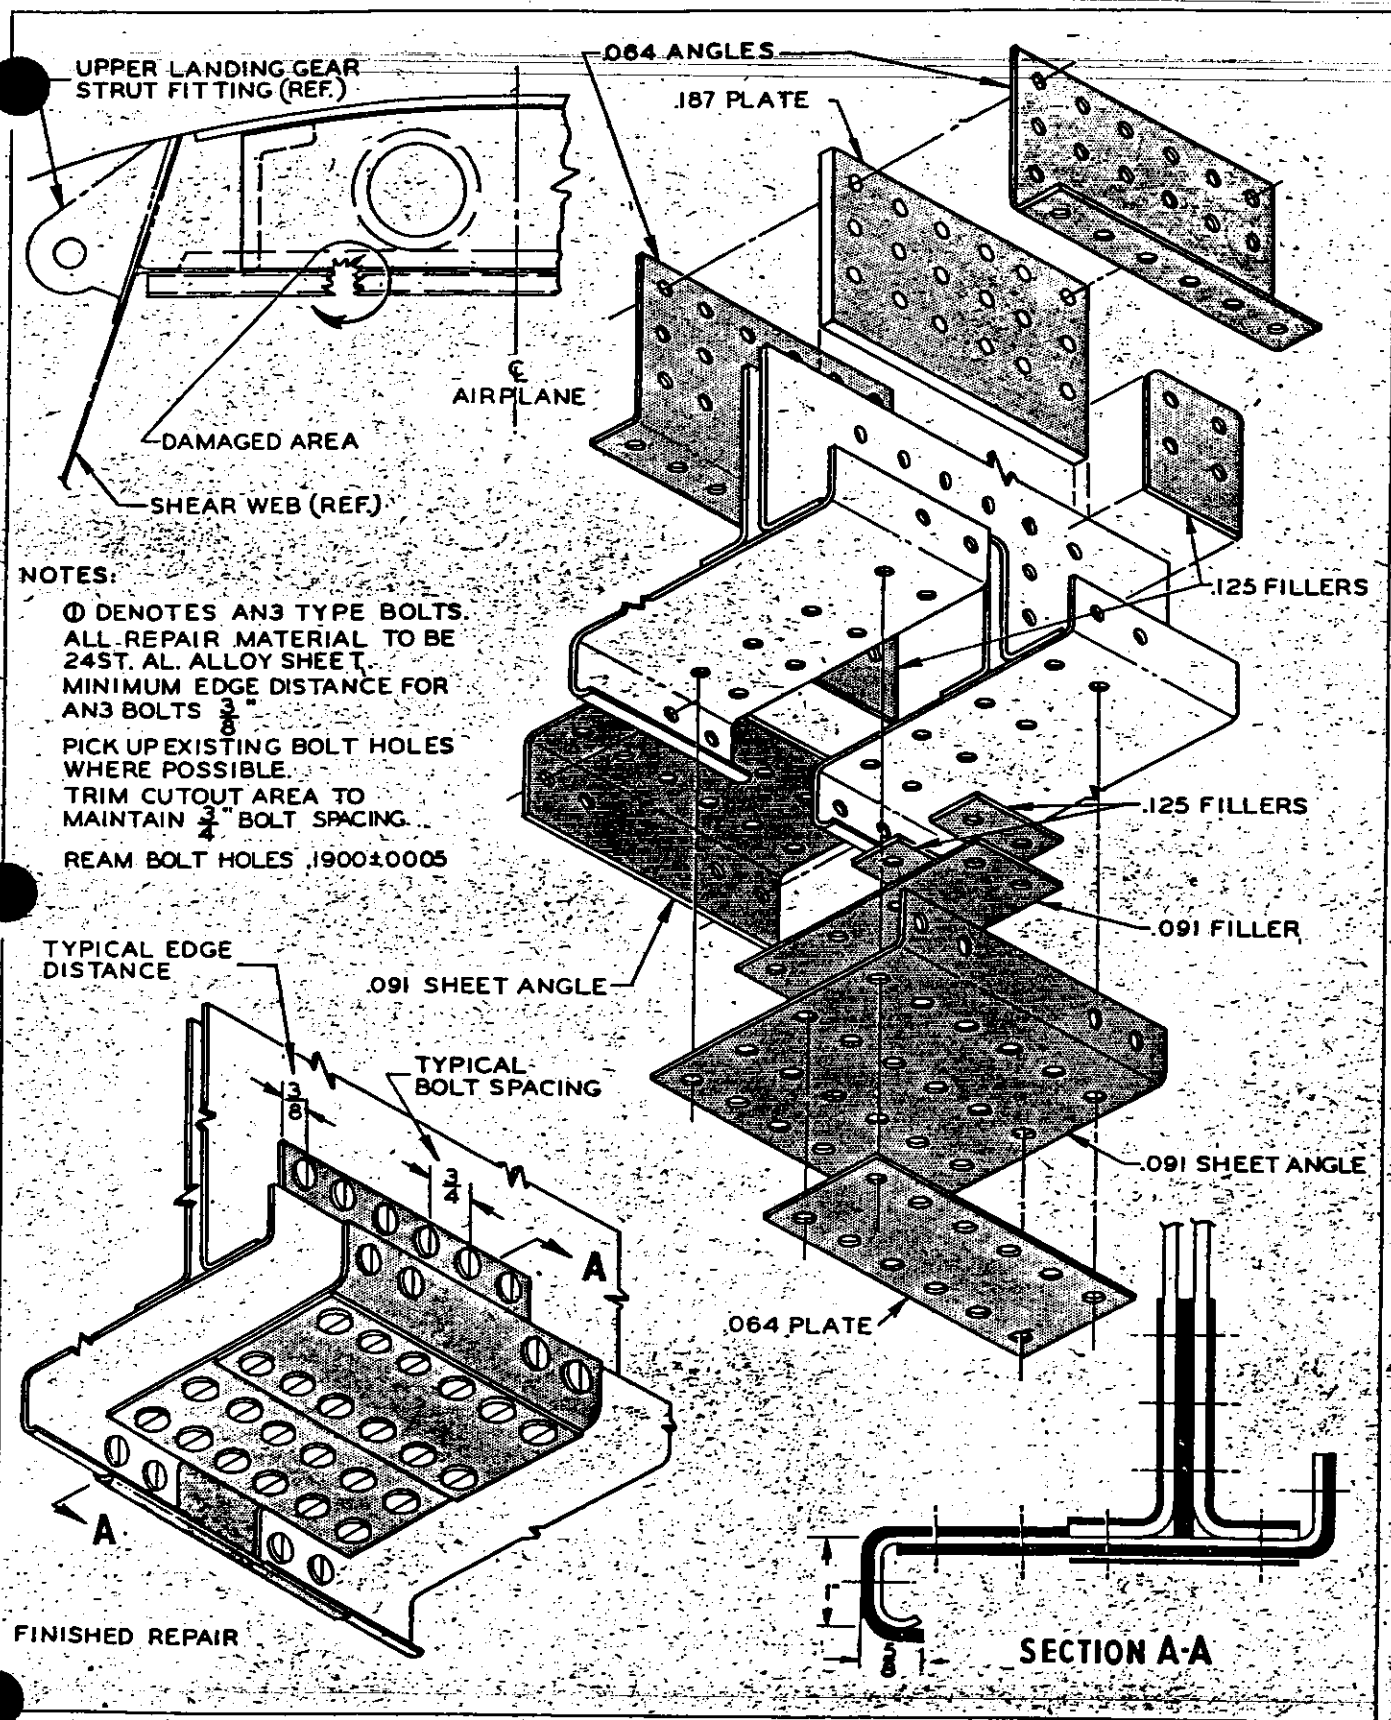
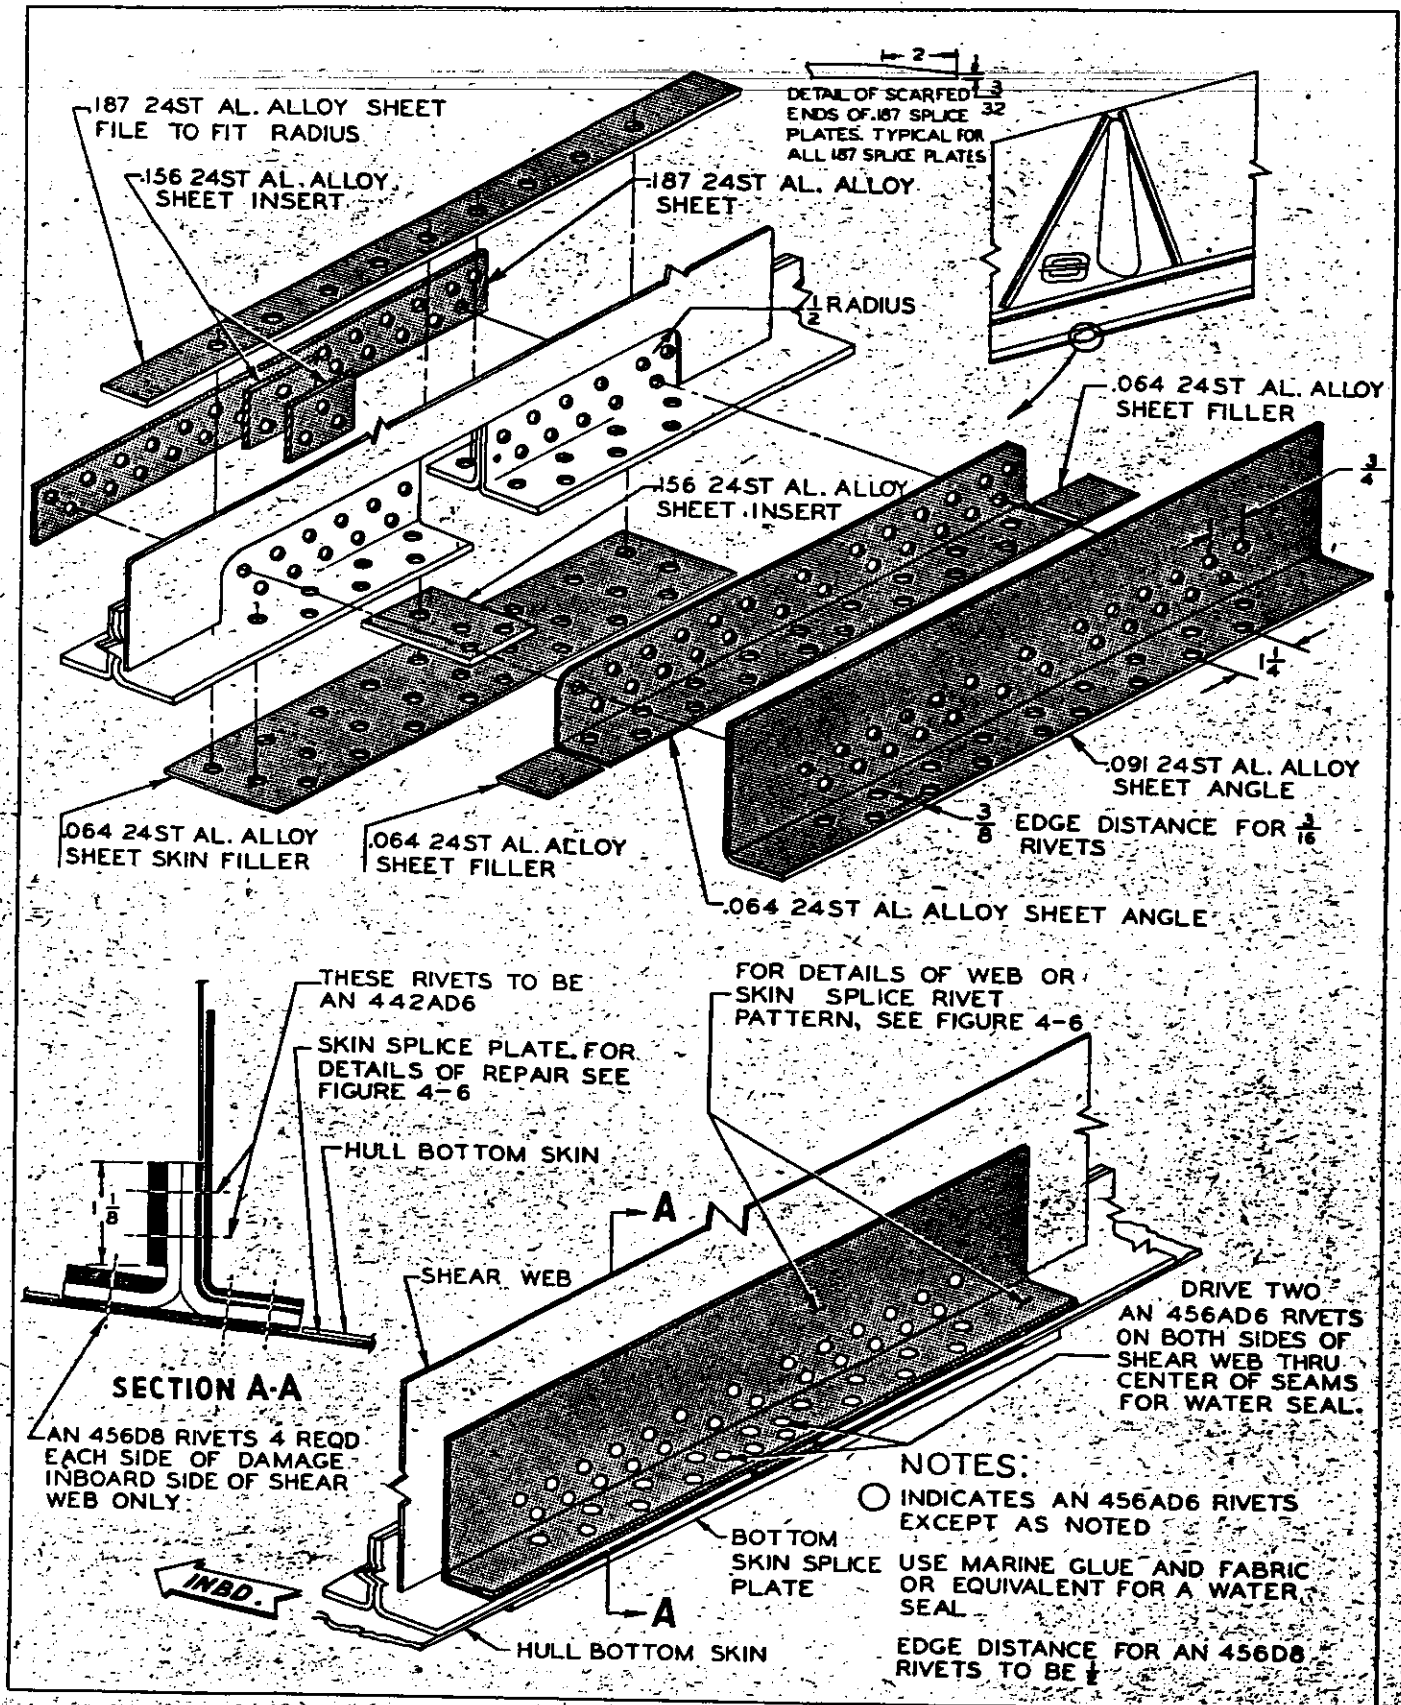
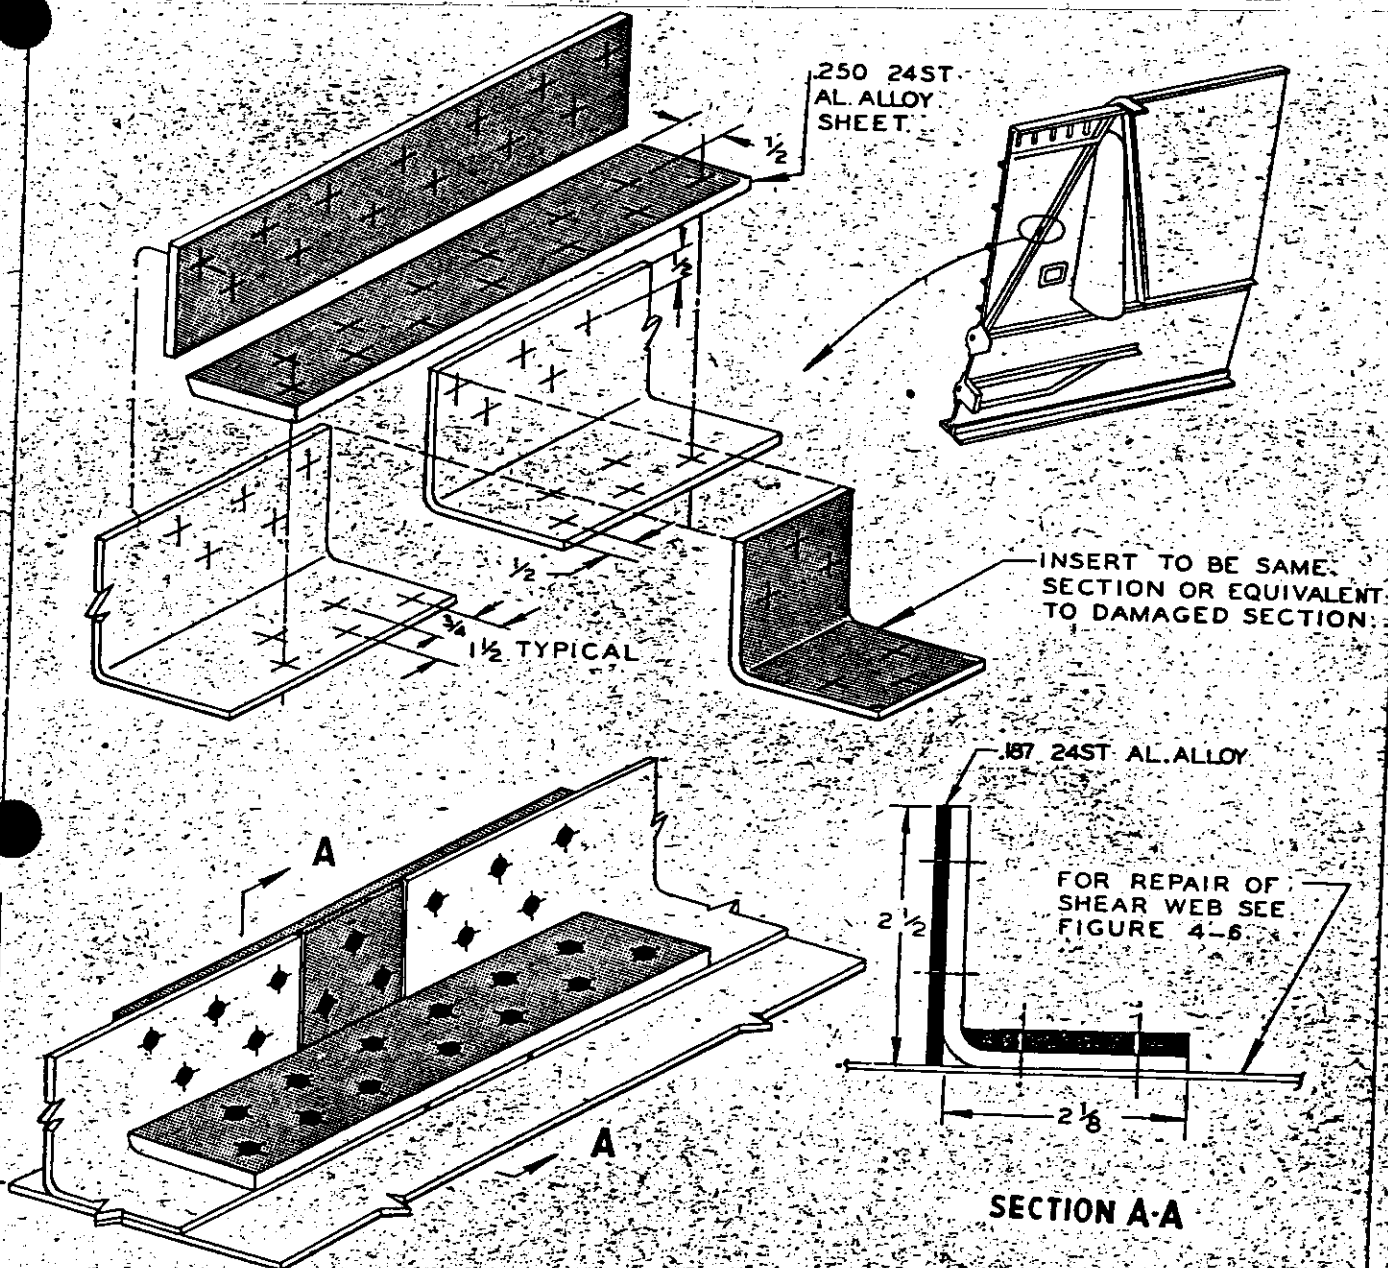
Figure 4-35 (Sheet 1 of 5 Sheets)—Main Wheel Well Enclosure Repair

- INDICATES AN4 STEEL BOLTS AN365 STEEL LOCK NUTS AND AN960 ALUMINUM INSULATING WASHERS

ALL REPAIR MATERIAL TO BE 24ST ALUMINUM ALLOY.

4-41. Repairs to the twin keel sections between stations 1.0 and 2.0 and between stations 4.0 and 5.0 are shown in figures 4-32 and 4-35 respectively.

4-55. Typical repairs to heavy structural members in the main wheel well enclosure are shown in figure 4-35.

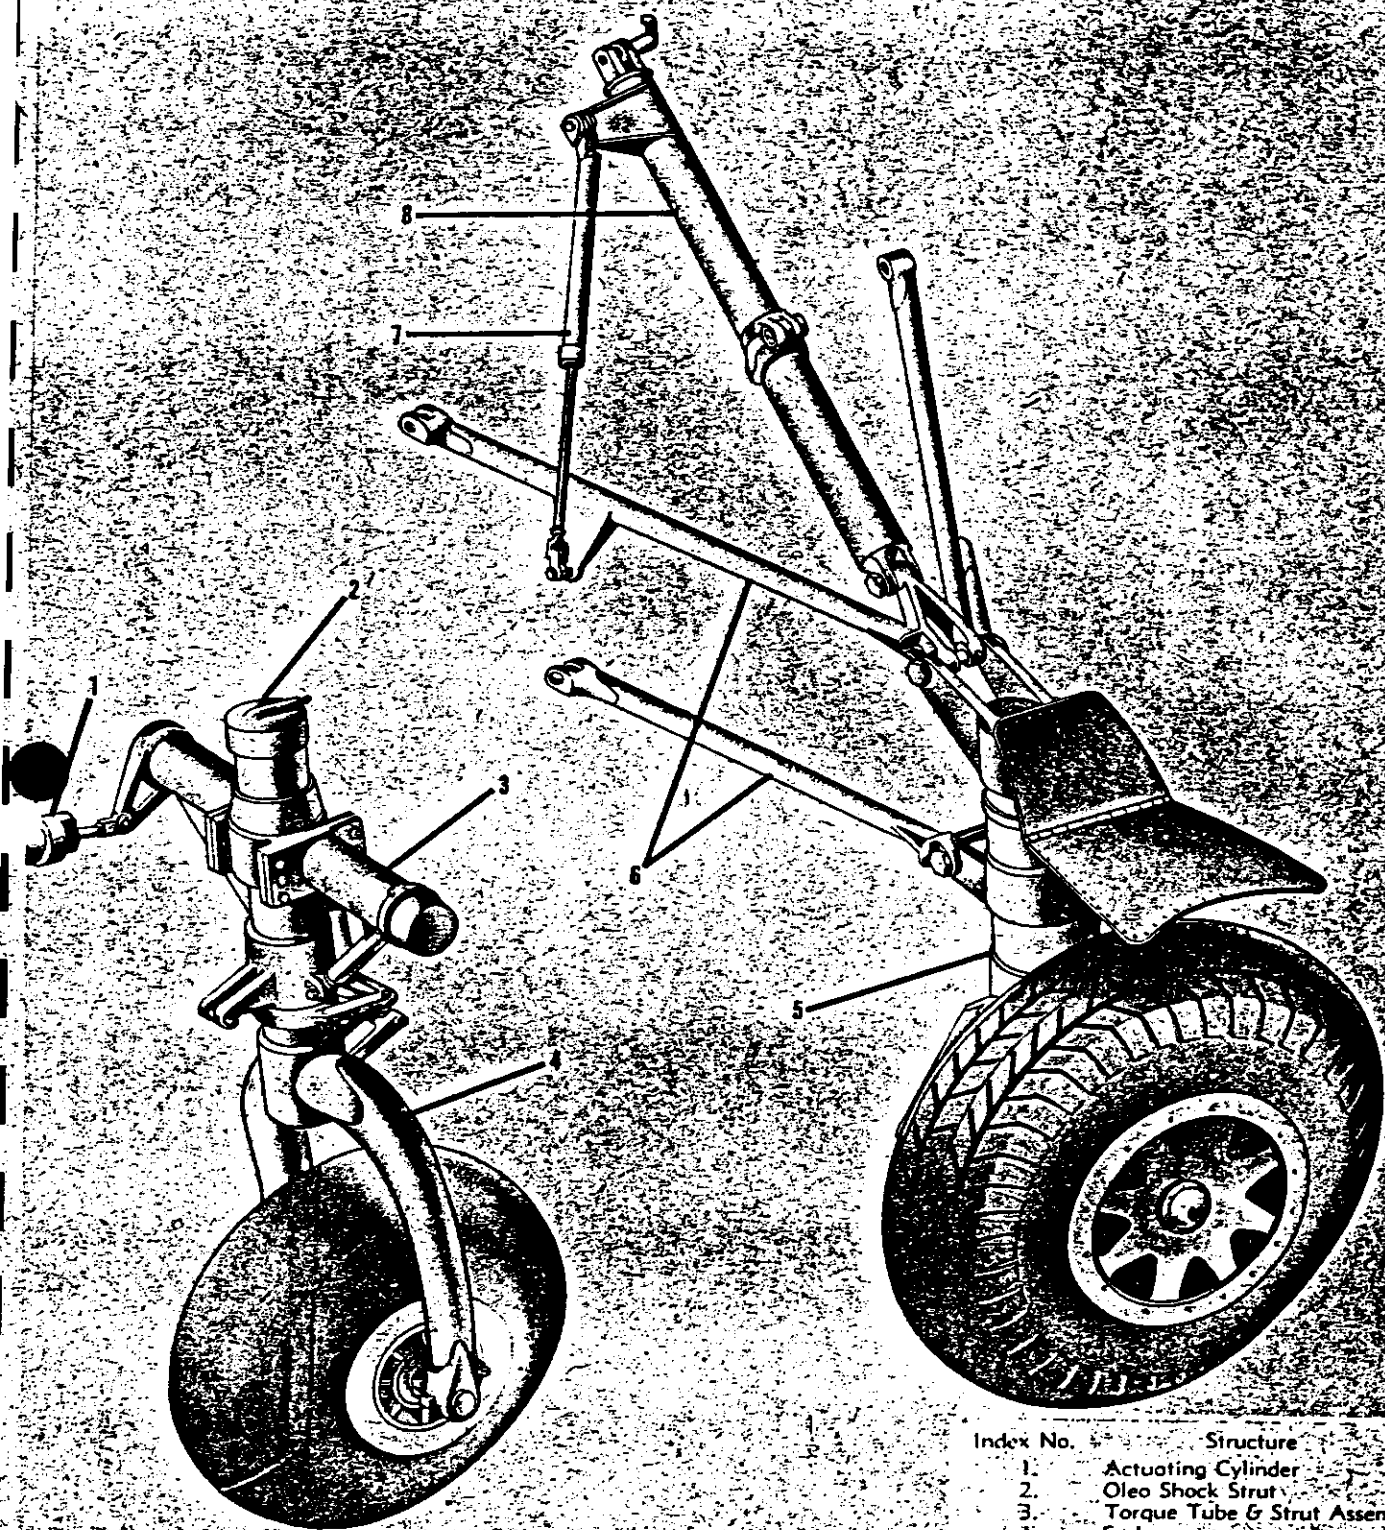
Figure 5-1 (Sheet 1 of 2 Sheets)—Main Alighting Gear Components

Index No.	Structure
1.	Actuating Cylinder
2.	Oleo Shock Strut
3.	Torque Tube & Strut Assem.
4.	Fork
5.	Oleo Shock Strut
6.	"Vee" Struts
7.	Actuating Cylinder
8.	Main Strut

(See figure 5-1.)

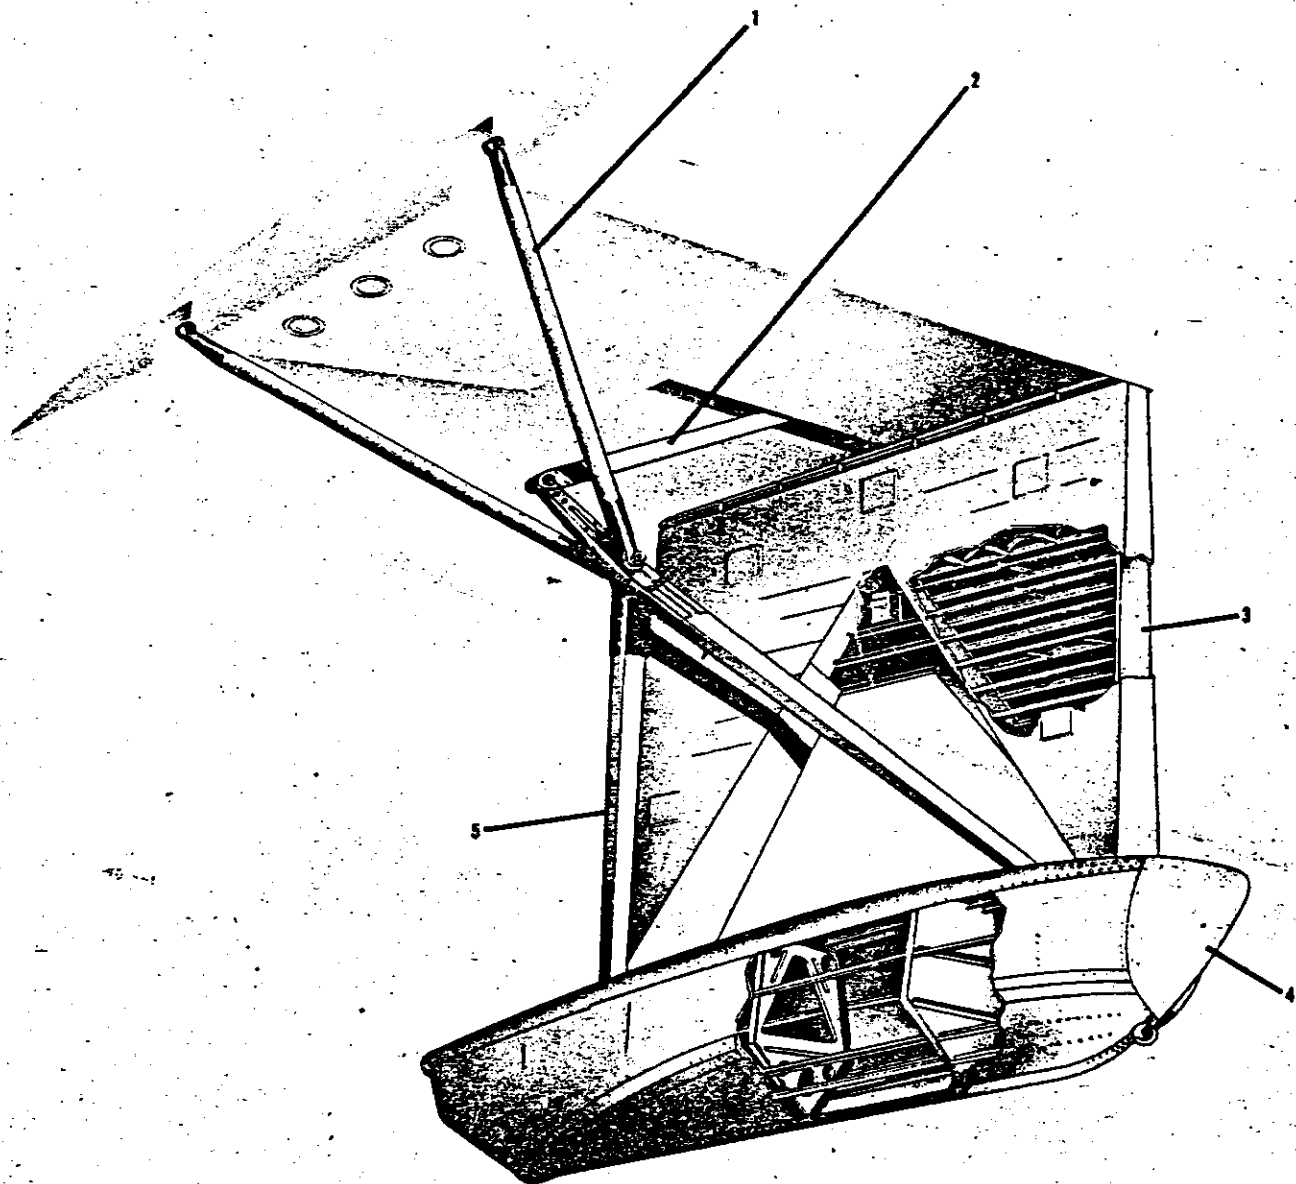
Index No.	Structure	Figure No.
1.	Upper "Vee" Strut	5-7
2.	"U" Strut	5-7
3.	Drag Panel	5-5, 5-6
4.	Float	5-2, 5-3, 5-4
5.	Lower "Vee" Strut	5-8

Figure 5-1 (Sheet 2 of 2 Sheets)—Main Alighting Gear Components

5-7. The strut assembly consists of two pairs of chrome-moly "vee" struts forming a parallelogram linkage from the oleo to the hull fittings and a chrome-moly main strut from the oleo to the upper inner portion of the wheel well. The main strut is broken near its center so that it may fold inward during retraction.

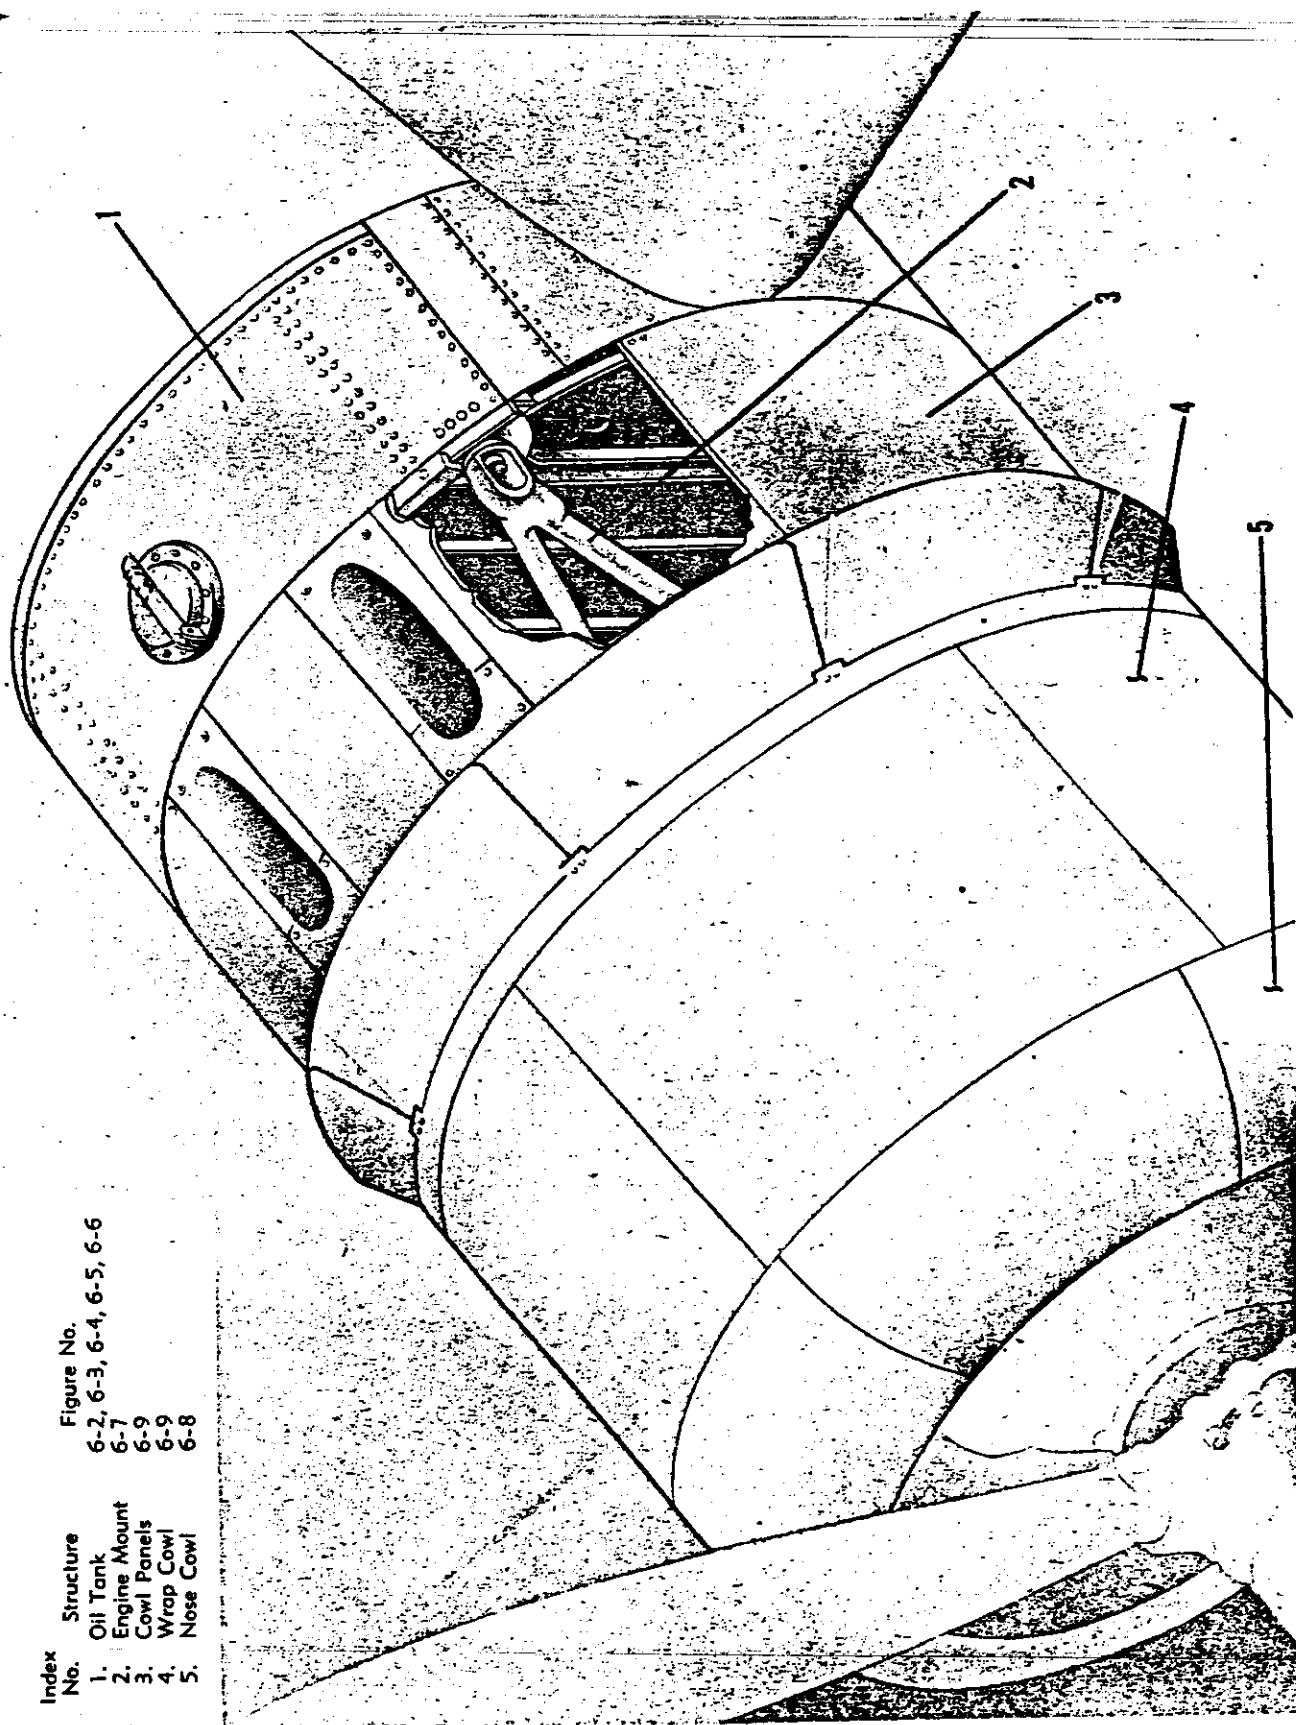
Figure 6-1—Engine Section Components

Index No.	Structure	Figure No.
1.	Oil Tank	6-2, 6-3, 6-4, 6-5, 6-6
2.	Engine Mount	6-7
3.	Cowl Panels	6-9
4.	Wrap Cowl	6-9
5.	Nose Cowl	6-8

(See figure 6-1.)

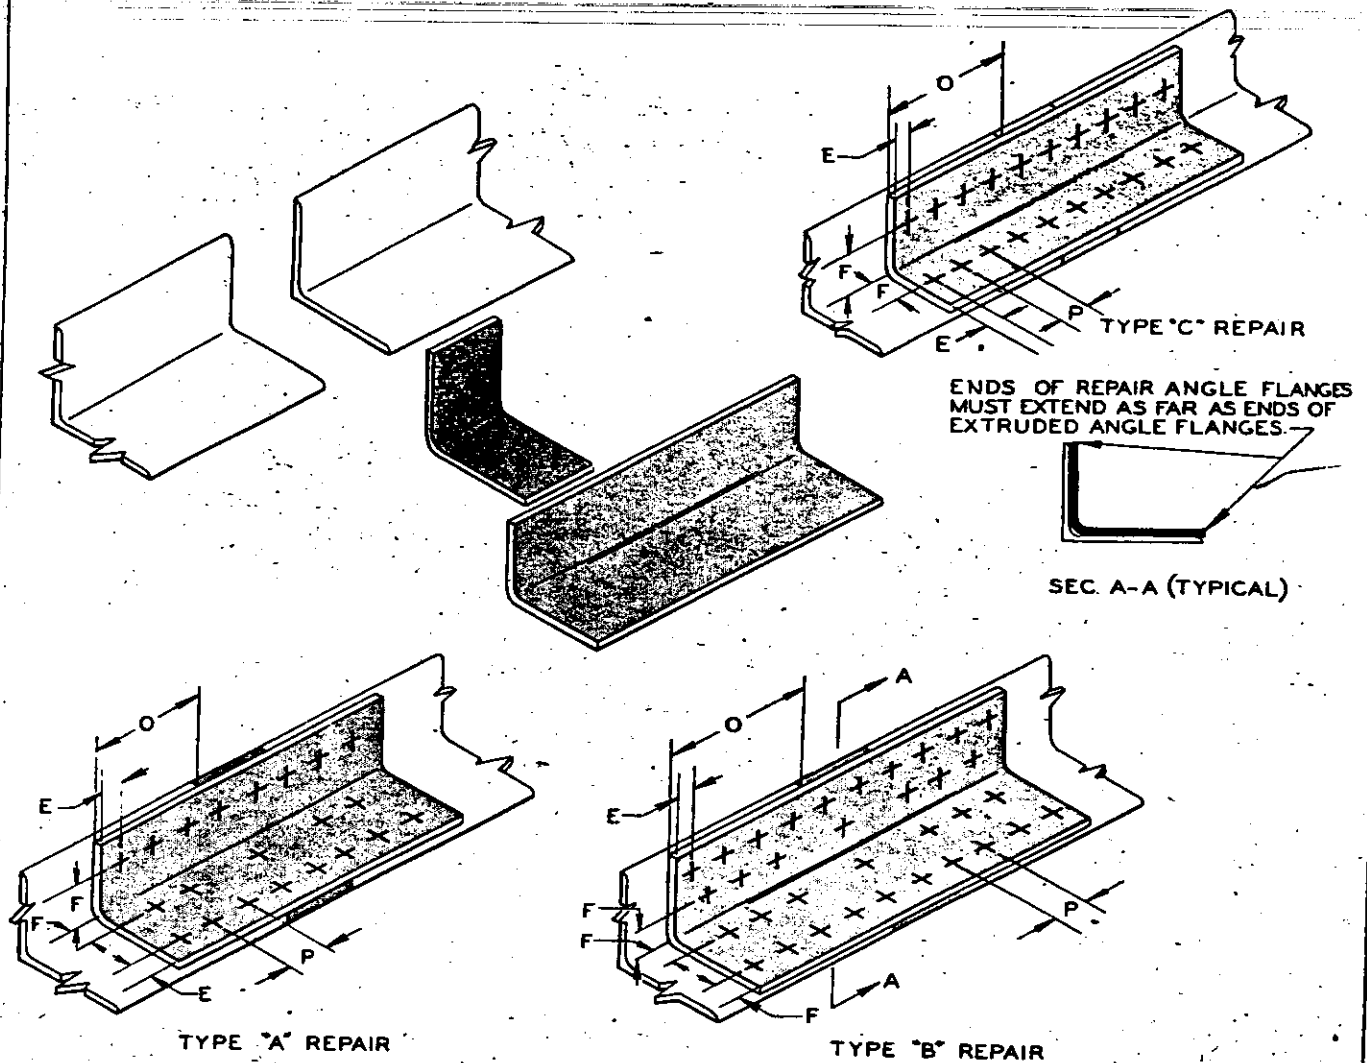
Figure B-2—Typical Repairs—Unequal Angles

NOTES:  
ALL SPLICE MATERIAL TO BE 24ST ALUMINUM ALLOY.  
FOR INSERT USE PIECE OF SAME EXTRUSION AS THAT DAMAGED  
OR THE EQUIVALENT BENT-UP SECTION GIVEN IN SECTION VIII.  
\* INDICATES TWO REPAIR ANGLES, ONE NESTED WITHIN THE OTHER.

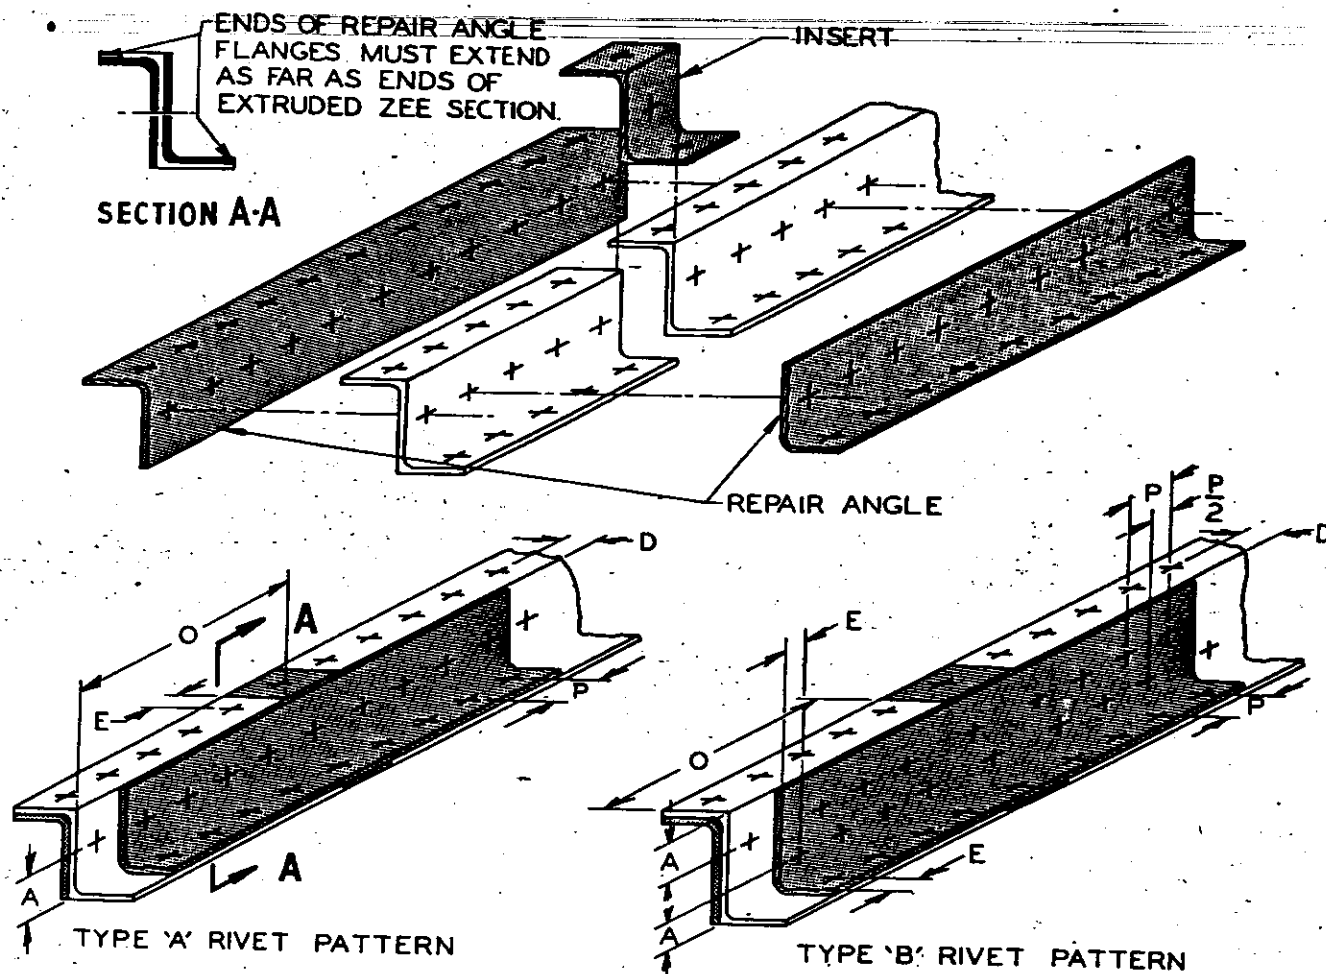
Figure B-4—Typical Repairs—Extruded Zee Sections

ALL SPLICE MATERIAL TO BE 24ST AL. ALLOY.  
FOR INSERT USE PIECE OF SAME EXTRUSION OR THE EQUIVALENT BENT UP SECTION  
GIVEN IN SECTION VIII.  
FILE OFF LIPS OF EXTRUSION TO ALLOW FOR SPLICING.

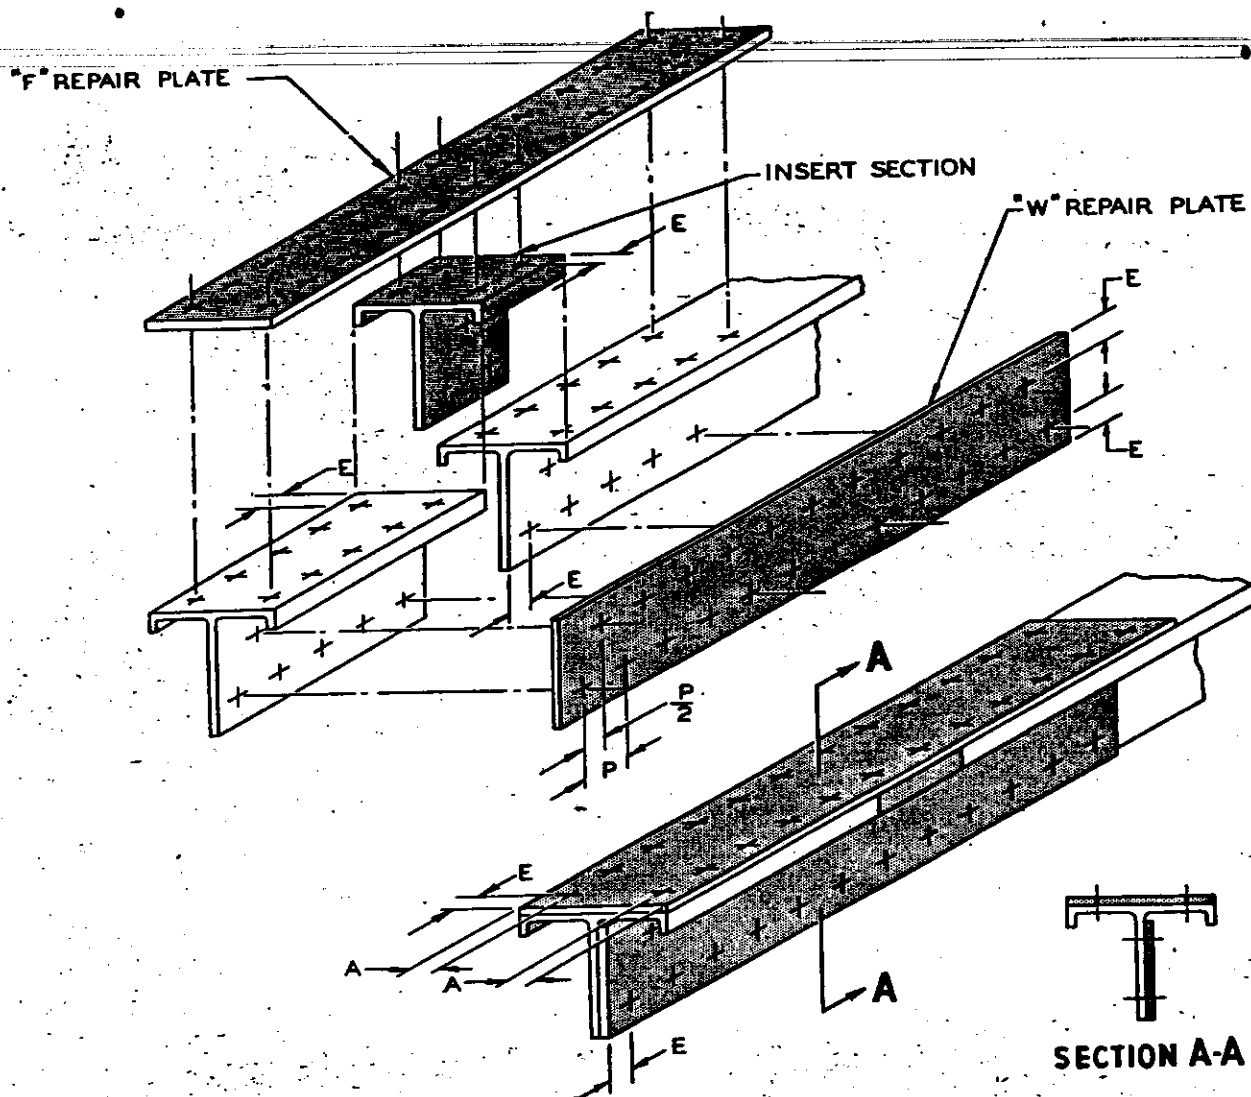
Figure B-5—Typical Repairs—Extruded Tee Sections

ALL SPLICE MATERIAL TO BE 24ST AL ALLOY.  
FOR INSERT USE PIECE OF SAME EXTRUSION AS THAT DAMAGED OR  
THE EQUIVALENT BENT UP SECTION GIVEN IN SECTION VIII
